## Learning from Earthquakes

# Observations on the Southern Sumatra Earthquakes of September 12-13, 2007

This report is derived from a longer version by Elizabeth Hausler and Aaron Anderson of Build Change, currently based in Banda Aceh, Indonesia. They conducted site visits to Indonesia's provinces of Bengkulu and West Sumatra September 17-25, and to the Mentawai Islands October 6-9. Their full report is available at [http://www.eeri.org/life/indonesia\\_southern\\_sumatra.html](http://www.eeri.org/life/indonesia_southern_sumatra.html). Two additional reports are available at the same URL: one by consulting engineer Teddy Boen of Jakarta, Indonesia, and the other by Dwikorita Karnawati, Iman Satyarno, and Subagyo Pramumijoyo of Gadjah Mada University in Indonesia.

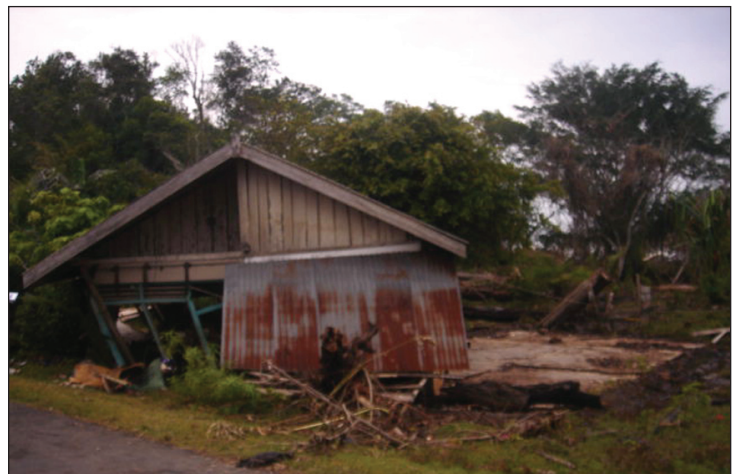
Tsunamis materialized from both shocks and affected coastal areas between Padang and Bengkulu and parts of the Mentawai Islands. Run-ups 2 m deep were observed in the south part of the Mukomuko regency, damaging houses within 500 m of beaches (Figure 2).

**Figure 2.** House pushed off its foundation by the tsunami at the coast of Serangai Village in Batik Nau District, south part of Mukomuko Regency,  $S3.2538^\circ E101.5335^\circ$  (photo: Karnawati).

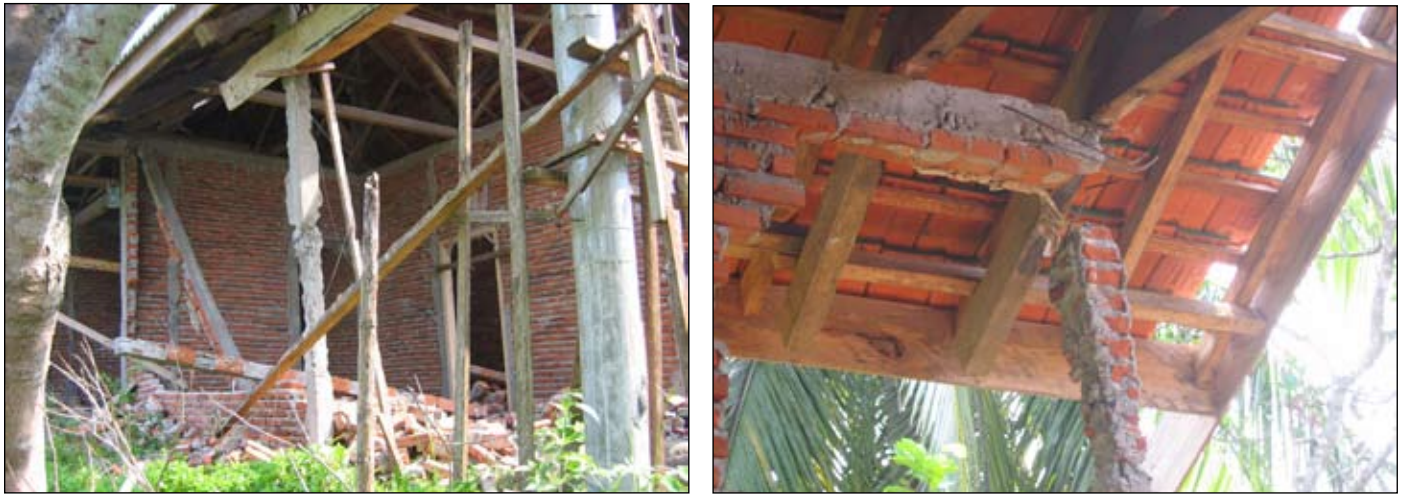
**Figure 3.** Confined masonry houses with failure in masonry walls and connections between tie columns and bond beams, Kec. Airnapal (North Bengkulu).

Figure 3 illustrates the importance of connections between confining elements. Note that the reinforced concrete columns and beams, despite their insufficient and inconsistent section and use of small diameter bars and stirrups or ties at large spacing, remain largely intact, with failure occurring in the masonry wall and at the connection between tie column and bond beam.

- (2) Poor quality workmanship in the masonry wall. Figure 3 also illustrates the importance of good quality masonry; in this case, partial collapse was initiated in the walls.
- (3) Lack of sufficient stiffness in the in-plane direction of the front wall. A common architectural preference in Indonesia is to have many large openings at the front of the house. This lack of stiffness in the in-plane direction contributed to several partial collapses (Figures 4 and 5).
- (4) Insufficient connections between tie columns and masonry walls.
- (5) Tall, slender wall prone to out-of-plane failure. With plaster, the common wall is only 13 cm thick, and walls tend to be 3 m in height. In the case shown in Figure 6, the wall was over 3.5 m tall with a

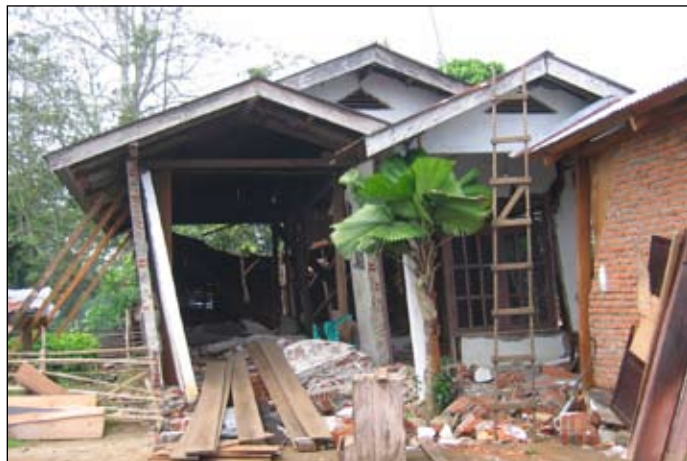
**Figure 4.** Partially collapsed unreinforced masonry house with timber bond beam (North Bengkulu).

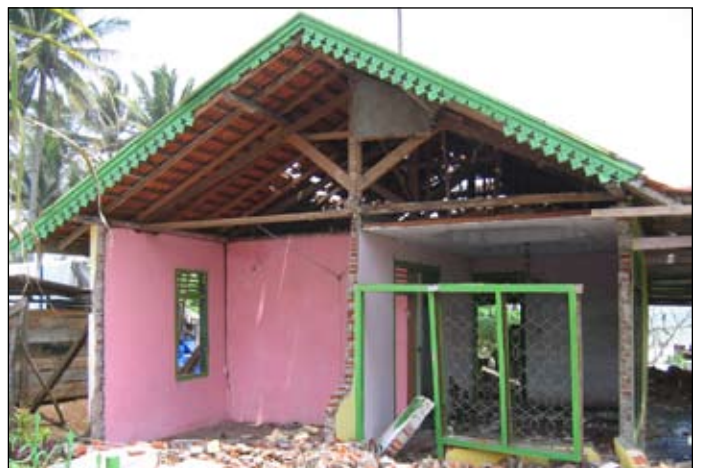
**Figure 5.** Partially collapsed brick masonry house with RC tie columns and timber bond beams. Note partial collapse of masonry gable wall and lack of inplane stiffness in front wall, Kec. Lais (North Bengkulu), S3.53217° E102.03771°.

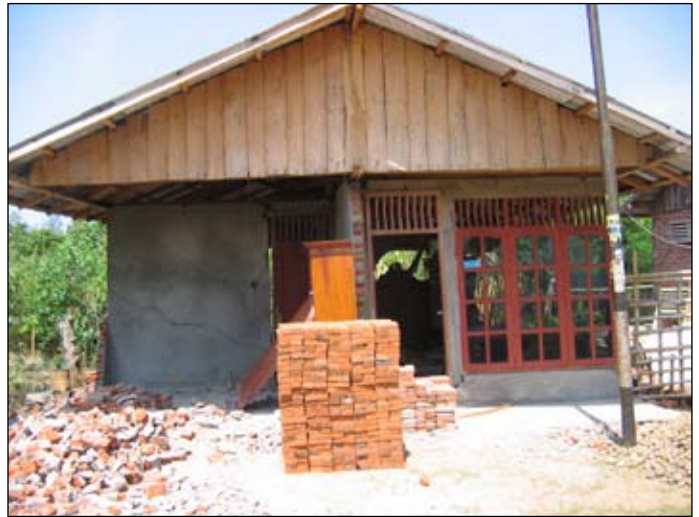
**Figure 7.** Partially collapsed unreinforced masonry house with timber bond beam, Lempuing (Bengkulu), S3.82799° E102.28473°.

- (6) Use of timber for bond beams. Common practice is to use reinforced concrete for tie columns and timber for the bond beams. This construction practice was not sufficient to prevent collapse of walls of some houses (Figure 7).

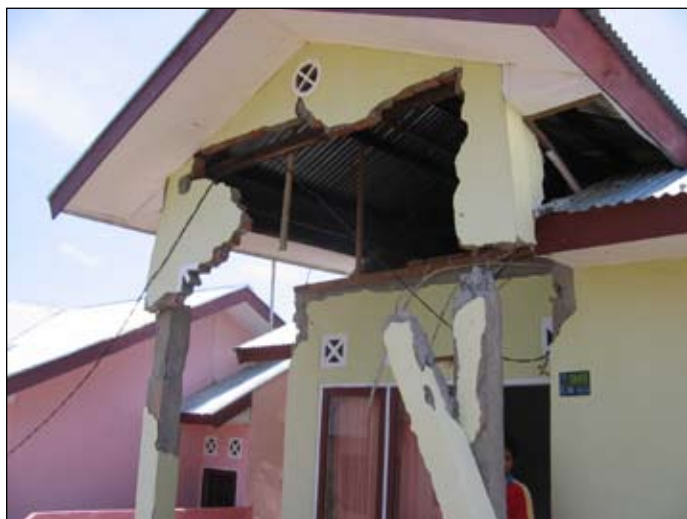
Damage was common at the upper column-beam connection in the open frame supporting the gable wall above the covered terrace (Figure 8). The gable wall and the side walls collapsed completely in several cases. The most significantly damaged structure was the only one that was not yet plastered (Figure 9); in Indonesia, cement-based plaster adds significant strength to the masonry wall. It is

**Figure 8.** Subdivision of confined masonry houses, damage to covered terrace, Bengkulu, S3.83218° E102.29287°.

likely that some houses were more damaged than others because of 1) variations in construction quality and workmanship, and 2) location on the hillslope. These failures should be studied for the purpose of improving guidelines for new confined masonry construction. The causes of these failures, particularly workmanship and poor connections, should be emphasized in the guidelines.

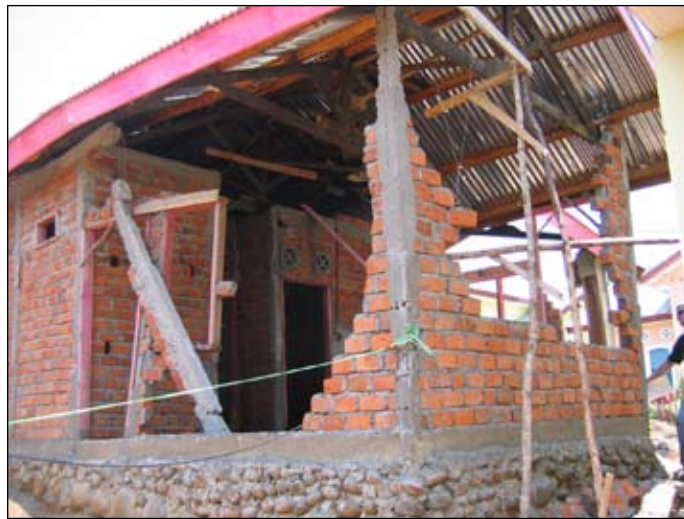
**Figure 9.** Subdivision of confined masonry houses, collapse of masonry wall exacerbated by insufficient connections, Bengkulu, S3.83218° E102.29287°.

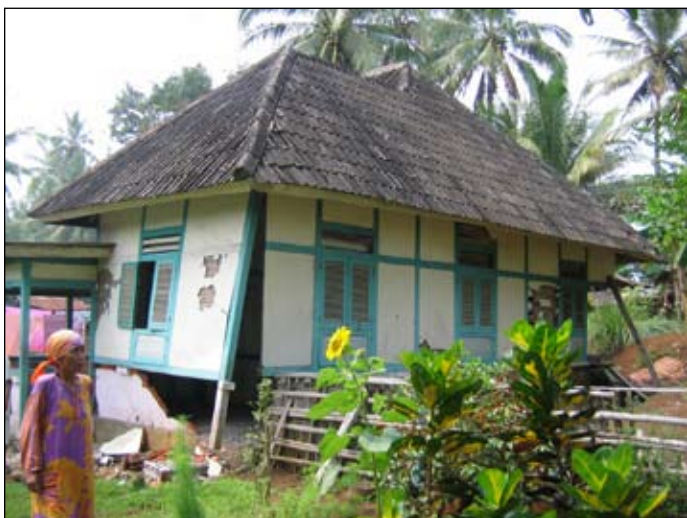
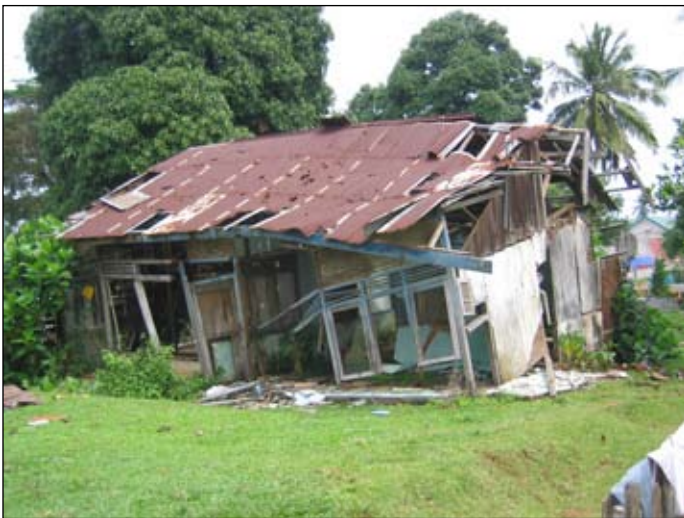
base of the wall performed well in the earthquake. Like confined masonry, this type of house is supported by a shallow stone masonry strip footing; however, there is rarely any connection between the timber posts and the footing, or the timber posts and the masonry panel. The damage to these structures, considered “semi-permanent” in Indonesia, consisted of cracking of the masonry panel, failure of the masonry panel as a rigid block, and shifting and damage to the timber frame (Figure 10).

**Figure 10.** Timber frames with masonry skirt, Kec. Lais (North Bengkulu). Left: Superstructure has shifted off, although the relatively heavy roof structure remains largely intact, and the masonry panel is partially collapsed, Kota Agung, S3.55841° E102.08951°.

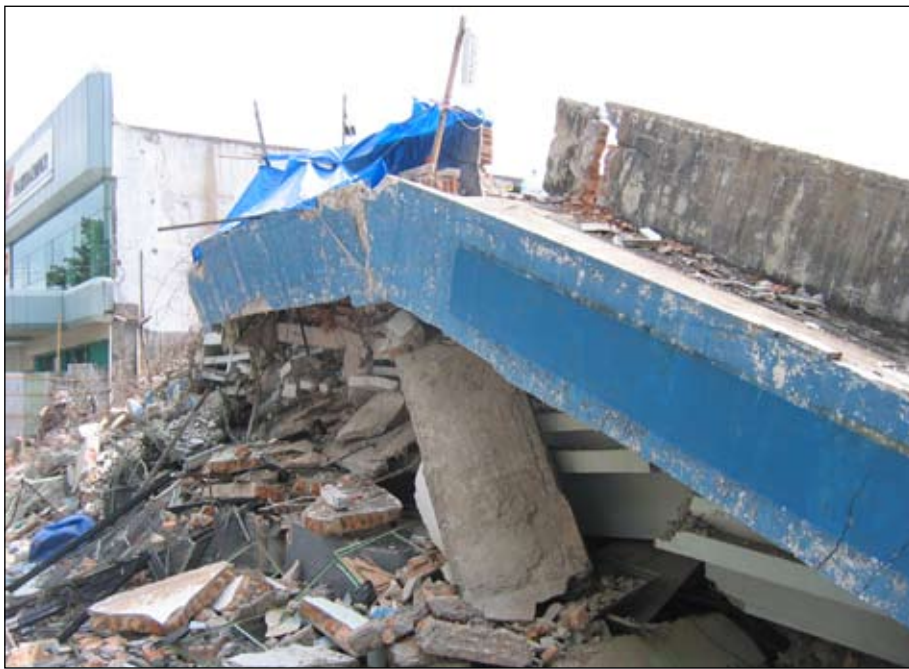
**Figure 15.** Hyundai Shop, Padang.

steel frame structures are under construction in Padang. In the cities, many multistory RC frame with masonry infill buildings had cracks; however, little structural damage was observed. In Padang, two buildings collapsed completely, both RC frame buildings with RC slab roof and floors. One of them, the Hyundai shop, is shown in Figure 15.

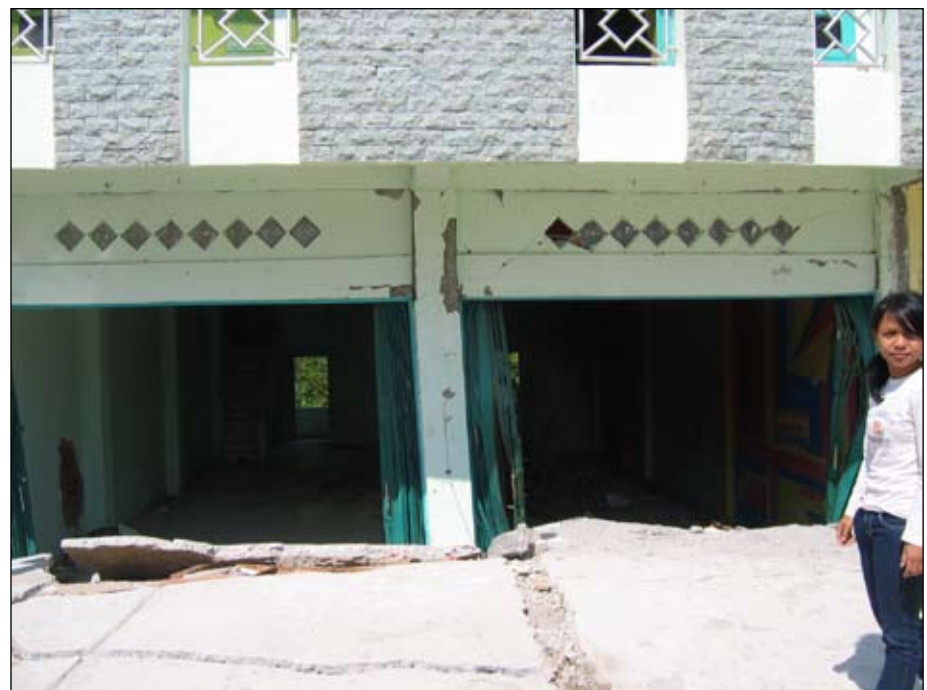
**Figure 16.** Two-story ruko, 3° tilt in first floor column, Bengkulu, S3.80362° E102.27617°.

The ground floor of the five-bay, two-story ruko shown in Figure 16 dropped by approximately 1 m due to failure at the column-slab interface. The structure is tilting back by approximately 4°, and the first floor columns are leaning to the left at 3°. Ribbed, 14 mm diameter steel was used in the columns and beams, with ties of 6 mm diameter spaced at 4 cm near the joint. Similar failure at the column-ground floor-beam interface occurred at a three-story, two-bay ruko (Figure 17). In this case, the failure was clearly exacerbated by slope failure towards the building. The columns were 32 cm x 32 cm and used up to eight smooth 15 mm diameter longitudinal bars.

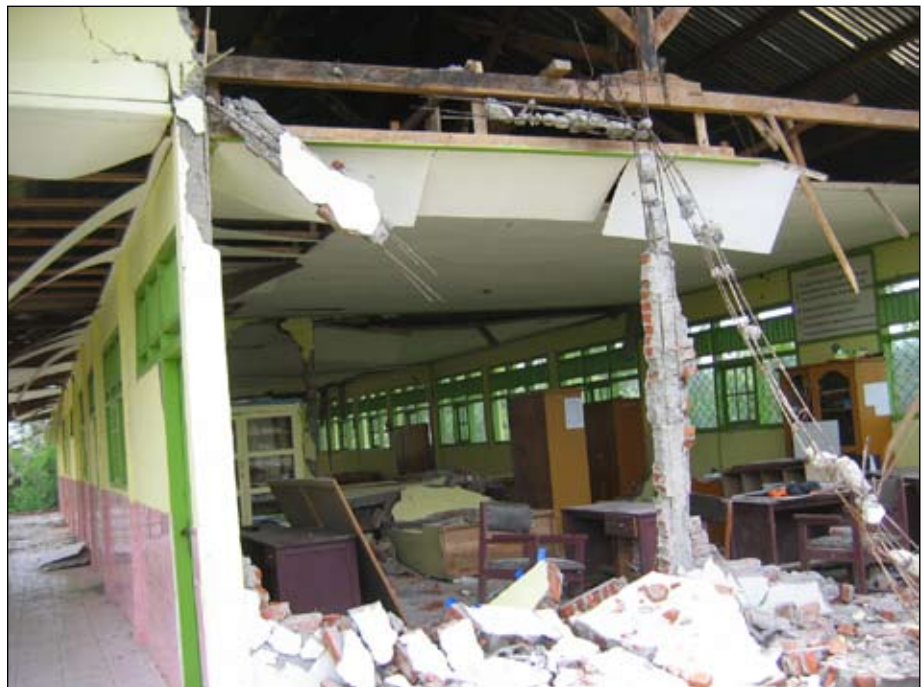
Confined masonry interior and end walls collapsed at a rural single-story school complex in Lais Sub-district (Figure 19), leaving the long walls standing and supported against out-of-plane failure primarily through column steel tied around the roof trusses. Without strong-motion recordings, it is difficult to

**Figure 19.** Sekolah Dasar Negeri No. 04, note steel splice location, use of rounded cobbles in concrete, Kec. Lais (Bengkulu), S3.52958° E102.04525°.

say how much directionality contributed to the end and interior wall collapses. The ring beams were not capable of spanning these wide classrooms. Ring beams were approximately 15 cm x 11 cm in section and used four 8 mm diameter longitudinal bars, with 4-5 mm diameter stirrups spaced at distances of 20-30 cm. Similar to the problems observed for confined masonry houses, connections between tie columns and bond beams were insufficient. Coarse gravel to cobble-size aggregate was used

in the concrete, which was broken easily by hand pressure.

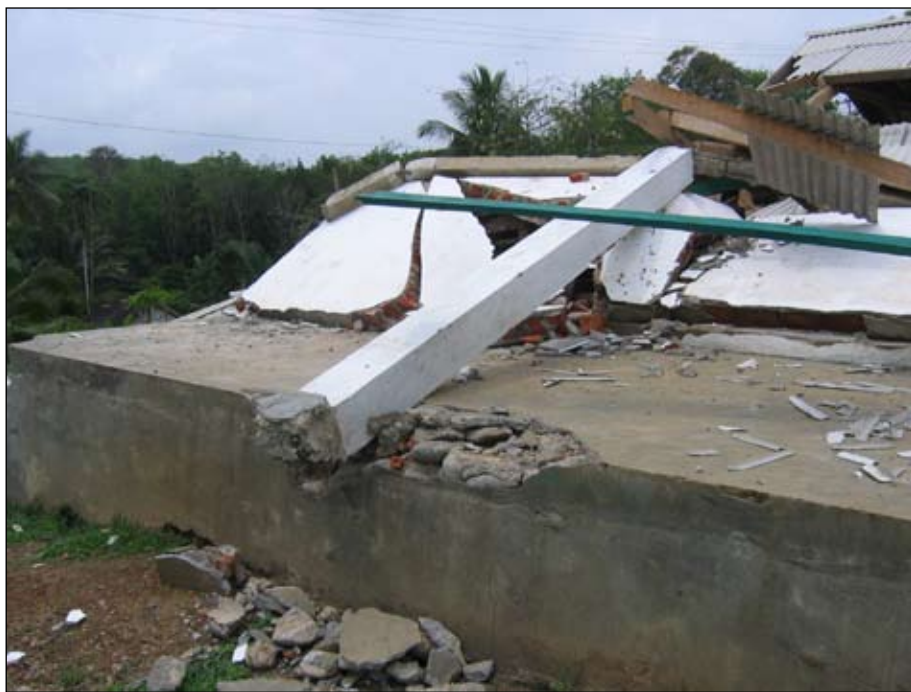
**Figure 20.** Collapsed confined masonry building, note lack of plinth beam and connection between column and plinth, Pal 30, Kec. Lais, (North Bengkulu), S3.53490° E102.05996°.

A second school compound with significant damage in Lais Subdistrict consisted of two buildings. A single-story confined masonry building collapsed (Figure 20). The plinth was built of rounded river stone masonry, without a plinth beam for the columns to tie into. Failure at these and the upper column-beam joints likely led to collapse. The columns themselves appeared to be largely intact. A newer single-story building, rectangular in

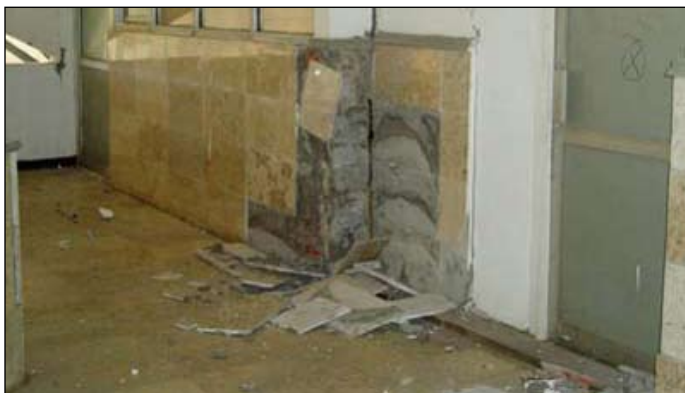
**Hospitals:** Nonstructural damage to hospital buildings in Bengkulu and Padang resulted in cracked masonry in fill walls, chipped plaster, and dust (Figure 21); patients were evacuated to tents (Figure 22). The M. Yunus hospital in Bengkulu was not operational right after the earthquake due to repair work needed. The building code considers masonry infill walls to be nonstructural elements, which has important implications for critical facilities that need to remain operational after earthquakes.

**Figure 21.** Nonstructural damage at M. Yunus hospital in Bengkulu (photo: Boen).
