### Damage to Housing

### Damage to Reinforced Concrete Buildings

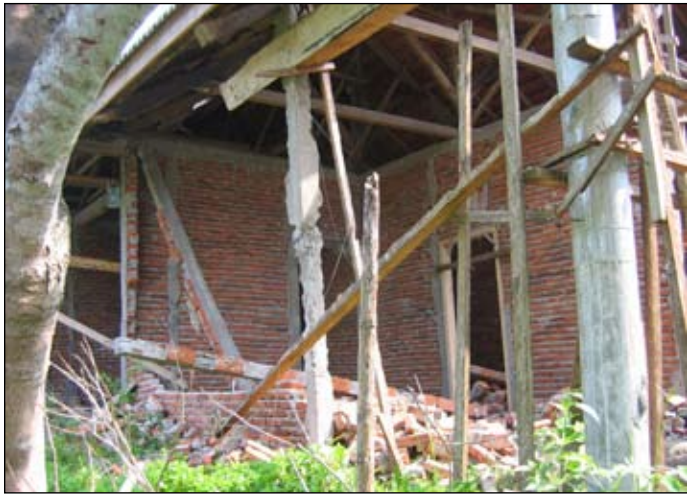
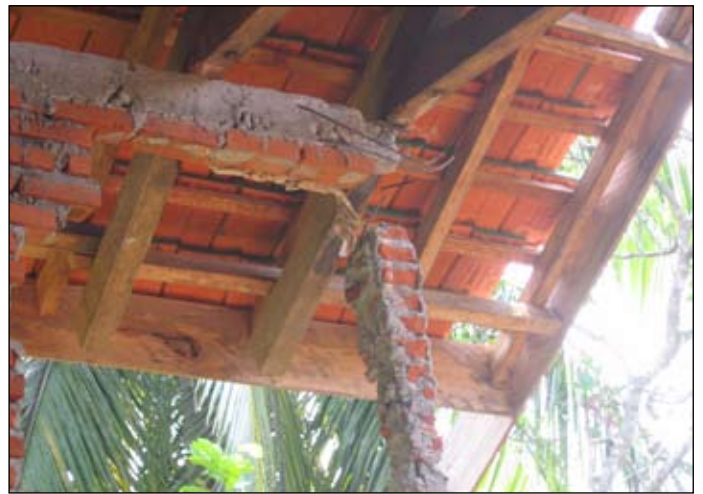
**Figure 3.** Confined masonry houses with failure in masonry walls and connections between tie columns and bond beams, Kec. Airnapal (North Bengkulu).

Figure 3 illustrates the importance of connections between confining elements. Note that the reinforced concrete columns and beams, despite their insufficient and inconsistent section and use of small diameter bars and stirrups or ties at large spacing, remain largely intact, with failure occurring in the masonry wall and at the connection between tie column and bond beam.

- (2) Poor quality workmanship in the masonry wall. Figure 3 also illustrates the importance of good quality masonry; in this case, partial collapse was initiated in the walls.
- (3) Lack of sufficient stiffness in the in-plane direction of the front wall. A common architectural preference in Indonesia is to have many large openings at the front of the house. This lack of stiffness in the in-plane direction contributed to several partial collapses (Figures 4 and 5).
- (4) Insufficient connections between tie columns and masonry walls.
- (5) Tall, slender wall prone to out-of-plane failure. With plaster, the common wall is only 13 cm thick, and walls tend to be 3 m in height. In the case shown in Figure 6, the wall was over 3.5 m tall with a

likely that some houses were more damaged than others because of 1) variations in construction quality and workmanship, and 2) location on the hillslope. These failures should be studied for the purpose of improving guidelines for new confined masonry construction. The causes of these failures, particularly workmanship and poor connections, should be emphasized in the guidelines.

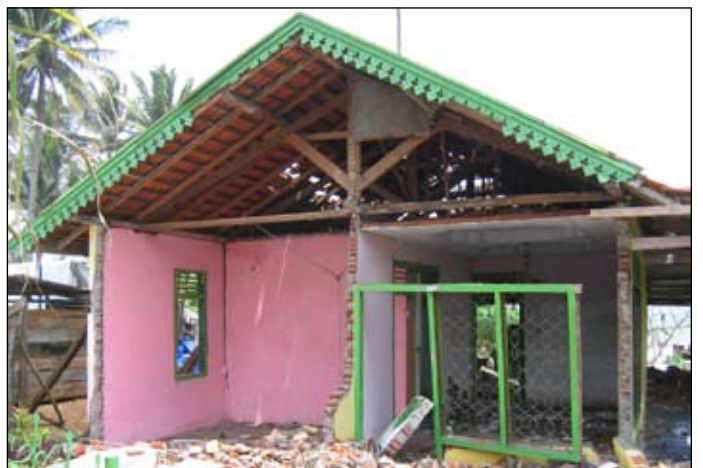
**Figure 5.** Partially collapsed brick masonry house with RC tie columns and timber bond beams. Note partial collapse of masonry gable wall and lack of inplane stiffness in front wall, Kec. Lais (North Bengkulu), S3.53217° E102.03771°.

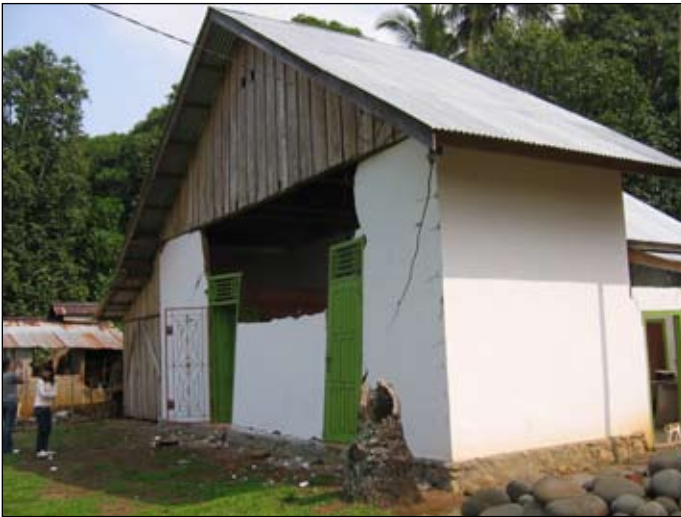
**Figure 6.** Confined masonry house with failure in masonry walls and connections between tie columns and bond beams, Kec. Airnapal (North Bengkulu).

span over 5 m without interior crosswalls or bracing.

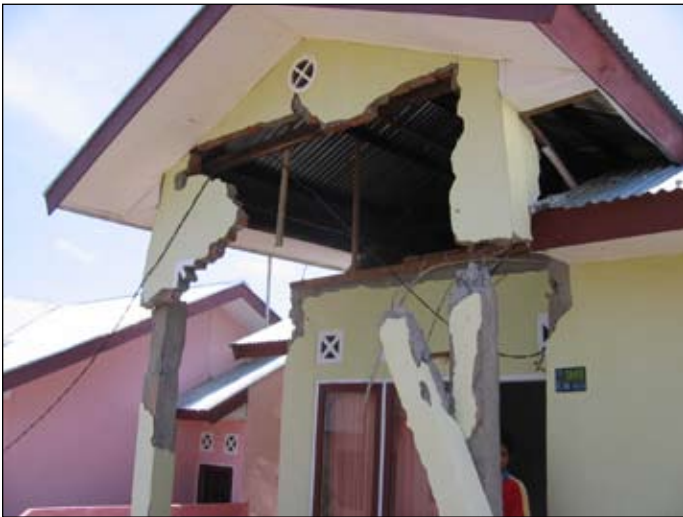
Damage was common at the upper column-beam connection in the open frame supporting the gable wall above the covered terrace (Figure 8). The gable wall and the side walls collapsed completely in several cases. The most significantly damaged structure was the only one that was not yet plastered (Figure 9); in Indonesia, cement-based plaster adds significant strength to the masonry wall. It is

**Figure 8.** Subdivision of confined masonry houses, damage to covered terrace, Bengkulu, S3.83218° E102.29287°.

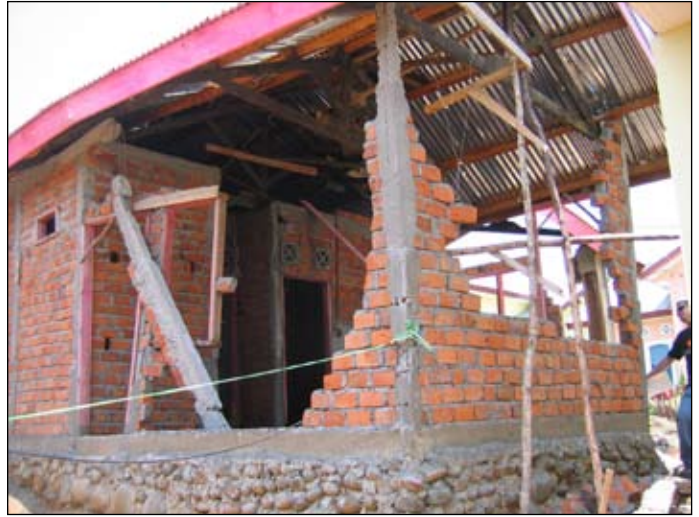
**Figure 9.** Subdivision of confined masonry houses, collapse of masonry wall exacerbated by insufficient connections, Bengkulu, S3.83218° E102.29287°.

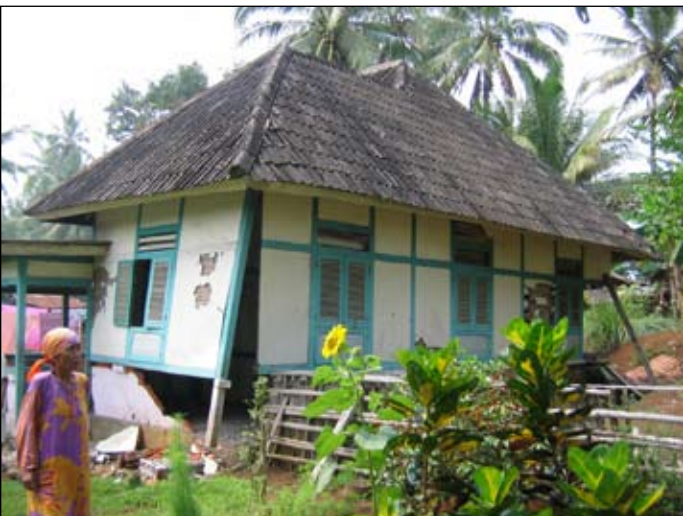
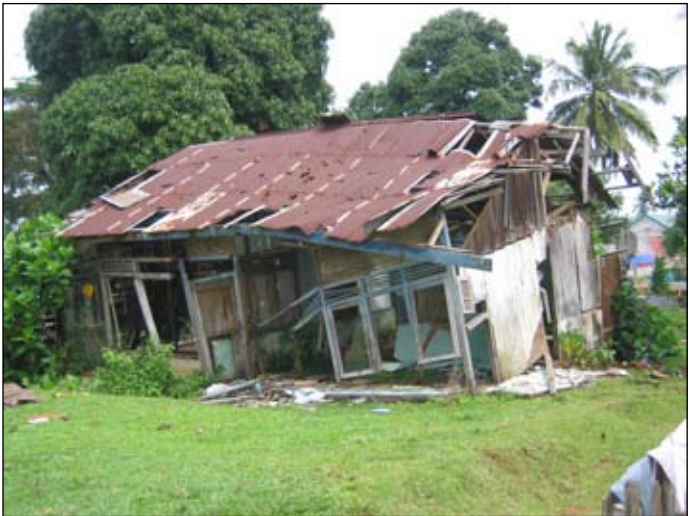
base of the wall performed well in the earthquake. Like confined masonry, this type of house is supported by a shallow stone masonry strip footing; however, there is rarely any connection between the timber posts and the footing, or the timber posts and the masonry panel. The damage to these structures, considered “semi-permanent” in Indonesia, consisted of cracking of the masonry panel, failure of the masonry panel as a rigid block, and shifting and damage to the timber frame (Figure 10).

**Figure 10.** Timber frames with masonry skirt, Kec. Lais (North Bengkulu). Left: Superstructure has shifted off, although the relatively heavy roof structure remains largely intact, and the masonry panel is partially collapsed, Kota Agung, S3.55841° E102.08951°.

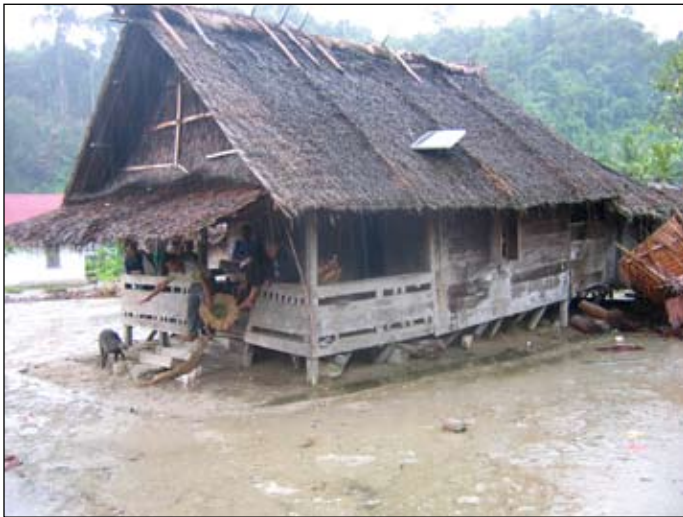
**Figure 11.** Timber frame with posts resting directly on soft ground, Barimanua, Pulau Sipora, Mentawai Islands.

Damage to the timber houses resulted from a few causes. First, timber posts rest directly on the ground, which caused the posts to sink in the ground at soft soil sites

and sites inundated by tsunami; this foundation system is vulnerable to weathering of the timber due to the lack of isolation from water uptake from the ground (Figure 11). Some houses with a stone or concrete stub foundation slid off the foundation. Superstructures lack bracing in the in-plane direction, and members are connected with nails only. Timber is not maintained or treated; newer houses with treated or painted timber performed better than those with older, weathered timber.

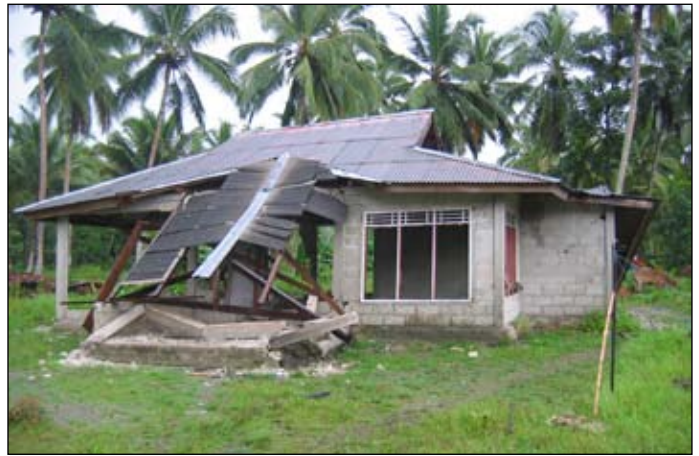
**Figure 12.** Confined concrete block masonry, partial collapse due to lack of sufficient connections between confining elements, Barimanua, Pulau Sipora, Mentawai Islands.

Confined concrete block masonry structures had similar problems to the confined masonry structures on the

mainland, including lack of sufficient connections between confining elements, and poor quality block masonry (Figure 12). Most concrete blocks are cellular. There was a wide variation in the strength of the blocks used, some of them crushing easily under hand pressure. This lack of strength results from low cement content, use of beach sand, and production by hand (without mechanical vibration).

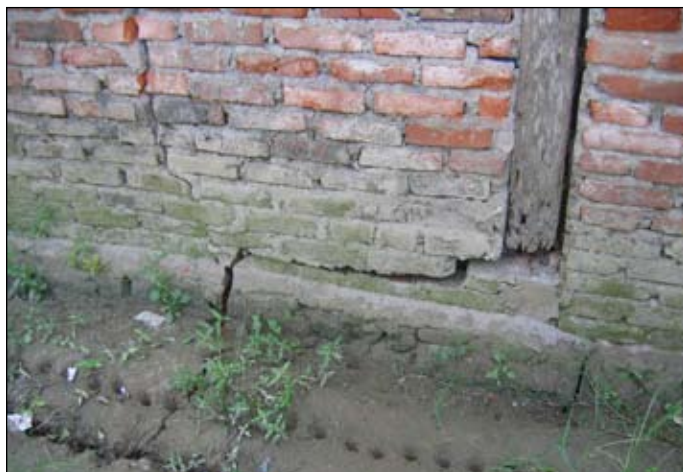
**Liquefaction effects on houses:** Effects of liquefaction, in the form of differential settlement and foundation cracking (Figure 13), vertical cracks in masonry walls, heave and cracking of interior floors, and reports of water and sand coming up

**Figure 13.** Cracks in foundation and walls associated with settlement and tilt on liquefiable soils, Lempuing (Bengkulu), S3.82799° E102.28473°

through the cracks in the floors, were found in at least six houses in Lempuing, a village on the edge of Bengkulu city. This low-elevation site consists of clean, fine to medium sand near the surface, on top of high groundwater. Floor slabs generally consist of thin (5-10 cm) unreinforced concrete.

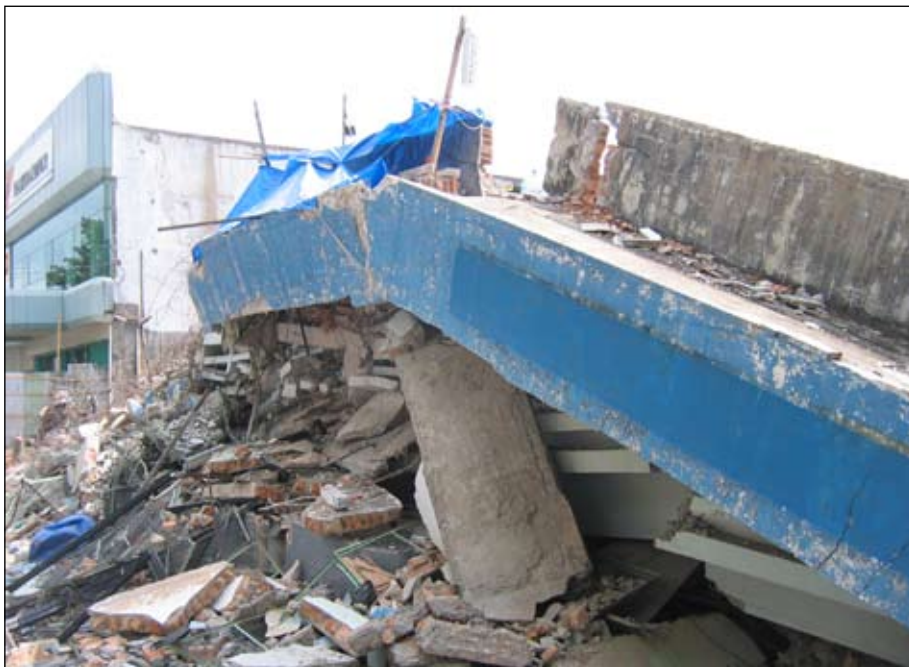
**Figure 15.** Hyundai Shop, Padang.

steel frame structures are under construction in Padang. In the cities, many multistory RC frame with masonry infill buildings had cracks; however, little structural damage was observed. In Padang, two buildings collapsed completely, both RC frame buildings with RC slab roof and floors. One of them, the Hyundai shop, is shown in Figure 15.

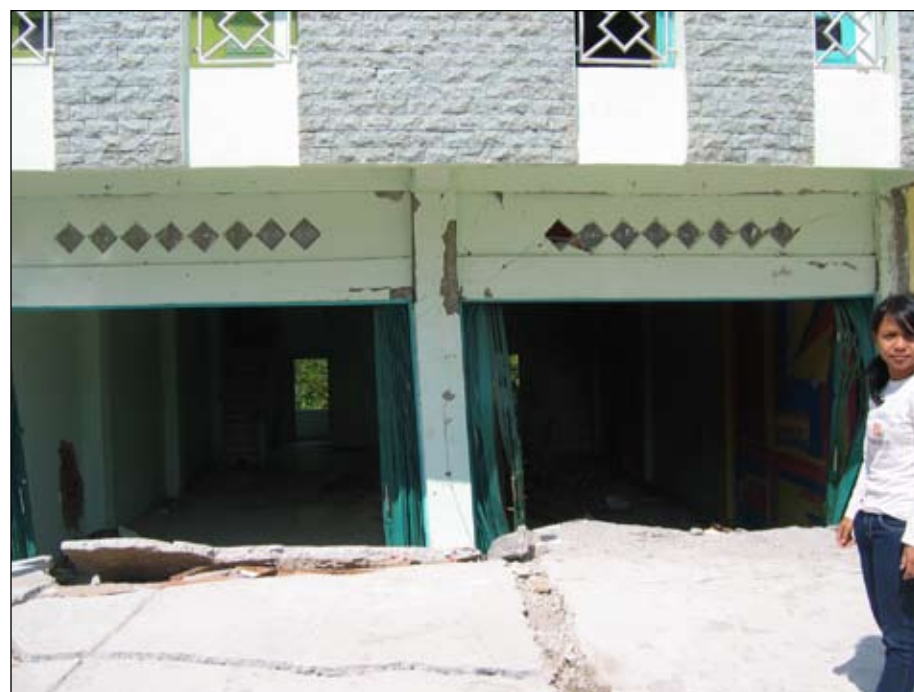
**Figure 16.** Two-story ruko, 3° tilt in first floor column, Bengkulu, S3.80362° E102.27617°.

The ground floor of the five-bay, two-story ruko shown in Figure 16 dropped by approximately 1 m due to failure at the column-slab interface. The structure is tilting back by approximately 4°, and the first floor columns are leaning to the left at 3°. Ribbed, 14 mm diameter steel was used in the columns and beams, with ties of 6 mm diameter spaced at 4 cm near the joint. Similar failure at the column-ground floor-beam interface occurred at a three-story, two-bay ruko (Figure 17). In this case, the failure was clearly exacerbated by slope failure towards the building. The columns were 32 cm x 32 cm and used up to eight smooth 15 mm diameter longitudinal bars.

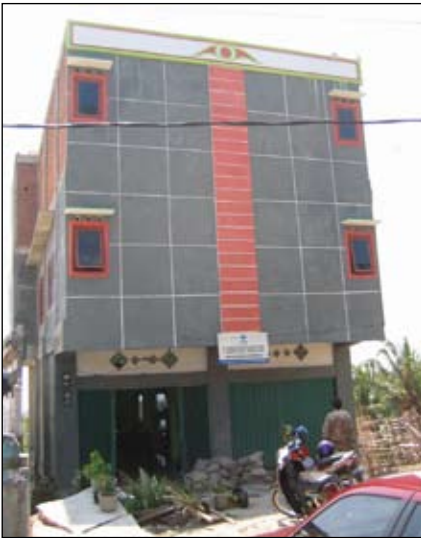
**Figure 17.** Three-story ruko, Bengkulu, S3.80581° E102.27953°.

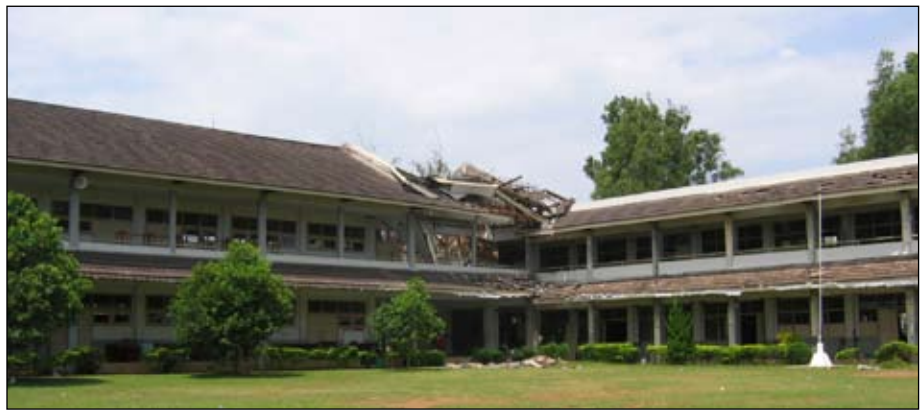
**Figure 18.** SMAK SNT Carolus School, pre-2000 earthquake building on right, post-2000 earthquake building on left, Bengkulu, S3.82846° E102.29587°.

ings, one of which was a new building constructed after the previous building collapsed in an earthquake in 2000. The other building was repaired after the 2000 earthquake. Only hairline cracks were found at the edges of masonry infill walls in the new building; however, the timber truss roof collapsed where it was joined to or battered by the older building (Figure 18). The repaired building had new, hairline cracks in the same pattern as those that were plastered and painted after the last earthquake. The tops of the first floor columns were

also cracked. It appeared that they had been previously repaired by a sealant or adhesive. Some masonry interior walls were partially collapsed.

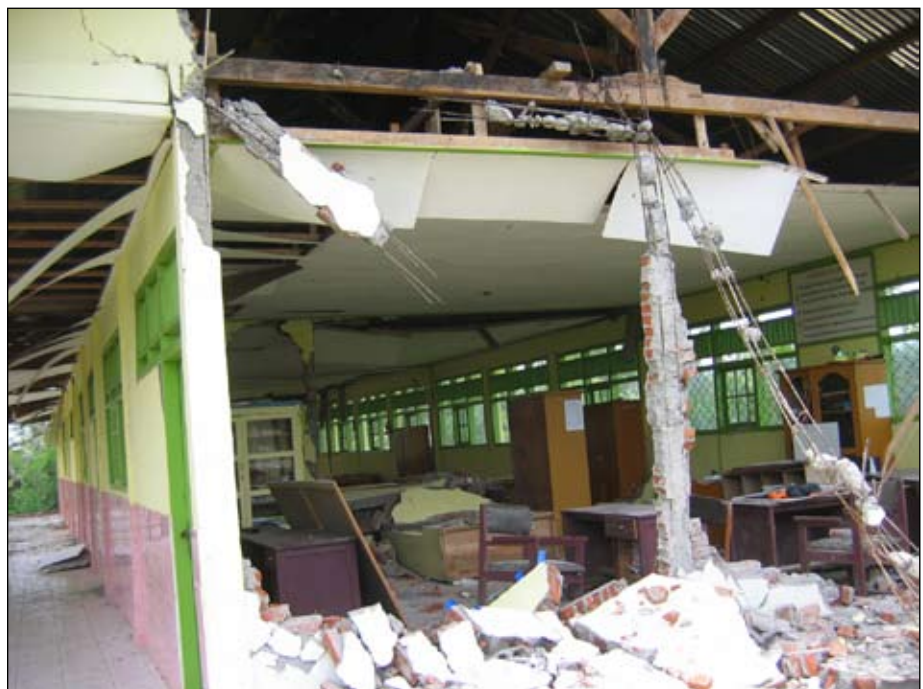
Confined masonry interior and end walls collapsed at a rural single-story school complex in Lais Sub-district (Figure 19), leaving the long walls standing and supported against out-of-plane failure primarily through column steel tied around the roof trusses. Without strong-motion recordings, it is difficult to

**Figure 19.** Sekolah Dasar Negeri No. 04, note steel splice location, use of rounded cobbles in concrete, Kec. Lais (Bengkulu), S3.52958° E102.04525°.

say how much directionality contributed to the end and interior wall collapses. The ring beams were not capable of spanning these wide classrooms. Ring beams were approximately 15 cm x 11 cm in section and used four 8 mm diameter longitudinal bars, with 4-5 mm diameter stirrups spaced at distances of 20-30 cm. Similar to the problems observed for confined masonry houses, connections between tie columns and bond beams were insufficient. Coarse gravel to cobble-size aggregate was used

in the concrete, which was broken easily by hand pressure.
