## Learning from Earthquakes

# Preliminary Observations on the Taiwan Earthquake of December 26, 2006

*This report is compiled from observations made by a reconnaissance team assembled by the National Center for Research on Earthquake Engineering (NCREE), and by the National Science and Technology Center for Disaster Reduction (NCDR), both of Taiwan. The following individuals served on the teams: Yuan-Tao Weng, Yung-Kai Yeh, Chu-Chieh J. Lin, Wen-Yu Jean, Tao-Ming Chang, Jun-Shang Chiou, Tsung-Chih Chiou, NCREE; and Ching-Yun Kao, Ming-Wey Huang, Siao-Syun Ke, Wen-Ray Su, Hao-Jan Hsing, Tzu-Hsiu Wu, Bing-Ru Wu, NCDR. The publication of this report is made possible by their generosity and is supported by the National Science Foundation through Learning from Earthquakes grant #CMMI-0650182. A more detailed report on the earthquake can be found on the EERI web site at [http://www.eeri.org/lfe/taiwan\\_region.html](http://www.eeri.org/lfe/taiwan_region.html).*

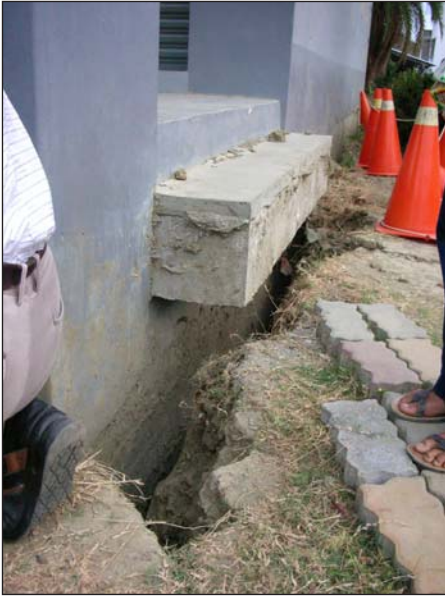
Serious geotechnical hazards were not found, but there were some cracks in ground surfaces and some displacement of school buildings. The asphalt pavement in front of the third nuclear power plant was damaged, and along an alley in front of the nuclear power plant, a series of parallel 1-5 cm wide cracks 5-10 m apart (in the direction of NW to SE) were observed on the road. At Hengchun Elementary School, some cracks were observed on ground surface, and ground settlement and horizontal displacement were observed, as shown in Figure 6. However, no sand boils or sign of

**Figure 6.** Ground settlements and lateral displacement observed in the Hengchun Elementary School.

soil liquefaction was observed nearby.

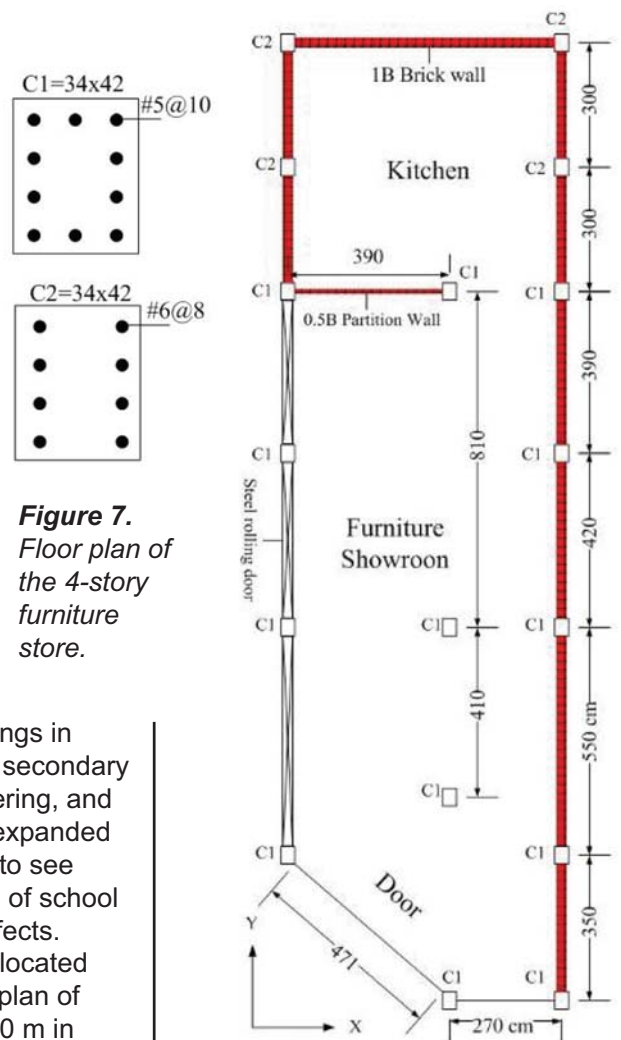
**Commercial/Residential Buildings:** The four-story collapsed furniture store with residential upper floors was constructed in the early 1980s. The brick walls were first erected and then reinforced concrete columns, beam, and slab were constructed using the brick wall as part of the formwork (reinforced masonry building). The total width and length of this building is 7 m x 23 m, respectively. The first floor of this building was for commercial use, and the rest of the floors were residential. Large openings for doors and windows were located at the street sides of the building. The frames above the ground floor were infilled with a brick masonry perimeter and partition walls. Thus, the bottom floor was comparatively weak due to the open front and open space. Figure 7 shows the schematic plan views of the building. There were a total of 15 columns. Along the long axis, the number of spans ranged from four to six; along the short axis there were one to two spans. There was obviously not

enough redundancy. Most of the brick walls were located on the right side along the long axis, which made the planar lateral stiffness asymmetric. Figure 8 shows the collapsed building after the main aftershock.

**Figure 7.** Floor plan of the 4-story furniture store.

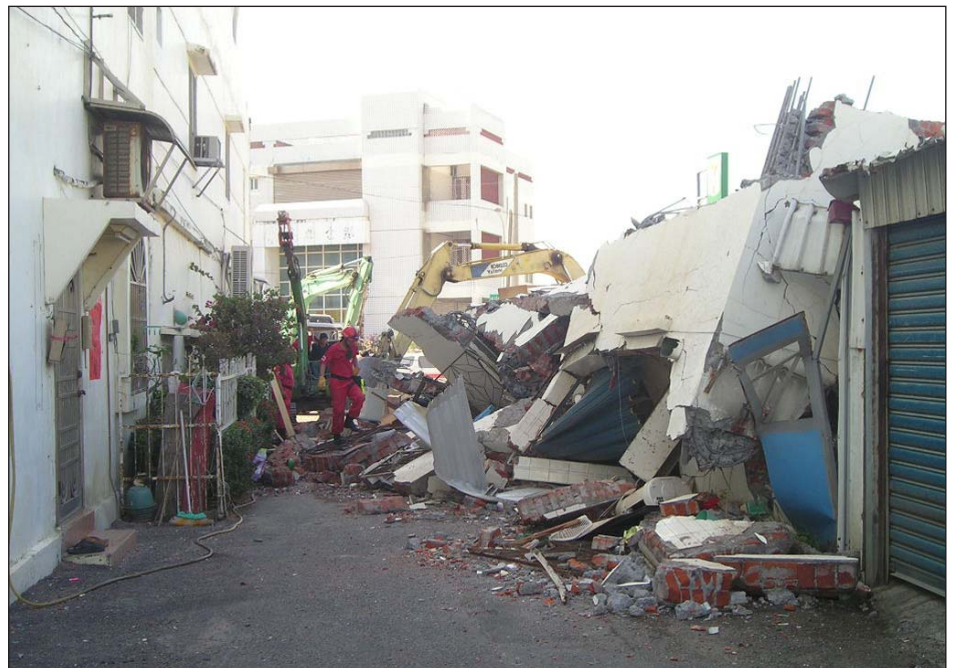
**Figure 8.** Side view of the collapsed furniture store.

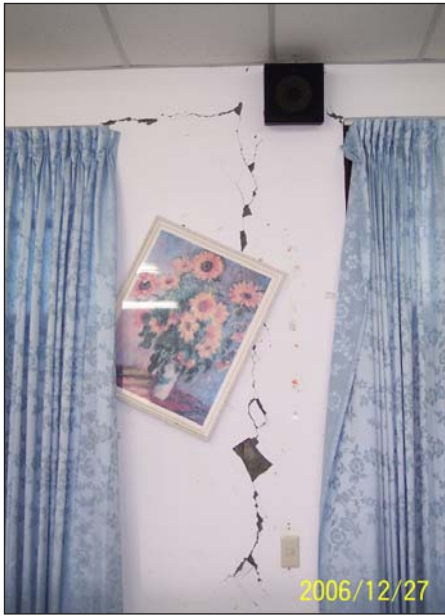
**Figure 9.** The damaged column along the corridor.

the window frame, the effective length of the column is shortened. The shorter the column, the larger the shear force. Therefore, the columns tend to fail in the shear mode rather than in the flexural mode. Figure 9 shows the column failure in shear mode, while Figure 10 shows a typical short column.

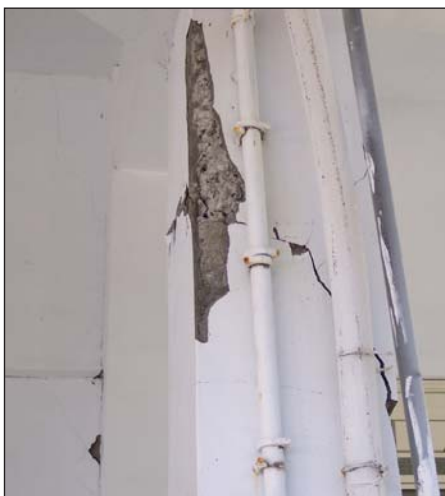
depth perpendicular to the corridor. The corridor may or may not be cantilevered. The stiffness in the direction perpendicular to the corridor is much higher than that along the corridor. In order to utilize the natural light and ventilation, windows and doors fully occupy both sides of the corridor. At the upper portion of the columns, they are constrained by the window frame made of aluminum or wood. The lower portions of the columns are constrained by the windowsill made of brick walls. Since the windowsill is rigid compared with

**Figure 10.** Shear cracks due to the short column effect.

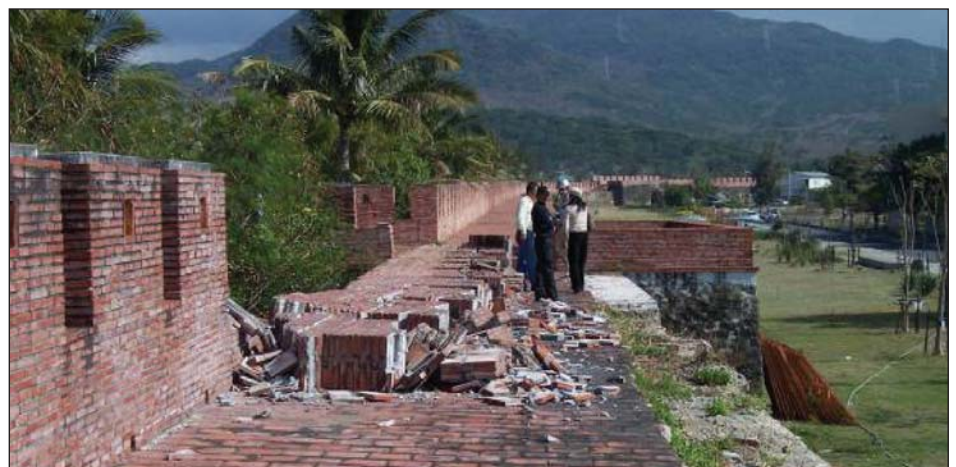
**Historical Sites:** The old city wall and gate tower of Hengchun were damaged. Several eaves of the gate tower collapsed, and a 30 m-long crack was found on the top of the wall. Around 15 battlements collapsed, as shown in Figure 11.

**Figure 11.** Collapsed battlements of the old city wall.
