Learning from Earthquakes

Preliminary Observations on the Taiwan Earthquake of December 26, 2006

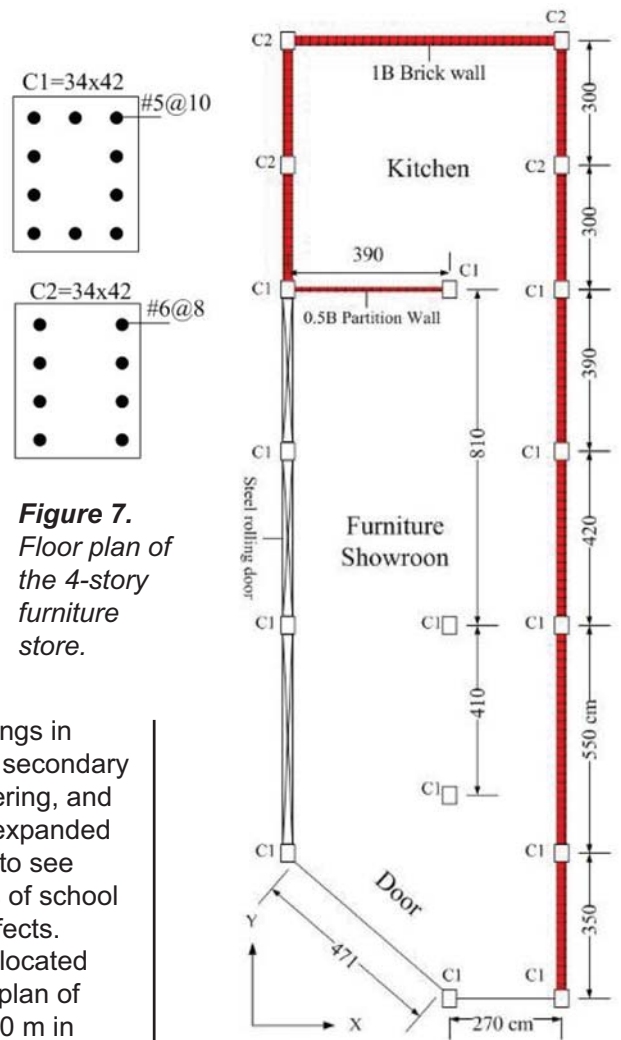
Commercial/Residential Buildings: The four-story collapsed furniture store with residential upper floors was constructed in the early 1980s. The brick walls were first erected and then reinforced concrete columns, beam, and slab were constructed using the brick wall as part of the formwork (reinforced masonry building). The total width and length of this building is 7 m x 23 m, respectively. The first floor of this building was for commercial use, and the rest of the floors were residential. Large openings for doors and windows were located at the street sides of the building. The frames above the ground floor were infilled with a brick masonry perimeter and partition walls. Thus, the bottom floor was comparatively weak due to the open front and open space. Figure 7 shows the schematic plan views of the building. There were a total of 15 columns. Along the long axis, the number of spans ranged from four to six; along the short axis there were one to two spans. There was obviously not

enough redundancy. Most of the brick walls were located on the right side along the long axis, which made the planar lateral stiffness asymmetric. Figure 8 shows the collapsed building after the main aftershock.

Figure 7. Floor plan of the 4-story furniture store.

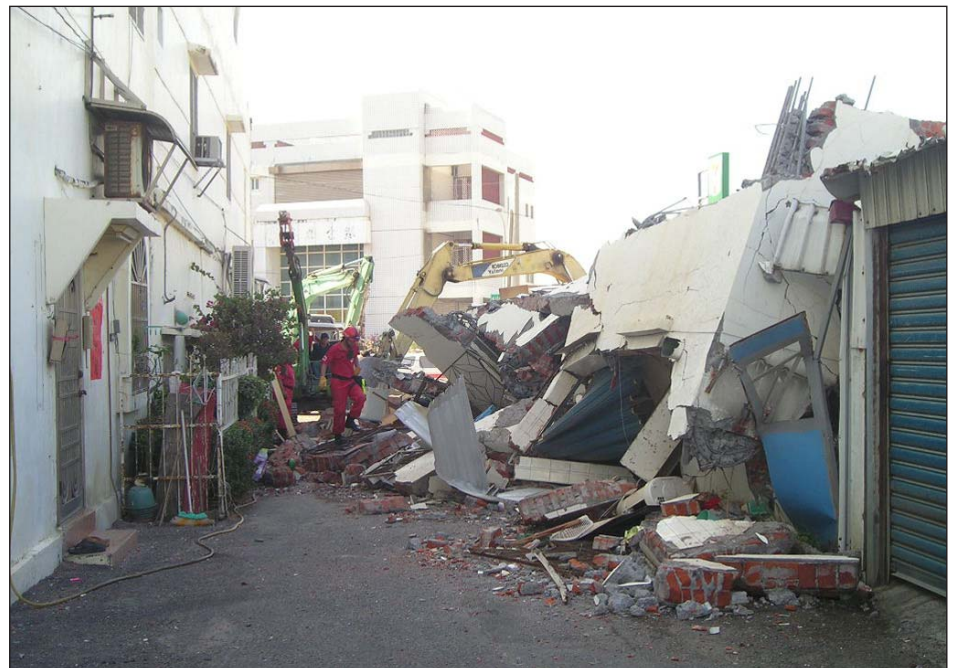
Figure 8. Side view of the collapsed furniture store.

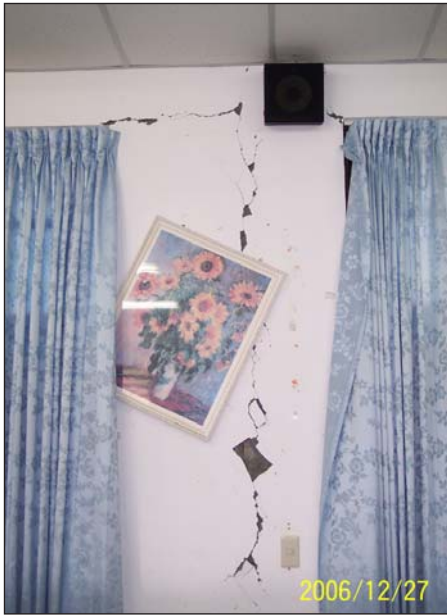
Figure 9. The damaged column along the corridor.

the window frame, the effective length of the column is shortened. The shorter the column, the larger the shear force. Therefore, the columns tend to fail in the shear mode rather than in the flexural mode. Figure 9 shows the column failure in shear mode, while Figure 10 shows a typical short column.

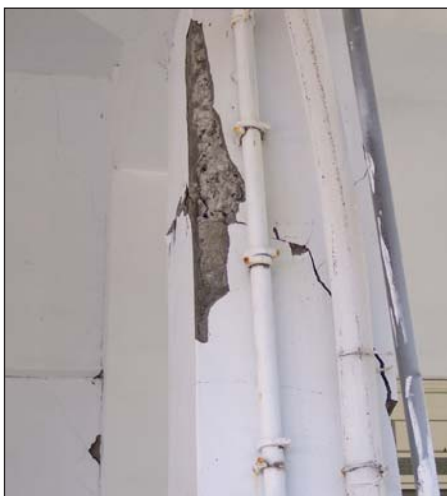
depth perpendicular to the corridor. The corridor may or may not be cantilevered. The stiffness in the direction perpendicular to the corridor is much higher than that along the corridor. In order to utilize the natural light and ventilation, windows and doors fully occupy both sides of the corridor. At the upper portion of the columns, they are constrained by the window frame made of aluminum or wood. The lower portions of the columns are constrained by the windowsill made of brick walls. Since the windowsill is rigid compared with

Figure 10. Shear cracks due to the short column effect.

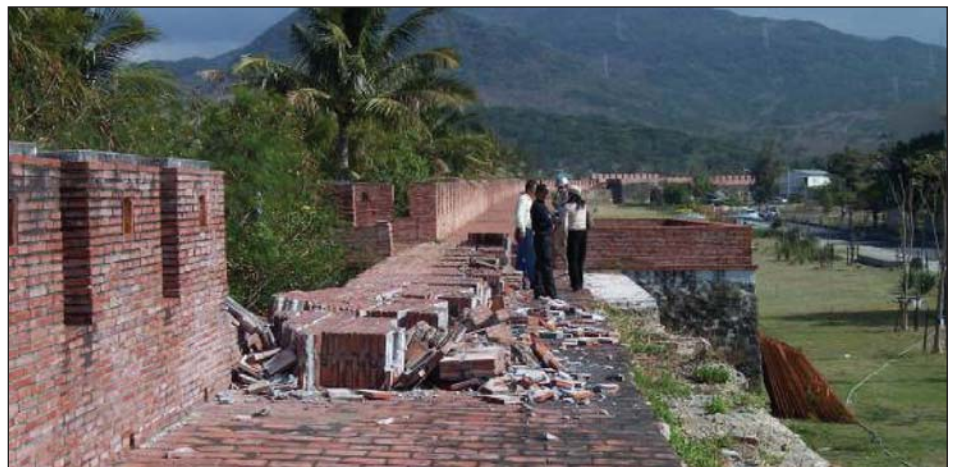
Historical Sites: The old city wall and gate tower of Hengchun were damaged. Several eaves of the gate tower collapsed, and a 30 m-long crack was found on the top of the wall. Around 15 battlements collapsed, as shown in Figure 11.

Figure 11. Collapsed battlements of the old city wall.
