Learning from Earthquakes

Preliminary Observations on the Taiwan Earthquake of December 26, 2006

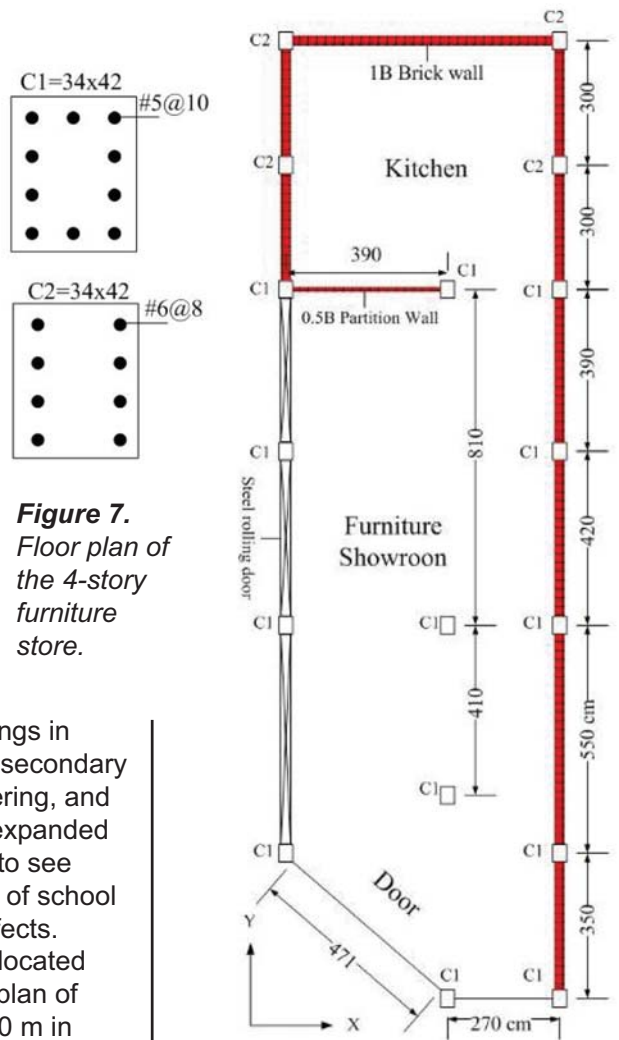
Commercial/Residential Buildings: The four-story collapsed furniture store with residential upper floors was constructed in the early 1980s. The brick walls were first erected and then reinforced concrete columns, beam, and slab were constructed using the brick wall as part of the formwork (reinforced masonry building). The total width and length of this building is 7 m x 23 m, respectively. The first floor of this building was for commercial use, and the rest of the floors were residential. Large openings for doors and windows were located at the street sides of the building. The frames above the ground floor were infilled with a brick masonry perimeter and partition walls. Thus, the bottom floor was comparatively weak due to the open front and open space. Figure 7 shows the schematic plan views of the building. There were a total of 15 columns. Along the long axis, the number of spans ranged from four to six; along the short axis there were one to two spans. There was obviously not

Figure 7. Floor plan of the 4-story furniture store.
