A Preliminary Engineering Report on the Bingöl Earthquake of May 1, 2003

Polat Gülkan, Sinan Akkar and Ufuk Yazgan

Middle East Technical University
Department of Civil Engineering and
Disaster Management Research Center

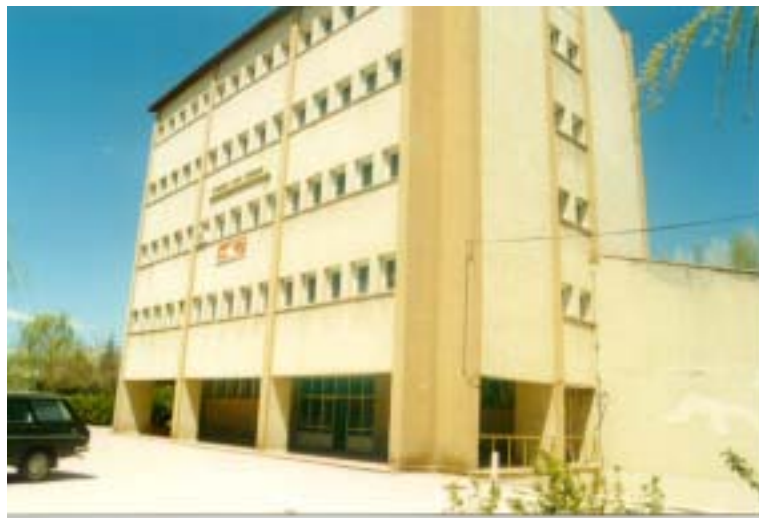
Figure 5. Ministry of Public Works and Settlement Regional Office in Bingöl (The recording instrument was in the back of the adjacent building.)

A digital instrument situated in a low-rise appurtenant building adjacent to the local office of the Ministry of Public Works and Settlement recorded the main shock. The main service building built according to a template design experienced what appeared to be moderate damage. (An identical building in Bolu was subjected to the November 12, 1999 earthquake that centered near Düzce, and was damaged more severely. Interestingly, an identical instrument in Bolu had then recorded a peak of about 0.79 g.) The new settlement area of the city situated in the north-east and shown in Figure 4 is built upon recent (Holocene) river terraces consisting of loose material with cobbles. The four-story Ministry of Public Works and Settlement building is shown in Figure 5.

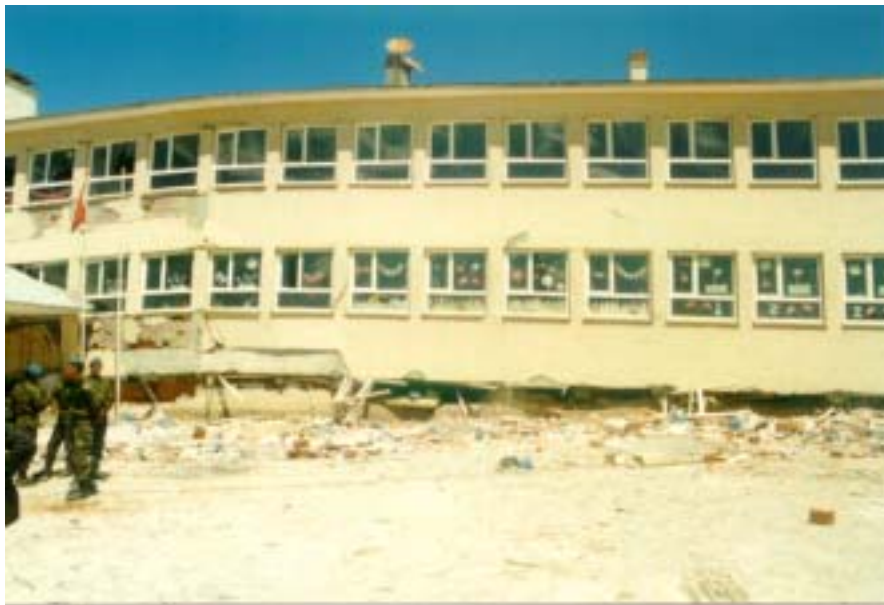
Figure 15. Çeltiksuyu Regional Primary Education School Building (Note identical entrance canopy partially visible on left. Again, the ground story had collapsed fully in exactly the same way as that in Figure 14. This building had been completed in 1998.)

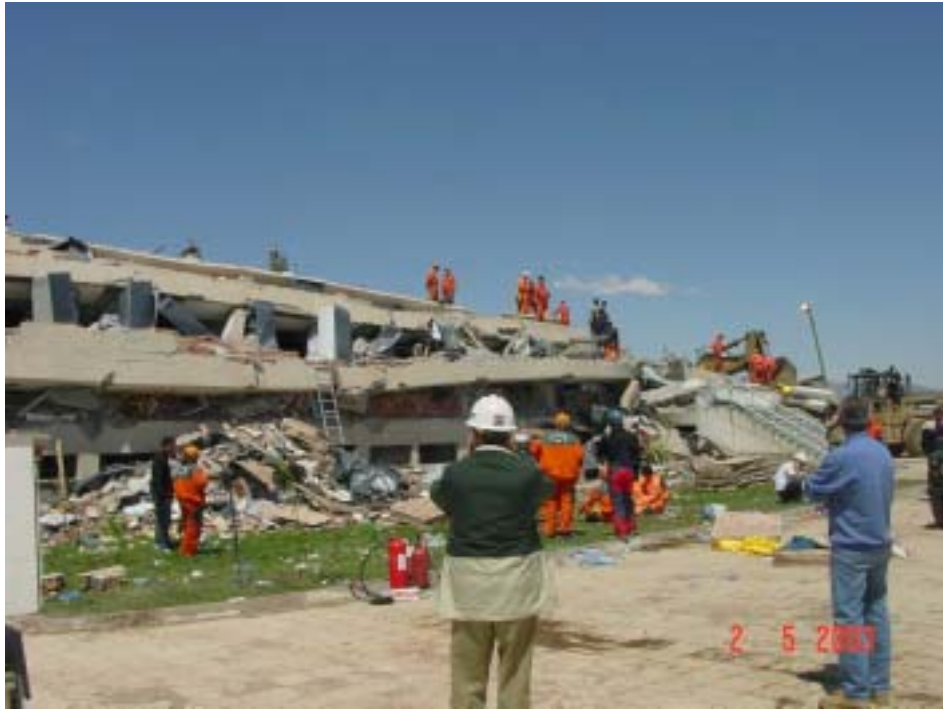
Figure 16. Dormitory Block on the west of the class room block at Çeltiksuyu Regional Primary Education School (All three stories appeared to have turned into mechanisms, resulting in complete pancake type collapse. Plain reinforcement was visible in broken columns.)

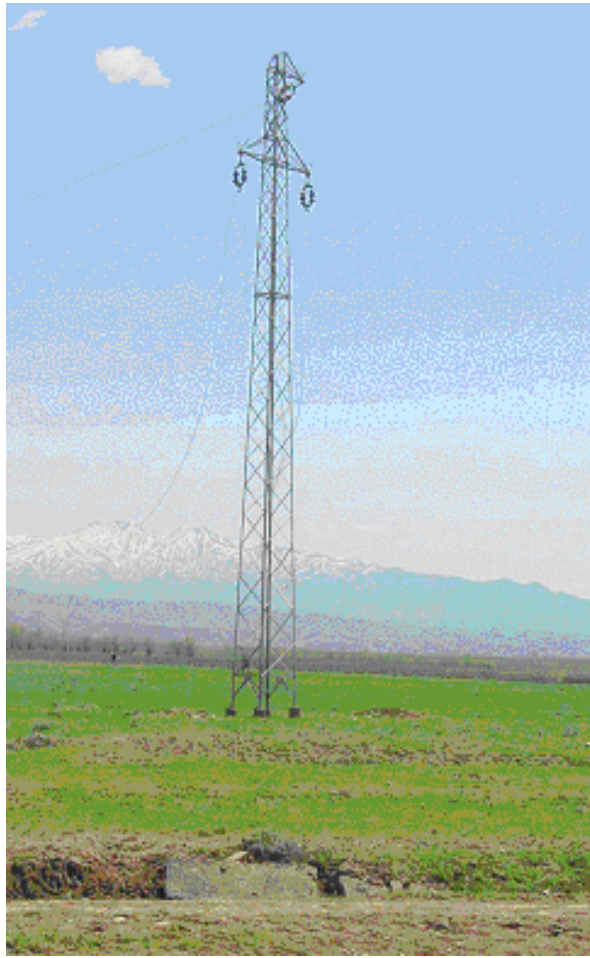
Figure 18. Power Pylon about 100 m Away from Çeltiksuyu School (Note loose alluvial soil and ground water seeping from ditch in foreground. This pylon had snapped the power cables on the west side. Soil here and at the school appeared to be S_E/S_F in the UBC characterization.)

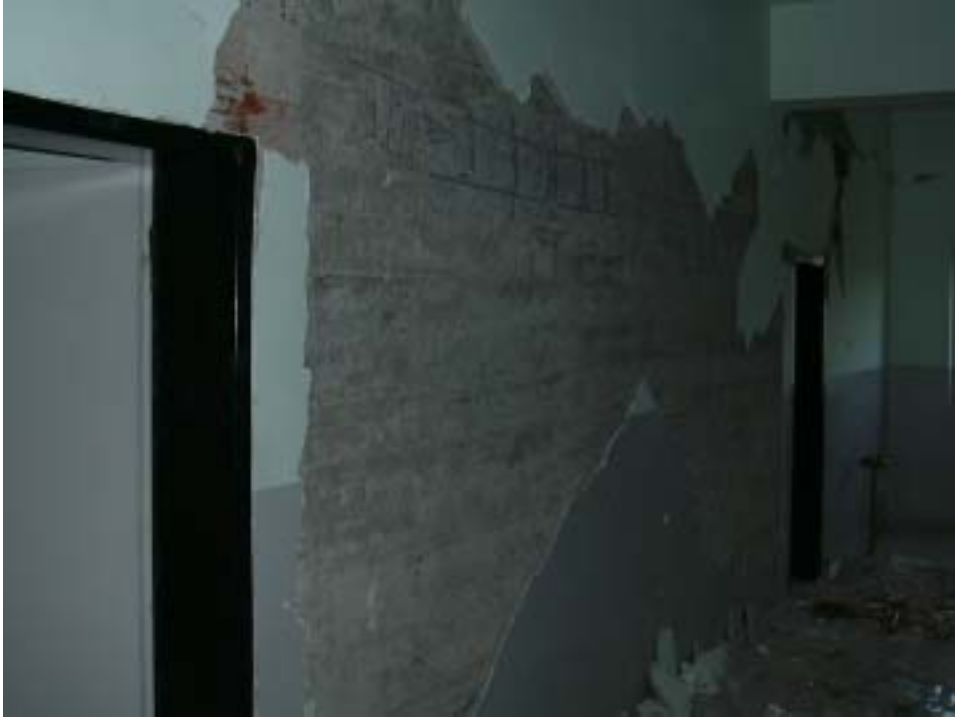
Figure 22. Just-Completed High School Building in City (The two shear walls flanking the hallway are the only ones in the longitudinal direction. Wall facing this one damaged worse. The only wall in the transverse direction appeared to be in a state similar to this. Source: Dr. E. Karaesmen.)

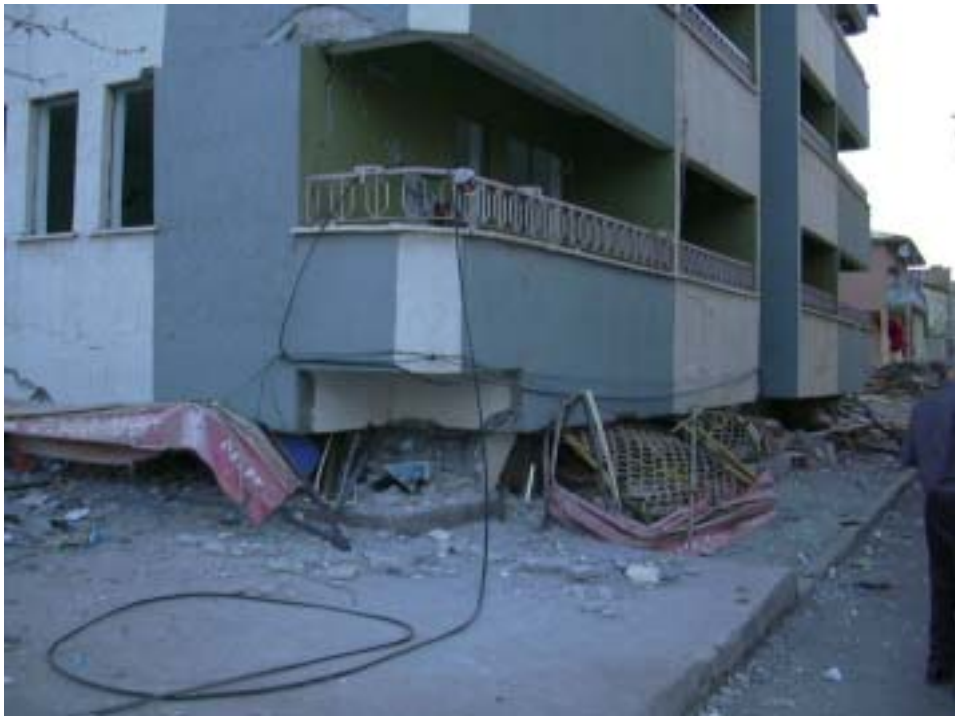
Figure 23. Another Recently Completed Building That Experienced Ground Story Failure (Source: Dr.E. Karaesmen)

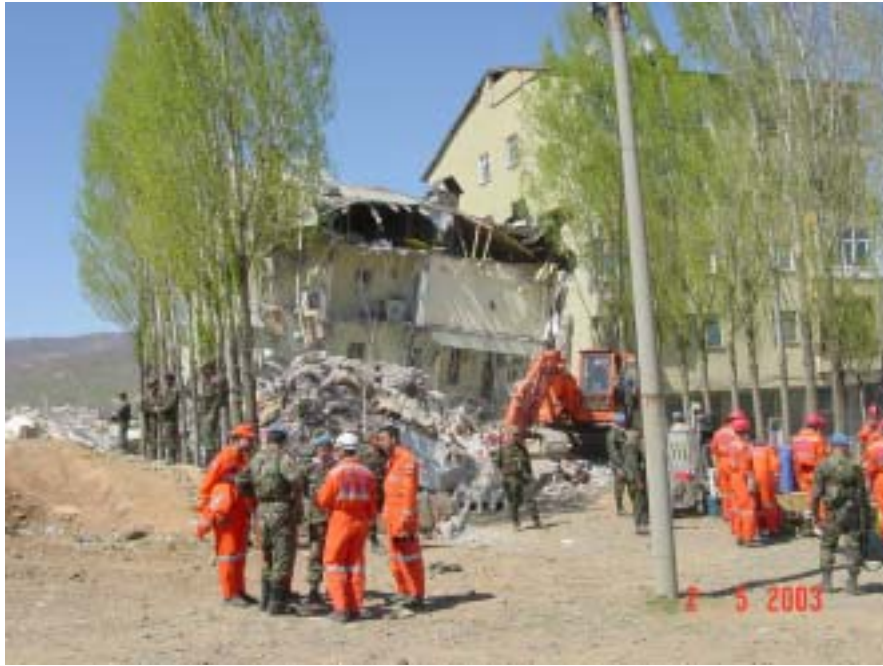
Figure 24. Collapsed Building at East Exit from City

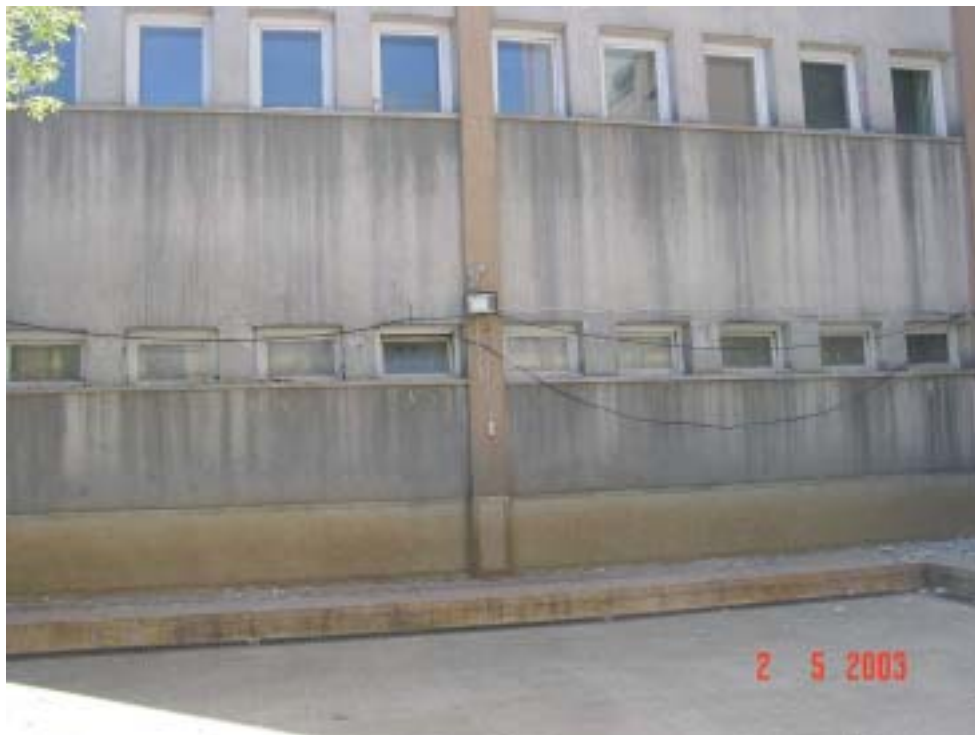
Figure 25. Regional Office Building of Public Works and Settlement from Inner Court (An identical replica in Bolu had suffered heavier damage in 1999 with column in middle shearing due to short column action. The situation here was one of impending failure in same way.)
