A Preliminary Engineering Report on the Bingöl Earthquake of May 1, 2003

Polat Gülkan, Sinan Akkar and Ufuk Yazgan

Middle East Technical University
Department of Civil Engineering and
Disaster Management Research Center

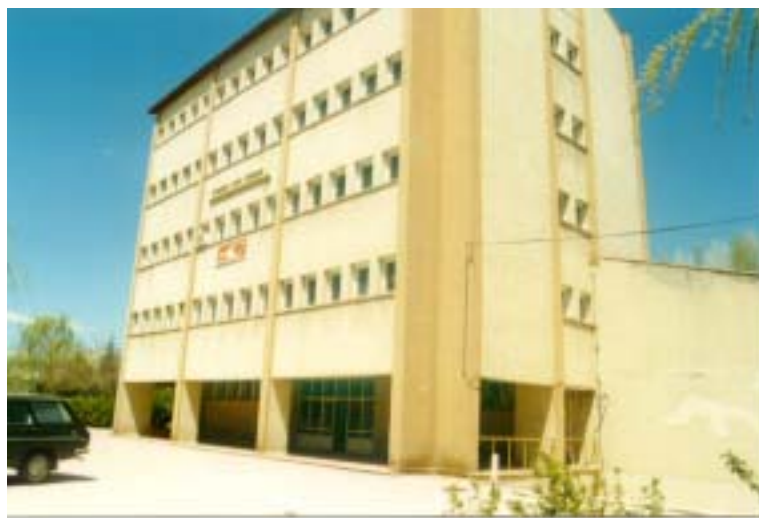
Figure 5. Ministry of Public Works and Settlement Regional Office in Bingöl (The recording instrument was in the back of the adjacent building.)

A digital instrument situated in a low-rise appurtenant building adjacent to the local office of the Ministry of Public Works and Settlement recorded the main shock. The main service building built according to a template design experienced what appeared to be moderate damage. (An identical building in Bolu was subjected to the November 12, 1999 earthquake that centered near Düzce, and was damaged more severely. Interestingly, an identical instrument in Bolu had then recorded a peak of about 0.79 g.) The new settlement area of the city situated in the north-east and shown in Figure 4 is built upon recent (Holocene) river terraces consisting of loose material with cobbles. The four-story Ministry of Public Works and Settlement building is shown in Figure 5.

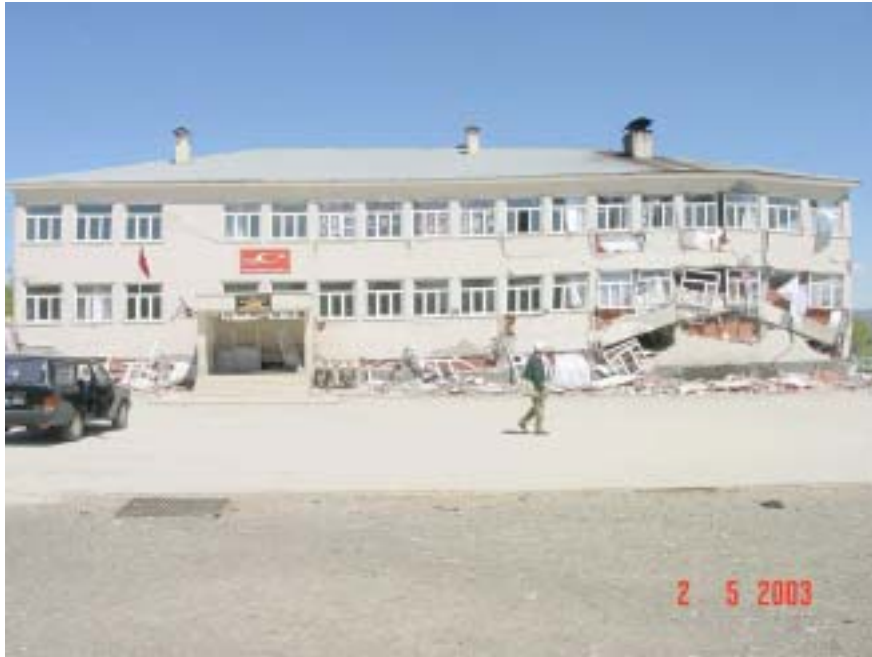
The most tragic building collapse occurred at Çeltiksuyu Regional Primary Education School when both the dormitory building with about 200 children asleep inside and the adjacent school block were badly damaged. An identical school building (Kaleönü) closer to the city and some 7 km away from the collapsed dormitory block failed in identical fashion. Regional schools are the response of the Government of Turkey to fulfill its obligation to provide facilities for the mandatory 8-year primary education. Kids from the small villages and hamlets in the surrounding area are enabled to live in them as boarders. Some are for combined boarder-daily commuter students when they are close to cities, and others may serve regular attending children during the day with no adjacent dormitories. Other institutional buildings in Bingöl also suffered structural damage.

Figure 14. Kaleönü Primary Education School Building (This school is located 7 km to the west of the one in the next figure, but has an identical design. It is located at the city fringe. Note the canopied entrance that is now at the second story level. The story mechanism appeared to have been triggered by flexural action. Column reinforcement was plain bars, transverse confinement in columns negligible, and nonexistent within joints.)

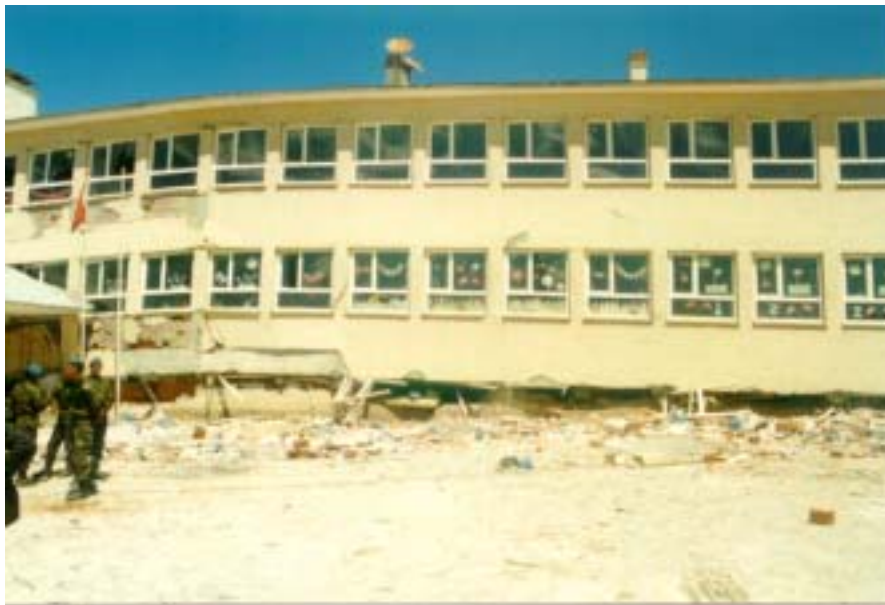
Figure 15. Çeltiksuyu Regional Primary Education School Building (Note identical entrance canopy partially visible on left. Again, the ground story had collapsed fully in exactly the same way as that in Figure 14. This building had been completed in 1998.)

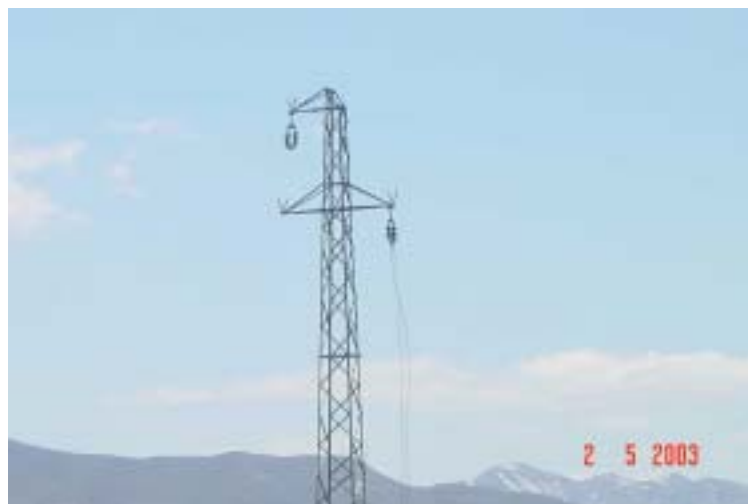
Figure 19. Pylon Immediately on West of That in Figure 18. (Could this have been an indication of an extremely powerful fling that caused the cables to rupture? The truss members appeared to be unaffected.)

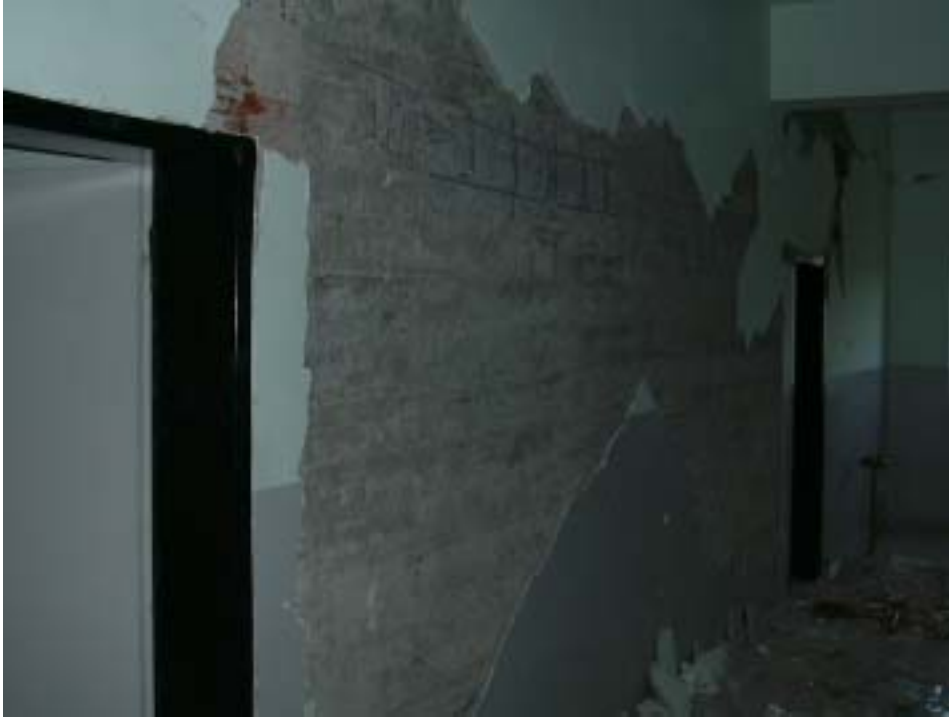
Figure 22. Just-Completed High School Building in City (The two shear walls flanking the hallway are the only ones in the longitudinal direction. Wall facing this one damaged worse. The only wall in the transverse direction appeared to be in a state similar to this. Source: Dr. E. Karaesmen.)

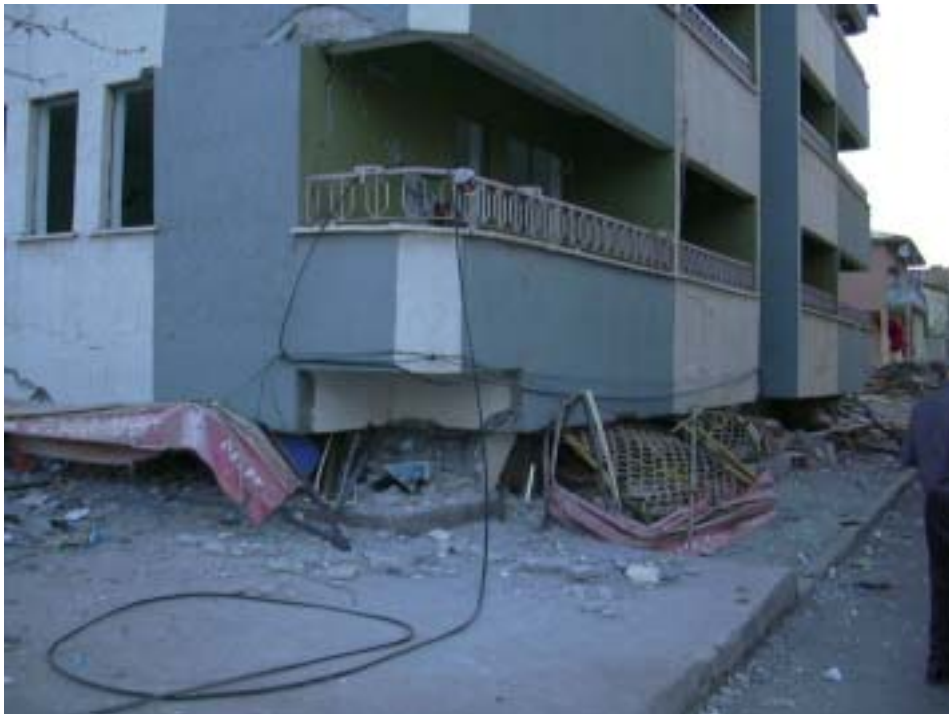
Figure 23. Another Recently Completed Building That Experienced Ground Story Failure (Source: Dr.E. Karaesmen)
