## SULTANDAGI EARTHQUAKE – TURKEY

Report by the Department of Earthquake Engineering, Kandilli Obs. and Earthquake Res. Ins., Bogazici University.

Prof. Dr. M. Erdik, K. Sesetyan, M.B. Demircioglu, U.Celep, Y.Biro; E. Uckan

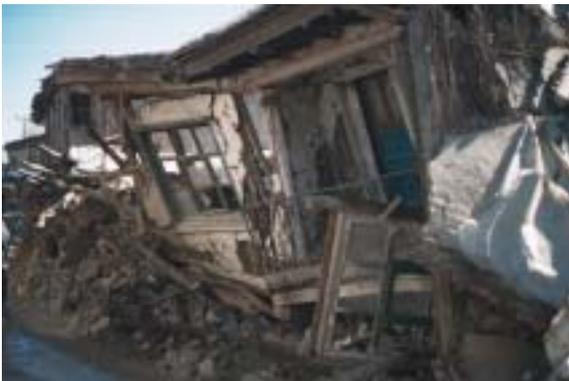
were traditionally built by their residents without engineering considerations. Thick perimeter walls and heavy roofs are common features of himis buildings providing heat isolation of the structure. The observed performance level of himis buildings indicated heavy damage and total collapse due to the poor strength and brittle behavior of the walls and considerable mass of the buildings. Observations suggest that due to the lack of rigid diaphragm action, most of the walls responded individually during the seismic attack. Moreover observation on collapsed buildings indicated that as a consequence of weak connections between the perimeter and orthogonal partitioning walls, separation occurred and most of the thick perimeter walls collapsed in the out of plane direction. Figure 7 shows a collapsed himis buildings in Eber.

Figure 7. Collapsed himis building in Eber

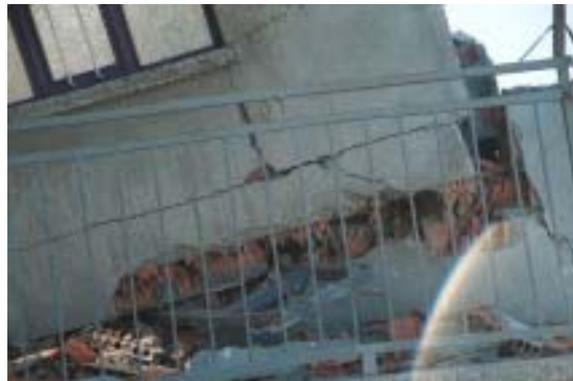
Observed heavy damage and collapse of unreinforced masonry buildings in the region are associated with hollow clay tiles used instead of solid brick units. Hollow clay tiles are widely used as infill panels in reinforced concrete buildings and are not allowed for masonry structures as load bearing members. First story collapse (Figure 8) is the common type of mechanism for the structures built with hollow clay tiles as a consequence of their very limited ductility capacities and poor strengths. Wide shear cracks between voids in the walls and evidence of crushing (Figure 9) has commonly been observed in heavily damaged hollow clay tiled buildings. However most of the buildings with less than 3 stories have survived the earthquake with minor damage even though they were built with hollow clay tiles.

Figure 8. Collapsed masonry building built with hollow clay tiles

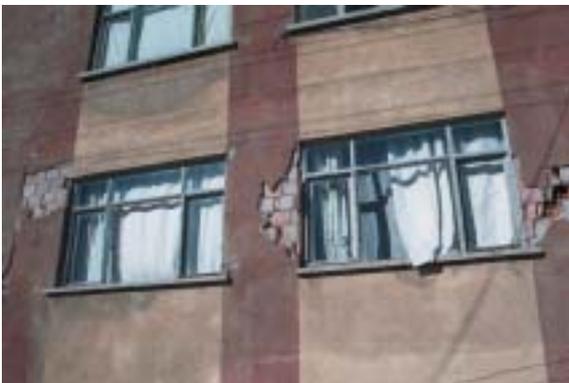
Figure 9. Heavily damaged 4 story masonry building in Cay.

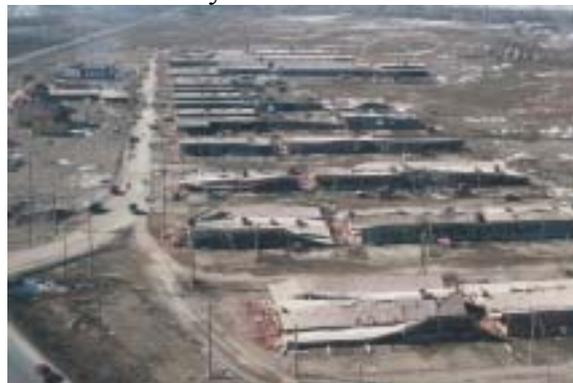
At least 30% of the blocks were totally collapsed and the remaining blocks suffered very heavy damage. The blocks were designed and completed in 90's where each block was composed of 4 spans in the transverse direction and 5 spans in the longitudinal direction. Observations suggest that plain round bars ( $f_y=220$  MPa, 40 ksi) and deformed bars ( $f_y=420$  MPa, 60 ksi) have been used as reinforcement. Bond failure of the column bars has been observed to be the major cause of the collapse where the column bars were not bent as  $90^\circ$  hooks in the beam-column joints and splices at column bases inadequately lapped. This resulted in the slip of the column bars from the joints and foundations before a sound plastic mechanism commences in the potential plastic hinge zones. Most of the collapsed blocks support this idea, that is, some of the columns either collapsed in the opposite direction of the collapsed slab or survived the earthquake even though the slab it has been supporting collapsed (Figure 12, Figure 13). Blocks that could survive the seismic attack also show the evidence of wide flexural cracks concentrated at the beam-column joint faces and splitting cracks in the beam-column joints, indicating some level of bar slip.

Figure 10. Cay commercial blocks and its mosque

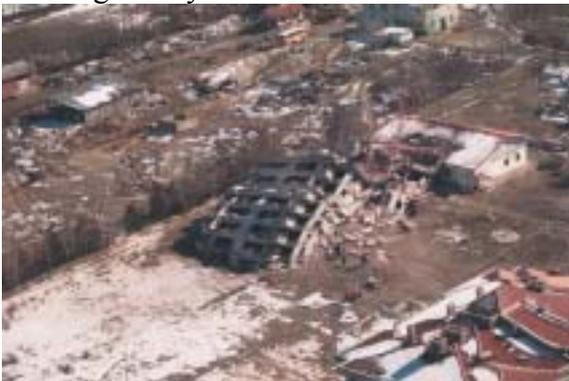
One of the buildings of three identical apartments totally collapsed and the other lost its first two stories. Observations suggest that loss of column bar anchorage at the foundation level and probably at the story levels (Figure 19) caused the collapse of the former building. Columns of the collapsed building showed no evidence of distributed flexural or shear cracks suggesting the possibility that column bars slipped before the attainment of flexural capacity. First two stories of the latter building collapsed due to inadequate transverse reinforcement details. There are many instance of crushed concrete due to excessive transverse expansion of the core concrete and shear cracks in the weak direction of the columns.

Figure 11. Collapsed and damaged 8-story apartment buildings

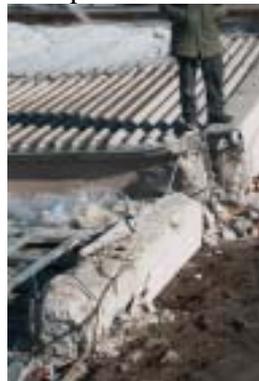
Figure 12. Collapsed column and slab in opposite directions

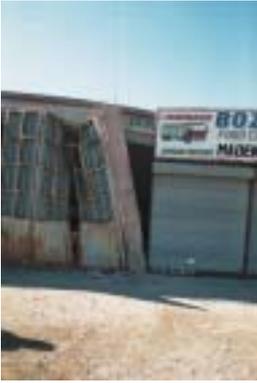
Figure 13. Collapsed slab due to bond failure of the column bars

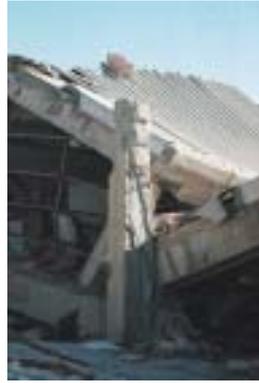
There are instances of column core concrete crushing as a consequence of inadequate transverse reinforcement failure. Transverse reinforcement spacing of 200 mm is common in most of the columns and most of the transverse reinforcement with  $90^\circ$  hooks opened (Figure 14) during the earthquake due to their poor anchorage features particularly after cover concrete spalling. Exterior beam-column joint failures have also been observed in some blocks. Details of the joints suggest that outer column bars buckled and joint cores crushed to some extent due to the lack of joint transverse reinforcement (Figure 15).

Figure 14. Spacing of transverse reinforcement visible in a column

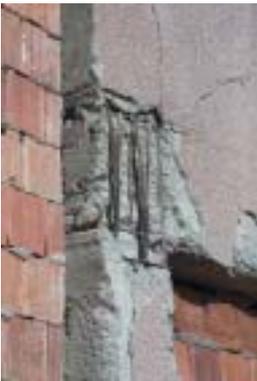
Figure 15. Exterior beam-column joint damage

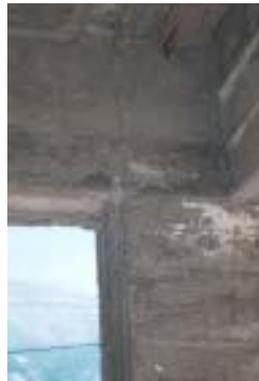
This soft story building survived the seismic attack with considerable damage. The structure is reinforced with plain round bars ( $f_y=220$  MPa, 40 ksi). Full depth single flexural cracks of 3-4mm wide at beams that are concentrated at column faces suggest some level of beam bar slip (Figure 16). Observed damage indicate that the building responded dominantly in the oblique direction causing biaxial bending at columns. Most of the bars buckled and cover concrete spalled at column corners. None of the columns exhibited shear-flexure cracks distributed over a constant length however one of the columns adjacent to infill walls in the first story failed in shear (Figure 17). It was observed that corner beam-column joints exhibited beam bar slip, longitudinal column bar buckling and some level of diagonal tension cracking (Figure 18).

Figure 16. Full depth beam flexural crack

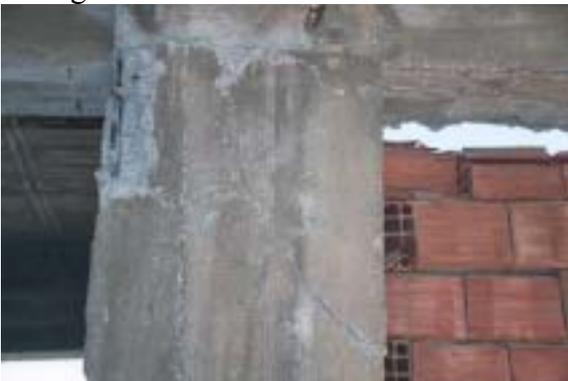
Figure 17. Observed column shear failure

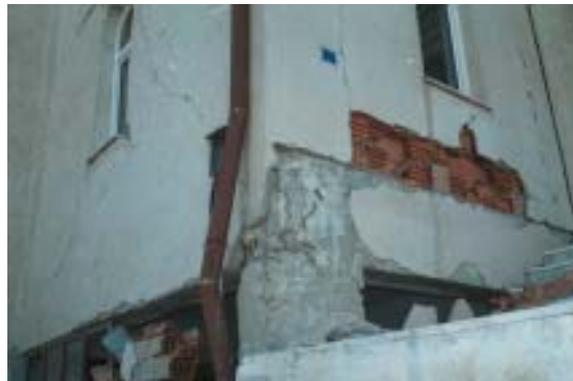
Figure 18. Damage at a beam-column joint

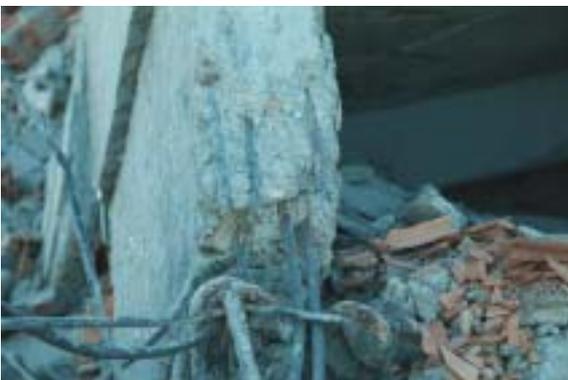
Figure 19. Bond failure at column base
