# The El Mayor Cucapah, Baja California Earthquake April 4, 2010

An EERI Learning from Earthquakes Reconnaissance Report

## An EERI Reconnaissance Report

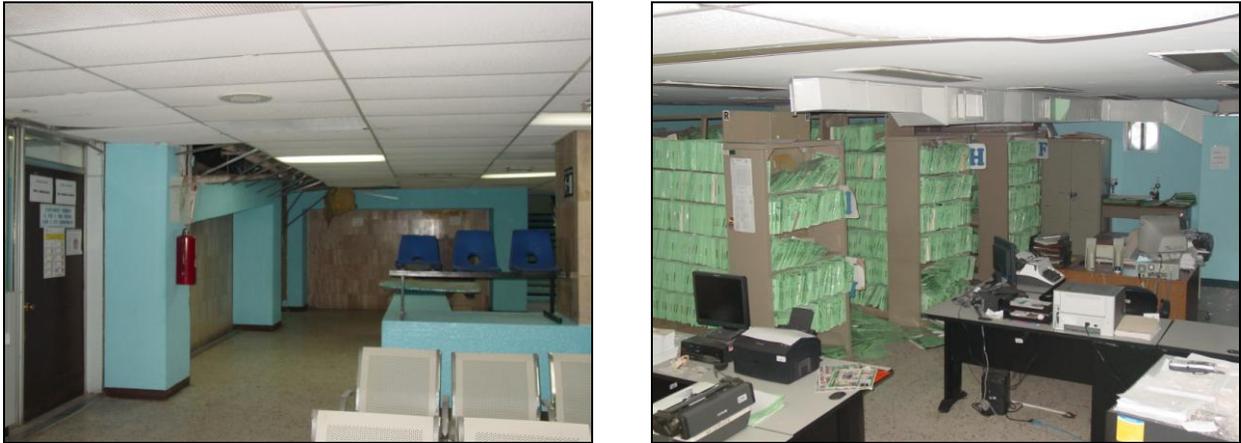
The Hospital General “5 de Diciembre” has a six-story reinforced concrete frame tower building with brick infill, and several one- and two-story wings. No structural damage was observed, but damage to exterior cladding, interior finishes, suspended ceilings, and mechanical equipment was visible. Damage to exterior cladding was concentrated in the first two floors, as shown in Figure 3.4. Suspended ceiling damage was minor, with most damage occurring adjacent to walls. Some medical records fell from shelves, but pharmaceuticals and supplies stored on open shelves did not fall (Figure 3.5).

**Figure 3.5:** Soffit and suspended ceiling damage (left), a few fallen medical records files (right), both in tower ground story.

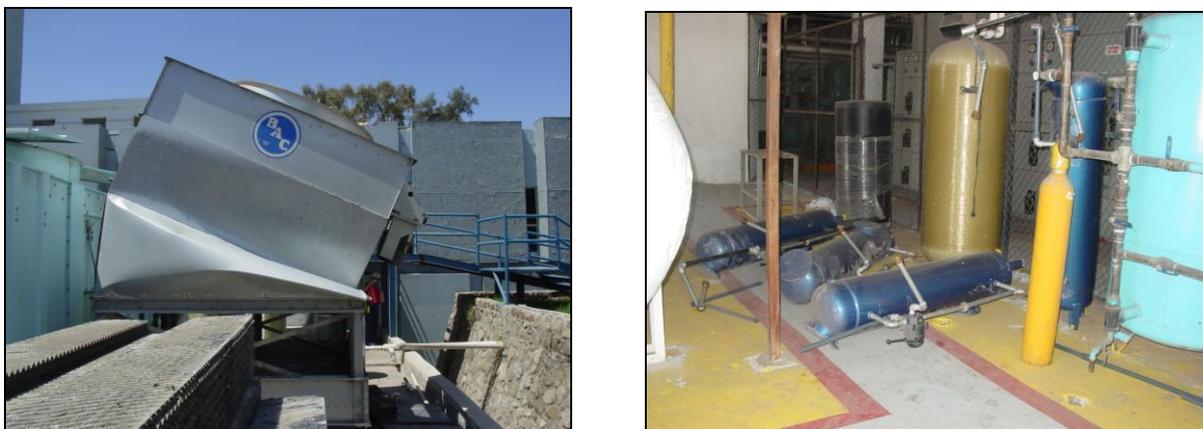
Most of the hospital’s mechanical equipment was undamaged, with a few exceptions. HVAC equipment in the yard at the back of the hospital was damaged, in part due to a water tank located on top (Figure 3.6). In the main mechanical room, several tall, thin tanks toppled and broke pipe connections, and a large boiler almost slid off its supports (Figure 3.7). The emergency generator was running during the reconnaissance team’s visit, so it was apparently either undamaged or had been quickly repaired. The bulk oxygen tank was well-anchored and undamaged.

**Figure 3.6:** Buckled HVAC unit in mechanical yard (left); toppled tanks in basement mechanical room (right).

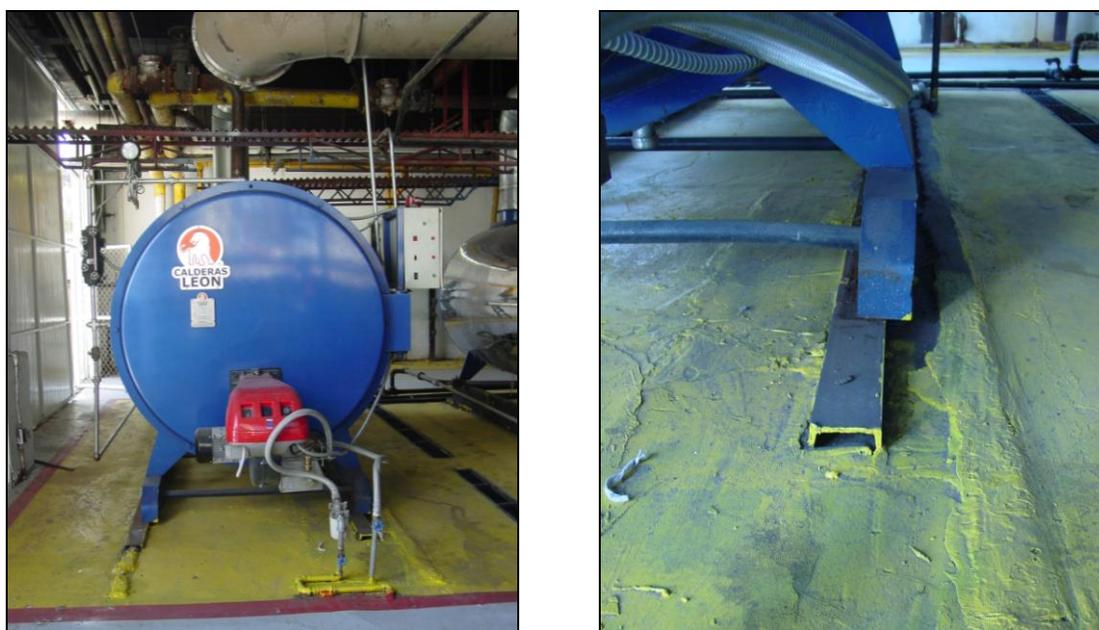
**Figure 3.7:** Unanchored boiler (left) in basement mechanical room nearly slid off support (right).

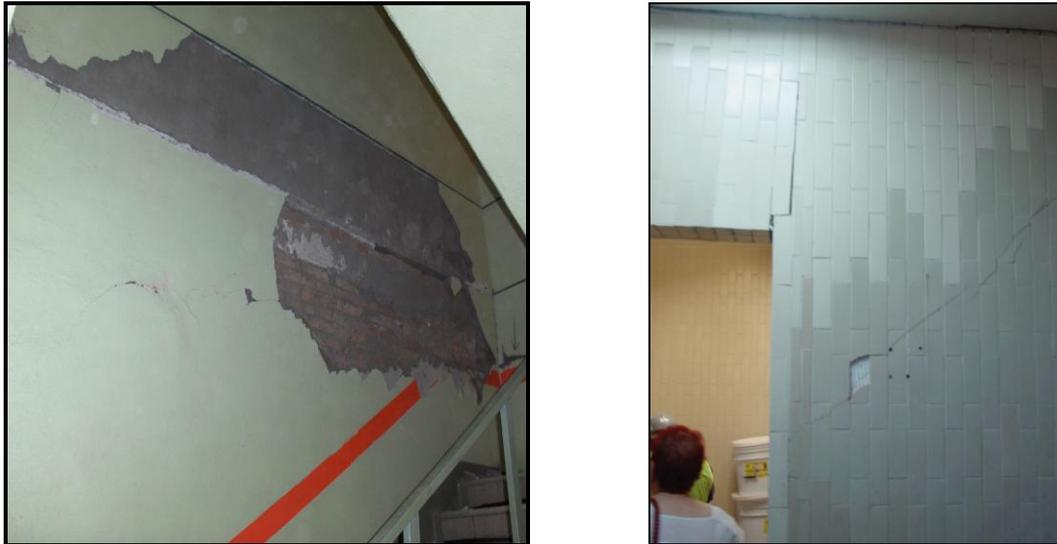
**Figure 3.8:** Plaster damage in stairwell (left); finish damage in wing with settlement (right).

Nonstructural damage was not observed in the tower, except for some fallen plaster in the stairwells and minor damage to finishes at the ground floor (Figure 3.8). There was some minor damage to HVAC equipment on the roof of the single-story wings, but repairs had already been made. One elevator was operating and in use, and had been “re-leveled”. The hospital had moved the Neonatal Intensive Care Unit to the ground floor from the tower; this was not due to equipment or systems damage.

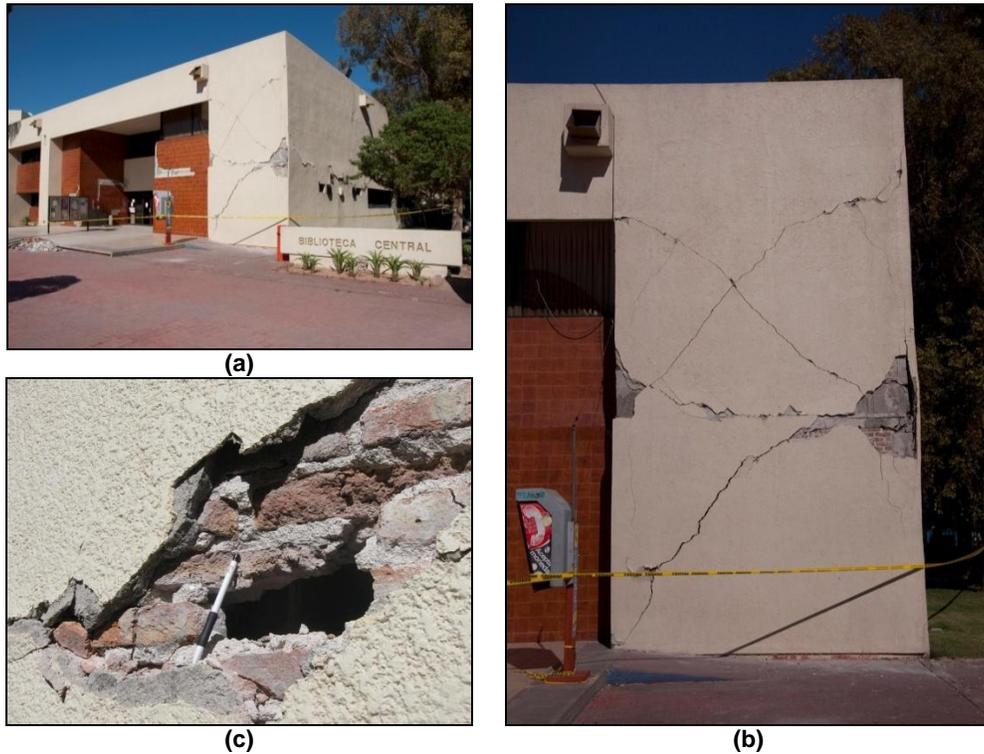
**Figure 3.10:** Library at the Mexicali campus of UABC; (a) building overview and entrance from the southwest corner; (b) shear cracks in the brick infill panels; (c) single width unreinforced brick wall (32.6337°N, 115.4442°W) (Building D in Figure 3.9).

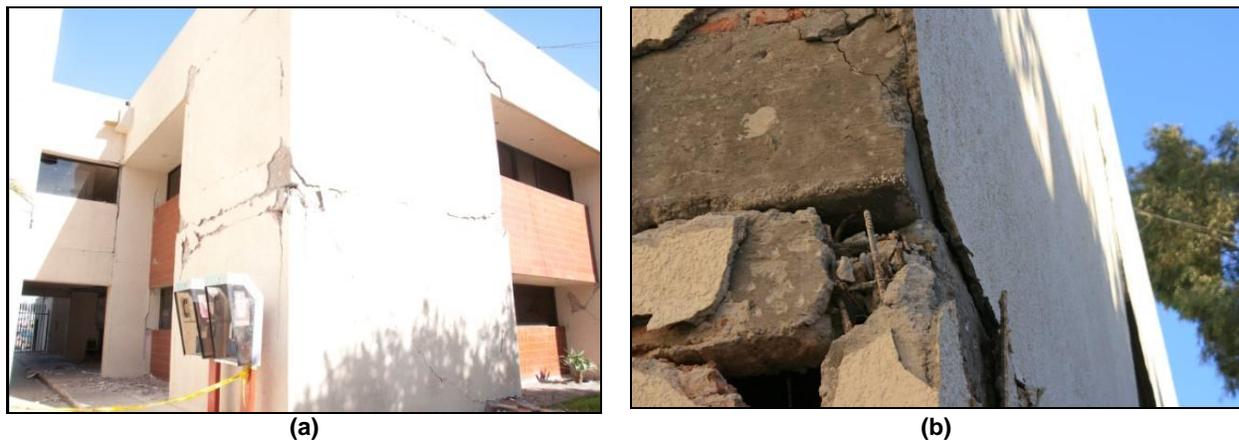
**Figure 3.11:** Library at the Mexicali campus of UABC; (a) poor reinforcement detailing at the northwest corner, (b) detail of discontinuous longitudinal column reinforcement in northwest corner (32.6337°N, 115.4442°W) (Building D in Figure 3.9).

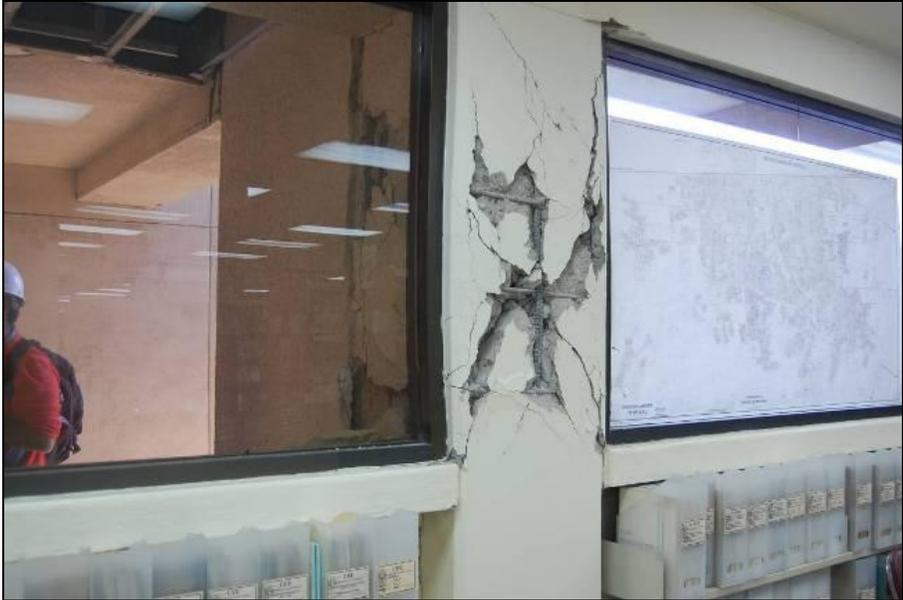
The library is located in the north section of campus (D in Figure 3.9). It is a two-story reinforced concrete frame with unreinforced brick infill walls built around 1988 (Figure 3.10a). The cross sectional dimensions of the north exterior columns were measured to be 0.5 m x 0.5 m (1.6 ft x 1.6 ft). Joint deterioration and shear cracking in the infill walls was observed (Figure 3.10b). The cracks revealed the column reinforcing details: #8 longitudinal bars and #3 stirrups spaced at 23 cm (9 inches) on center. Some bars were spliced at the upper third of the column, which was the location of shear failure. Gaps in the infill wall showed a single width brick thickness (Figure 3.10c). In the northwest corner of the library the column reinforcement was discontinuous at the second floor slab (Figure 3.11a), which resulted in significant joint deterioration during the earthquake. The building suffered extensive exterior damage (Figure 3.11b). Shear cracks were found in two columns on the north side of the building caused by the short-column effect (Figure

Figure 3.12: Severe shear cracks in exterior reinforced concrete column.

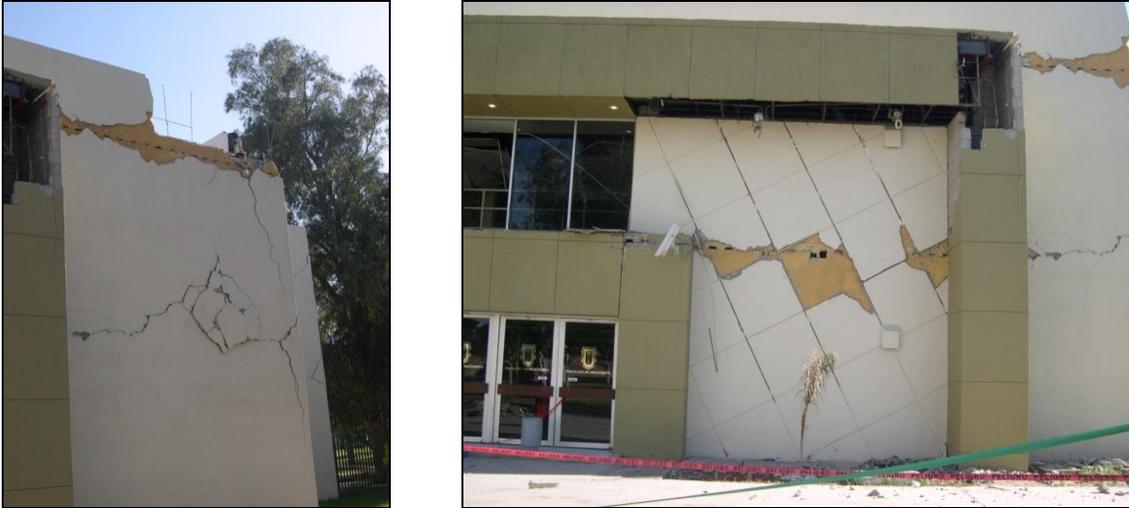
**Figure 3.19:** Damage to UABC Computer Science and Electronics Laboratory Building. Shear cracks are very visible at the masonry walls near the wall ends.

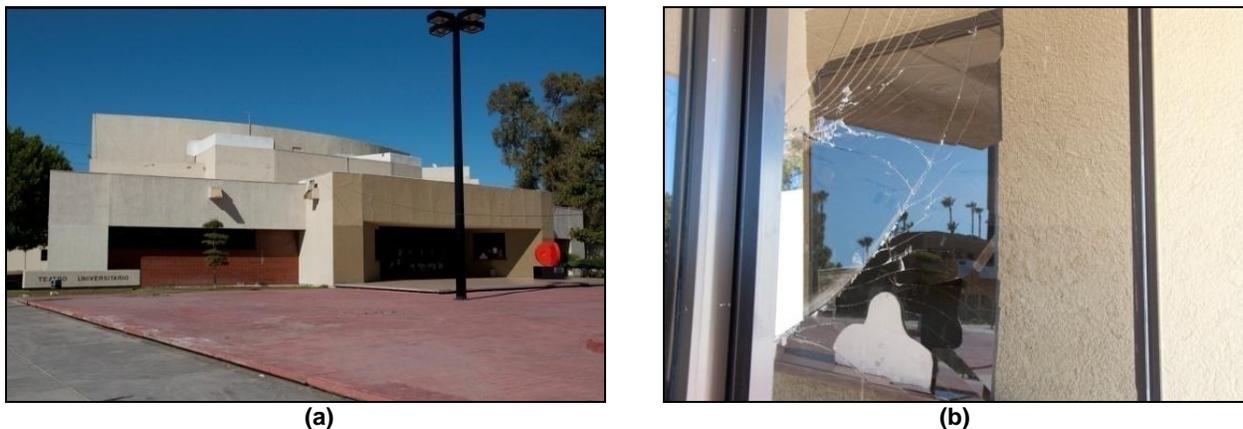
**Figure 3.26:** The university theatre at the Mexicali campus of UABC: (a) the front entrance to the building; (b) broken window on the front entranceway held in place by the film (32.6338°N, 115.4447°W) (Building C in Figure 3.9).

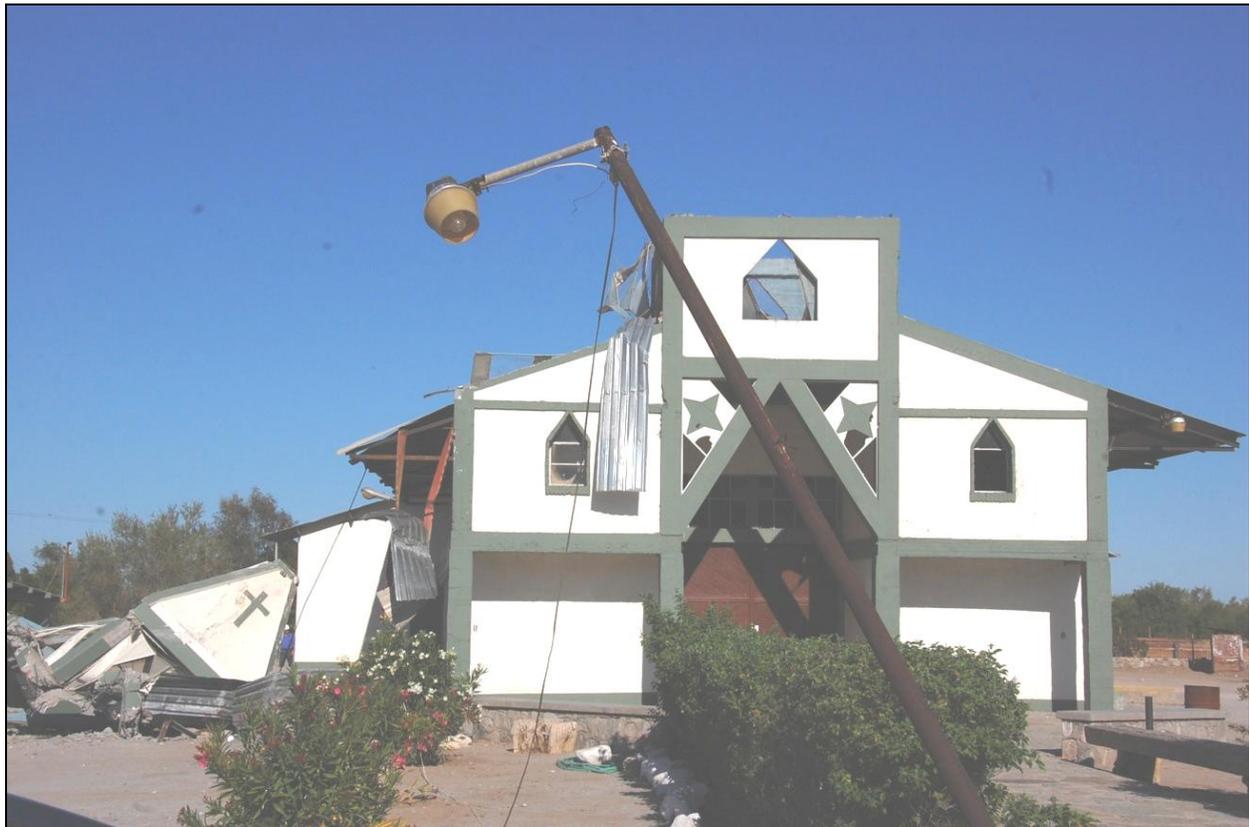
About 32 km (20 miles) south of the US border, there is a church named Nuestra Senora de la Merced. The church suffered partial collapse due to the earthquake (Figure 3.45). According to members of the church, the church building had been incrementally constructed over the past 50 years. The church is constructed of concrete frames with confined brick masonry infills and a steel deck roof over steel framing. It had a small concrete tower in the front that collapsed causing damage to the lower roof and walls. The tower seemed to have some reinforcing that was not properly developed into its supporting columns. There were also some partial out-of-plane masonry infill failures at the rear gable wall of the building and severe damage to the interior ceiling (Figure 3.46). The loss of the church was a big loss to the community. Despite severe localized damage to the steeple tower and infill brick in a rear wall, the main structural system remained stable. The small tower that collapsed could be rebuilt by properly supporting it all the way down to the foundation. The masonry infill could also be strengthened and rebuilt. Aside from this church, there were no reports of damages to other churches.

**Figure 3.45:** Exterior view of church showing collapse of tower.

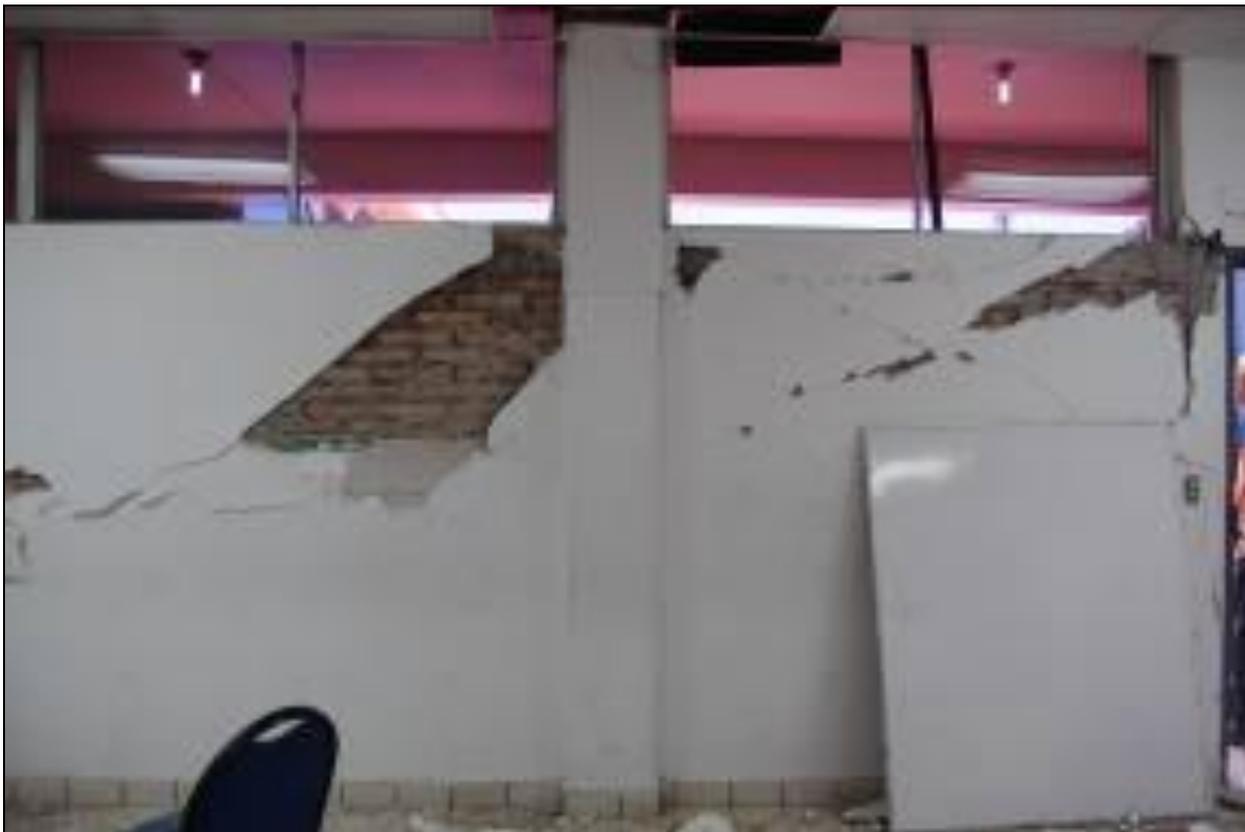
**Figure 3.51:** Damage to clay masonry infill next to a retrofitted column.

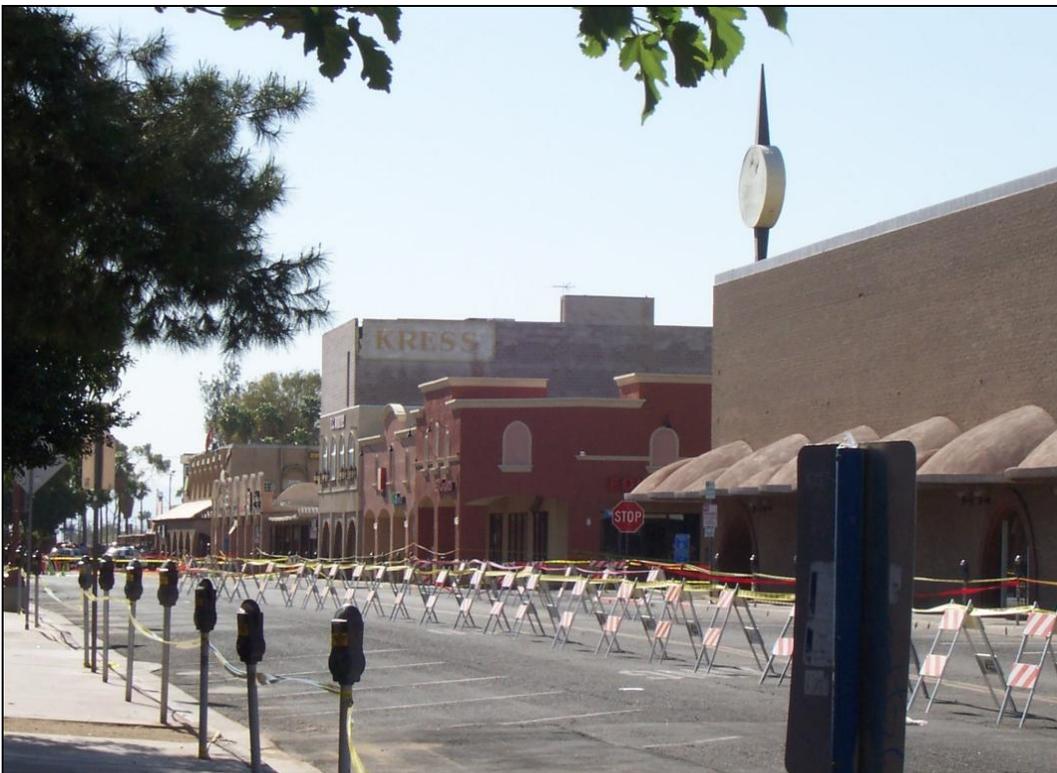
**Figure 3.54:** A view of 1st Street in downtown Calexico looking towards the west. A separation in the joint at the parapets at the Kress sign can be seen from here.

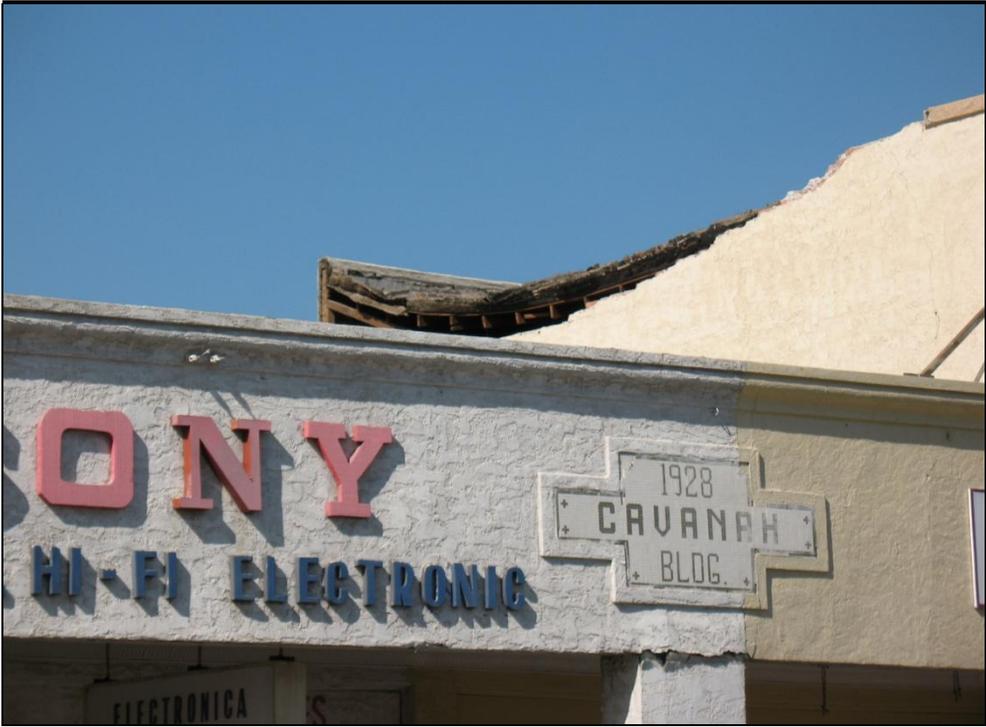
Figure 3.56: A close-up view of a partially collapsed roof. Cracking at the top of the column in the foreground can also be seen (32.666696°N, 115.496730°W).

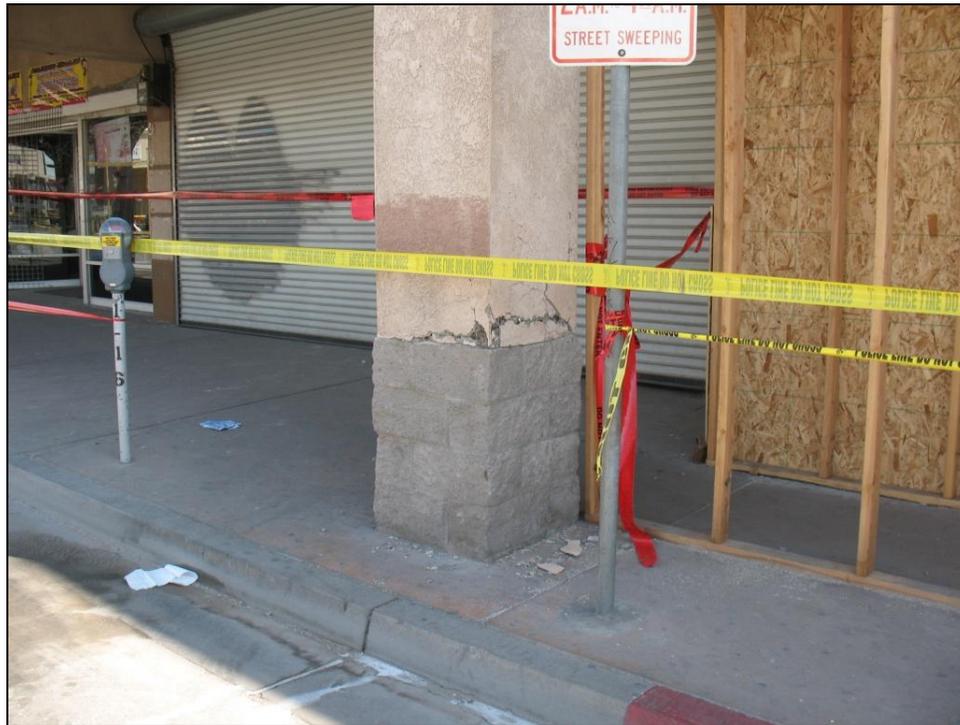
Figure 3.57: Column cracking at the store front.

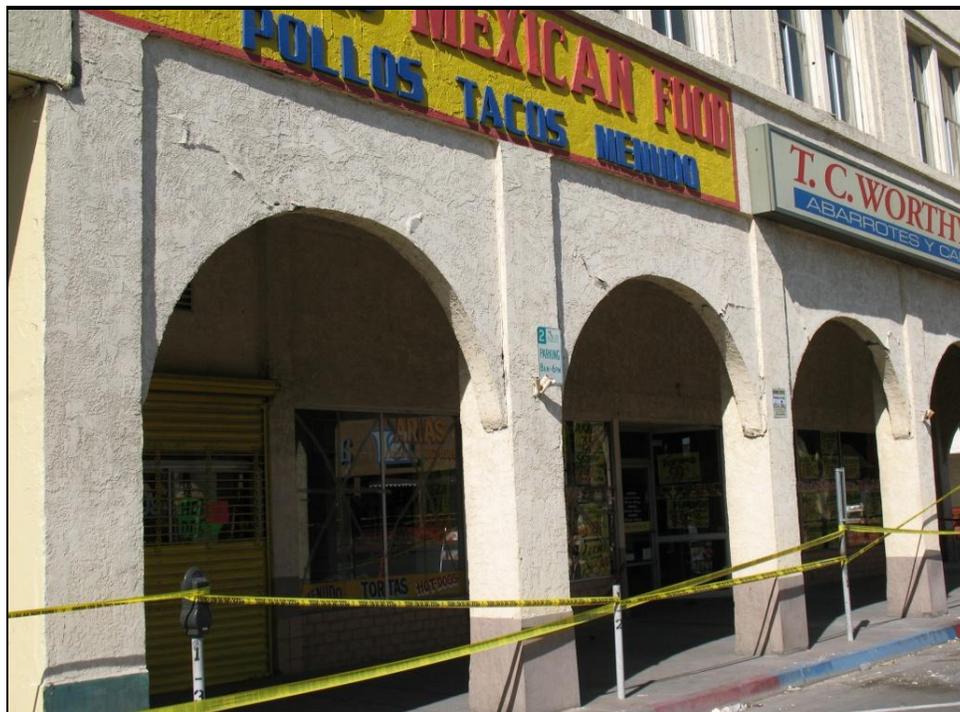
Figure 3.58: Diagonal cracking at arches.

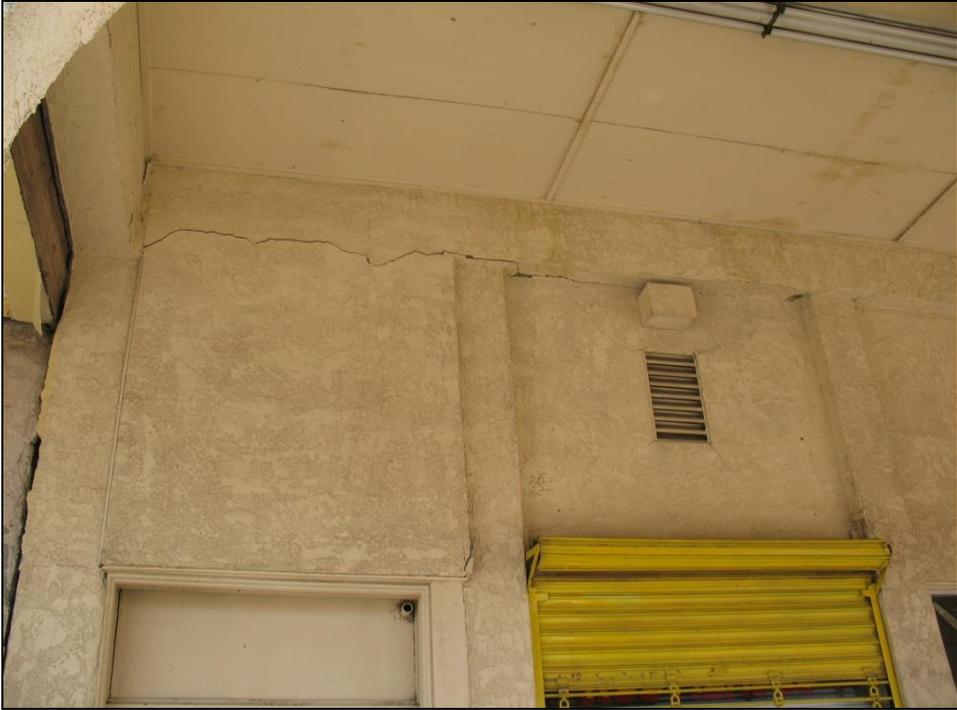
Figure 3.59: Wall cracks just below the floor line.

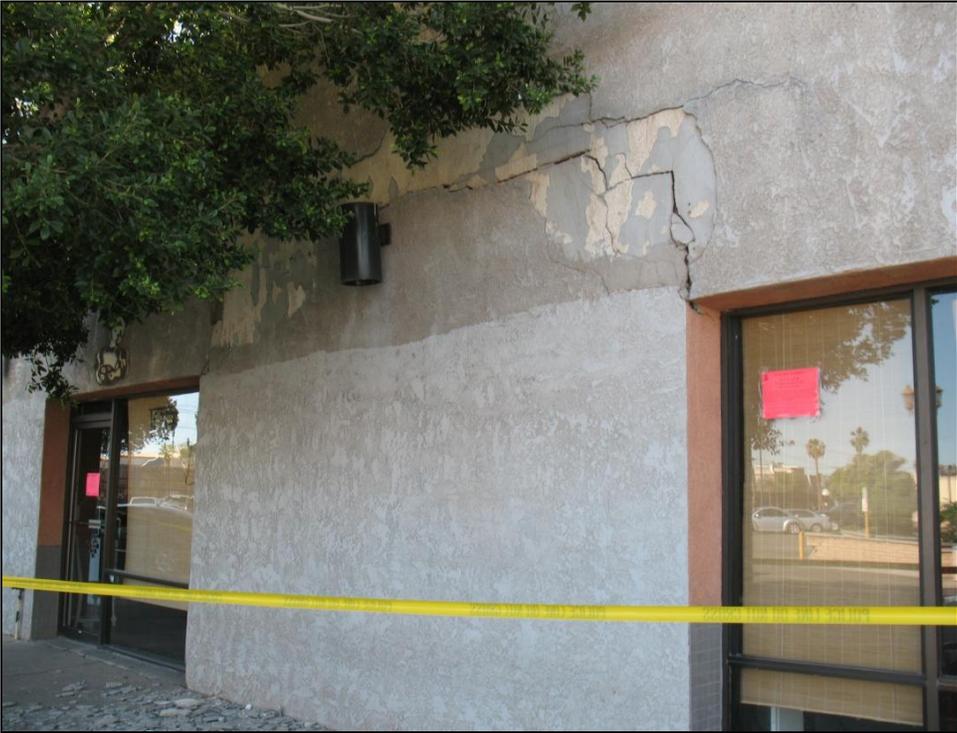
Figure 3.60: Wall cracks and spalled plaster.

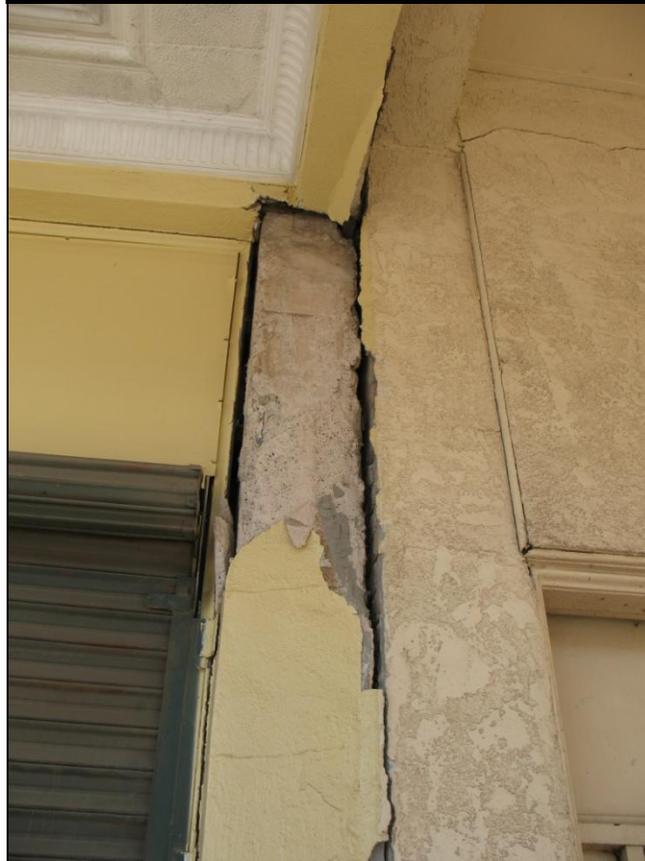
**Figure 3.61:** Cracking at the building joint.

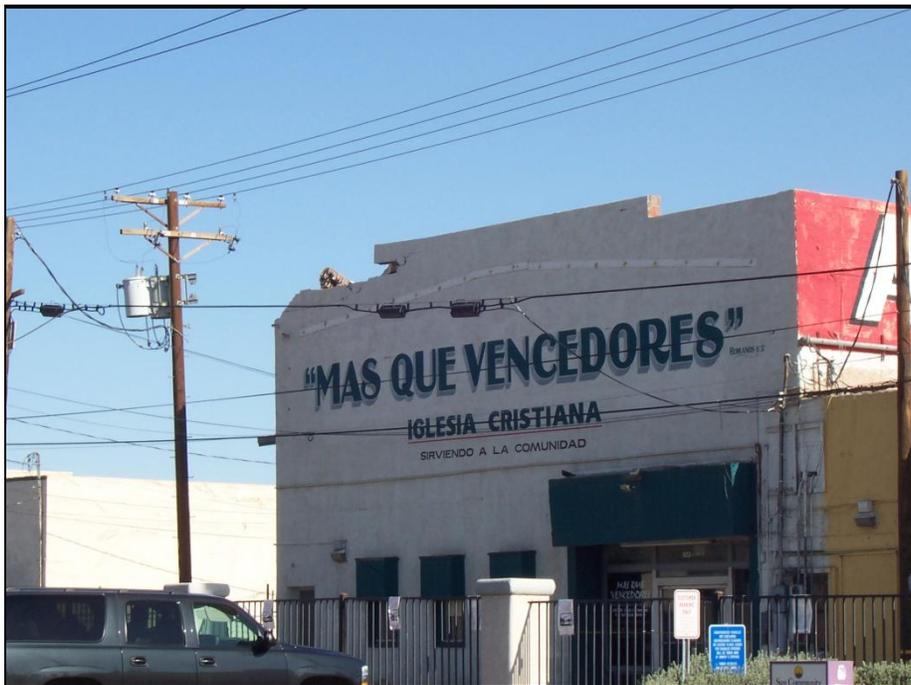
**Figure 3.62:** Parapet damage.

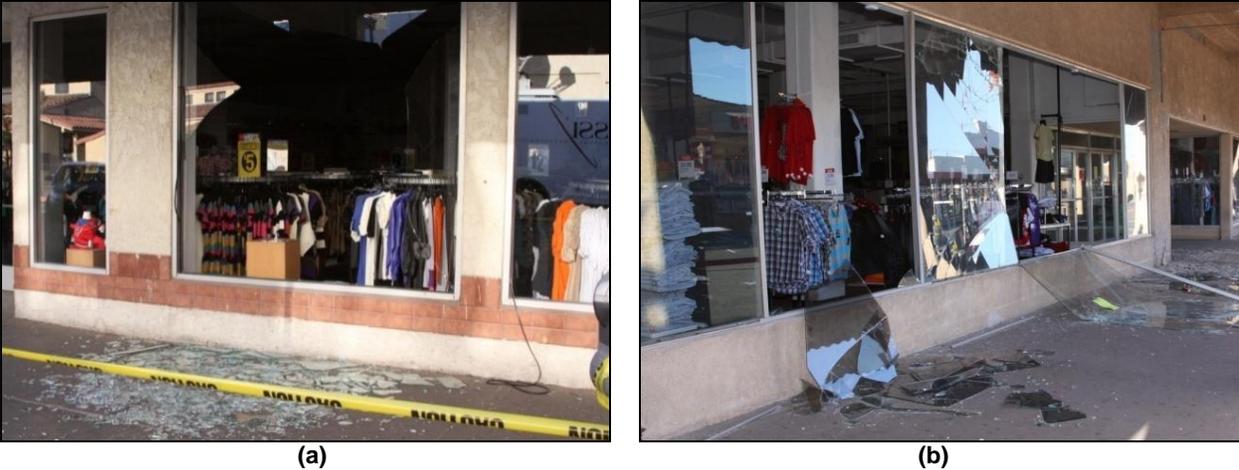
Figure 3.63: Typical damaged glass store front in downtown Calexico (images courtesy of professional photographer Joseph Llausas - taken April 5, 2010).

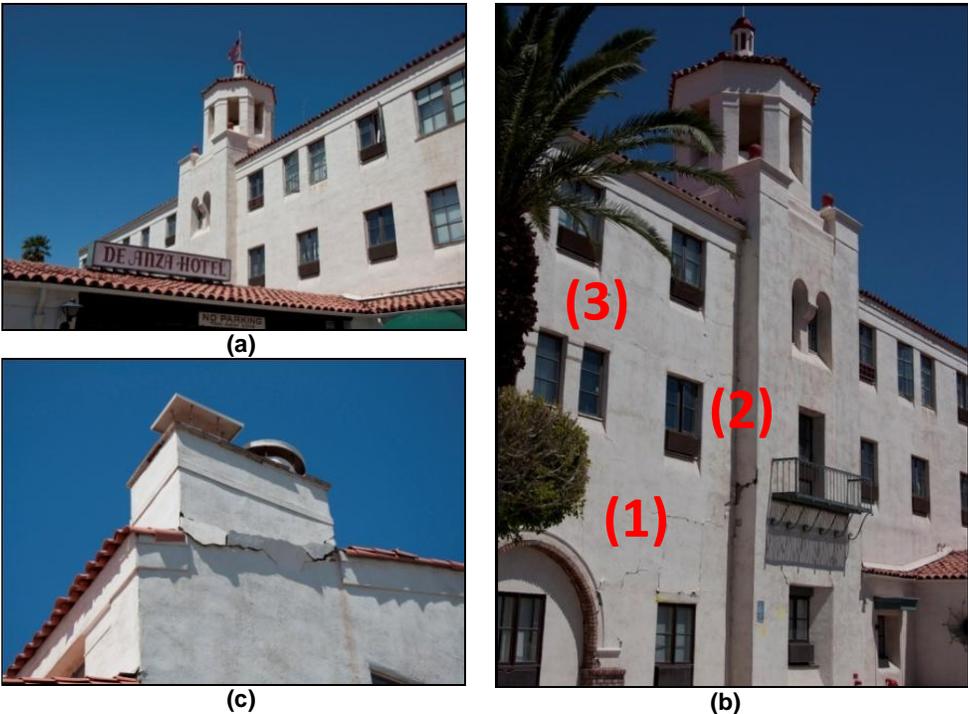
**Figure 3.67:** Damage observed at the Hotel de Anza within the city of Calexico, CA: (a) overview of front entrance; (b) significant cracks sustained just west of the tower section (1 = diagonal crack, 2 = vertical crack and 3 = horizontal cracks at floor levels); (c) chimney damage on the east wall (32.6689°N, 115.4956°W).

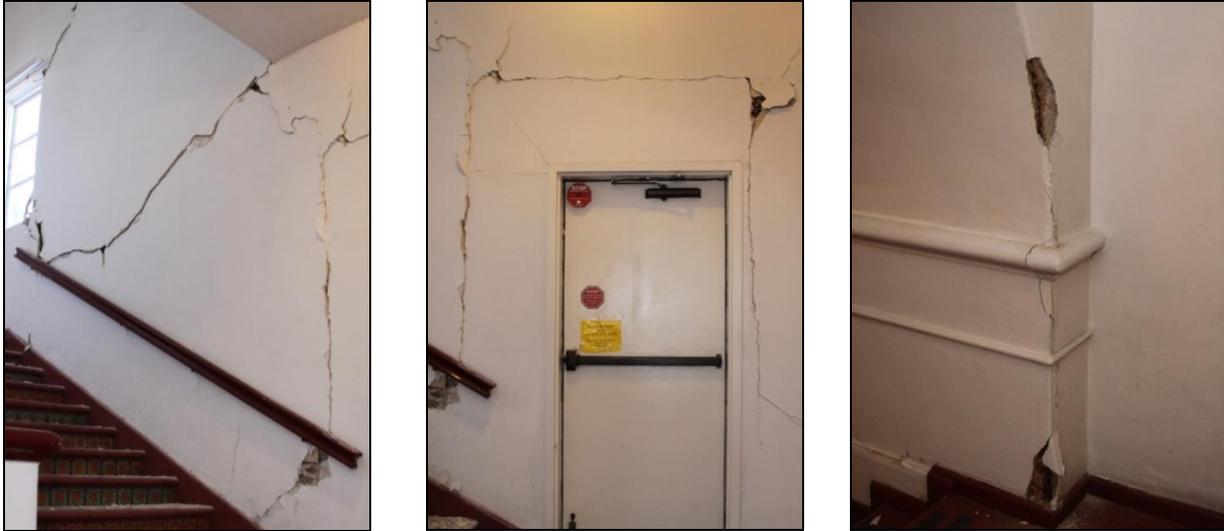
**Figure 3.68:** Typical interior damage at the Hotel de Anza in Calexico (images courtesy of professional photographer Joseph Llausas - taken April 6, 2010).

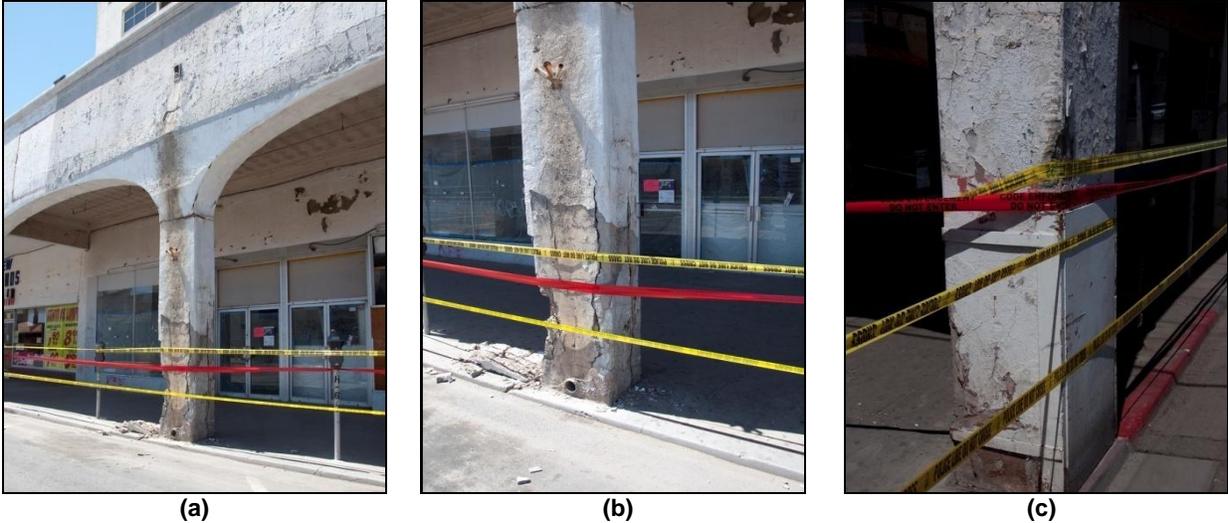
**Figure 3.70:** Damage observed within the Heffernan Business District (Calexico, CA): (a) overview interior column which experienced significant damage; (b) column base close-up showing reinforcement placing; (c) exterior column adjacent to the south with retrofit jacketing (32.6663°N, 115.4948°W).

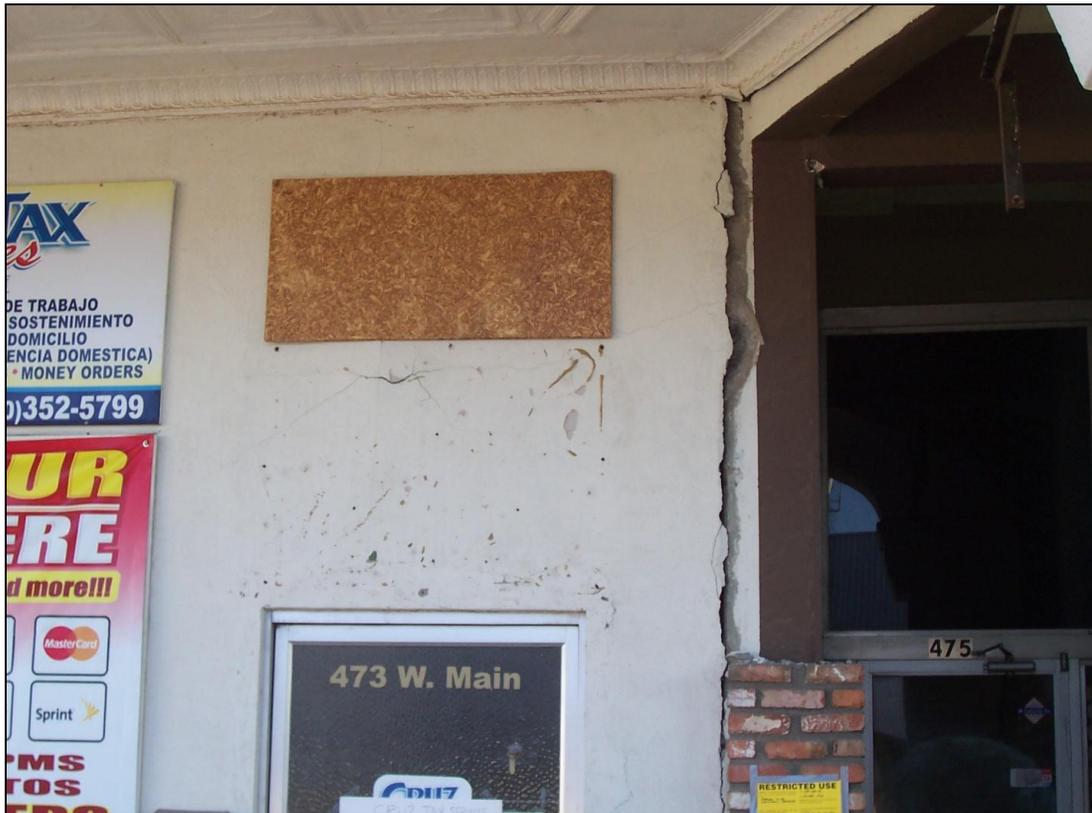
*Figure 3.76: Typical cracking and crushing of masonry and plaster at joints between buildings.*

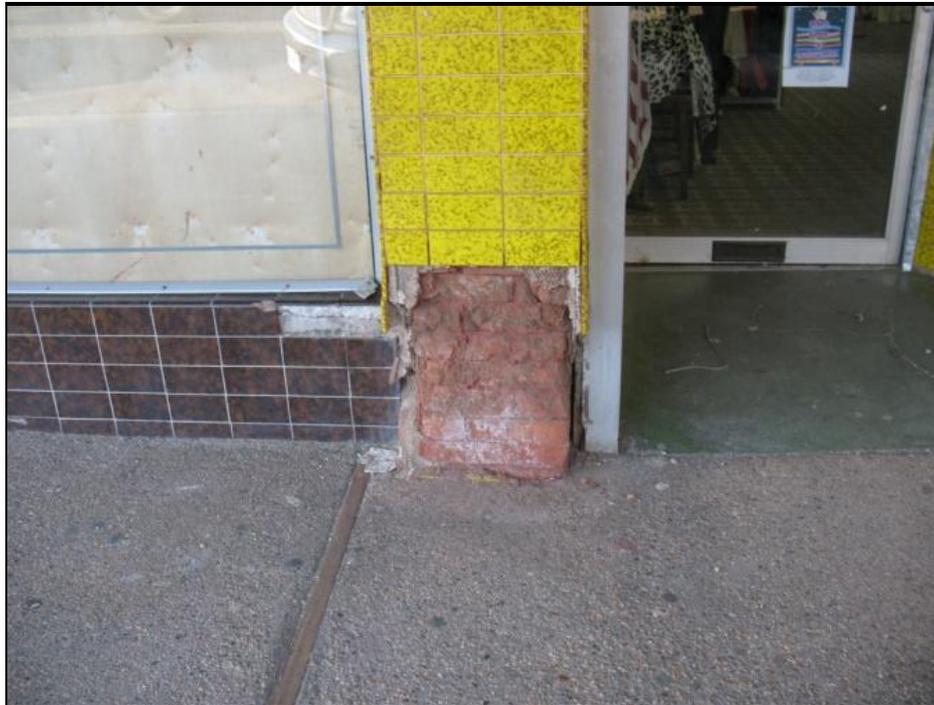
**Figure 3.77:** Damage was also prevalent at the base of the masonry columns at the store fronts, and can be attributed to the increased moment and rotational demands due to the absence of shear walls along the open store fronts.

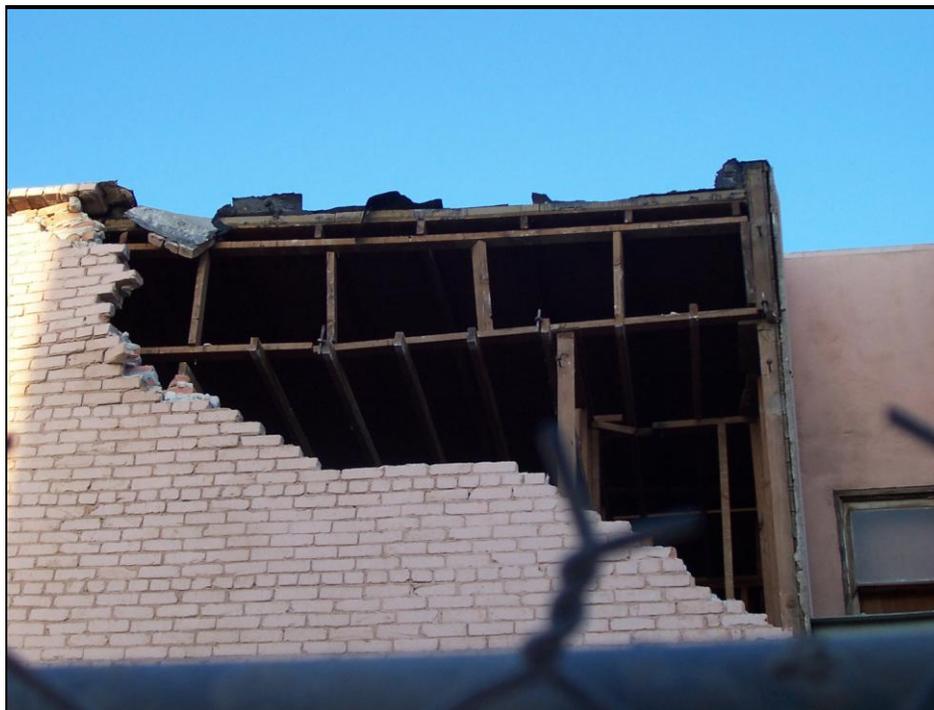
**Figure 3.78:** Abandoned mortuary building with typical out-of-plane failures of the masonry wall to wood diaphragm. The original wall to ceiling joist connection was insufficient. (32.7919°N, 115.5560°W).

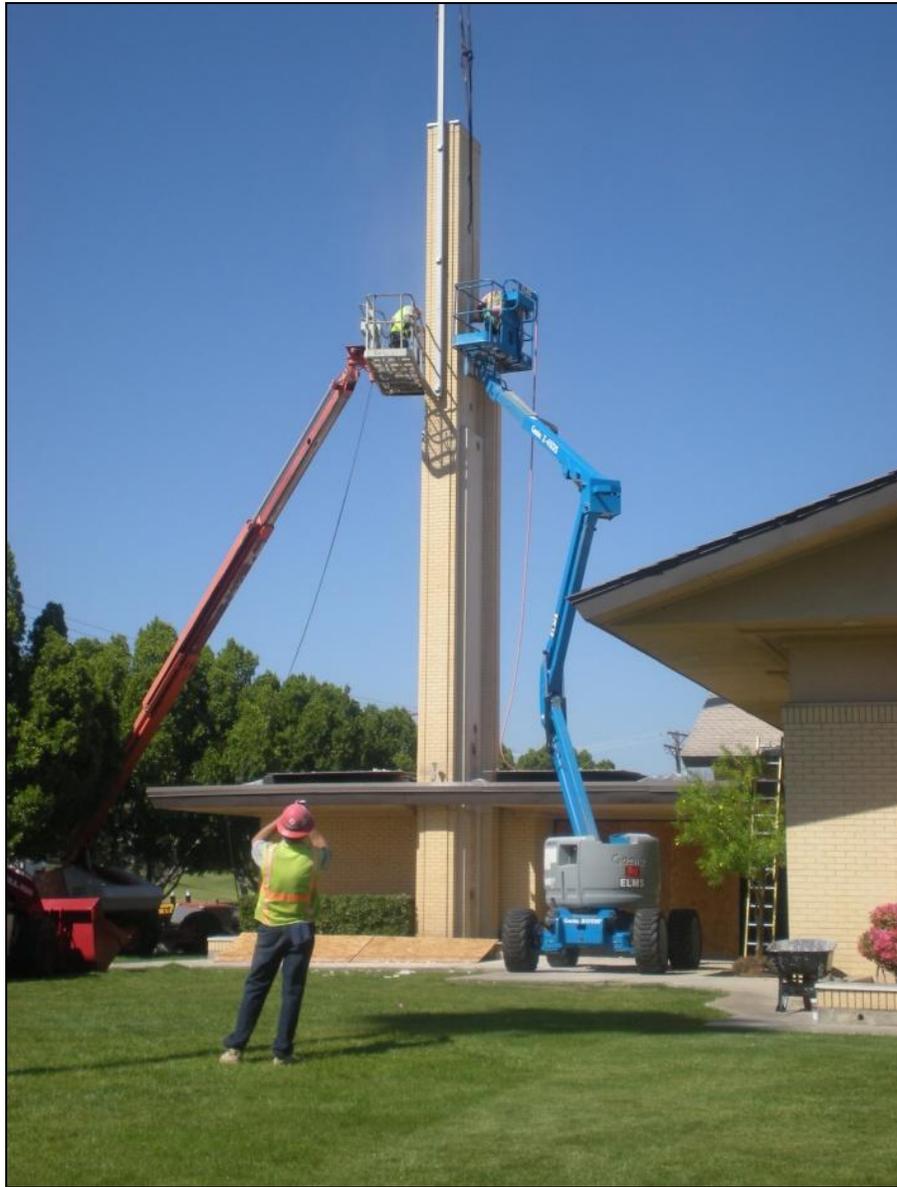
**Figure 3.83:** Damage to the masonry and concrete steeple required partial demolition and removal of the steeple above the roof line.

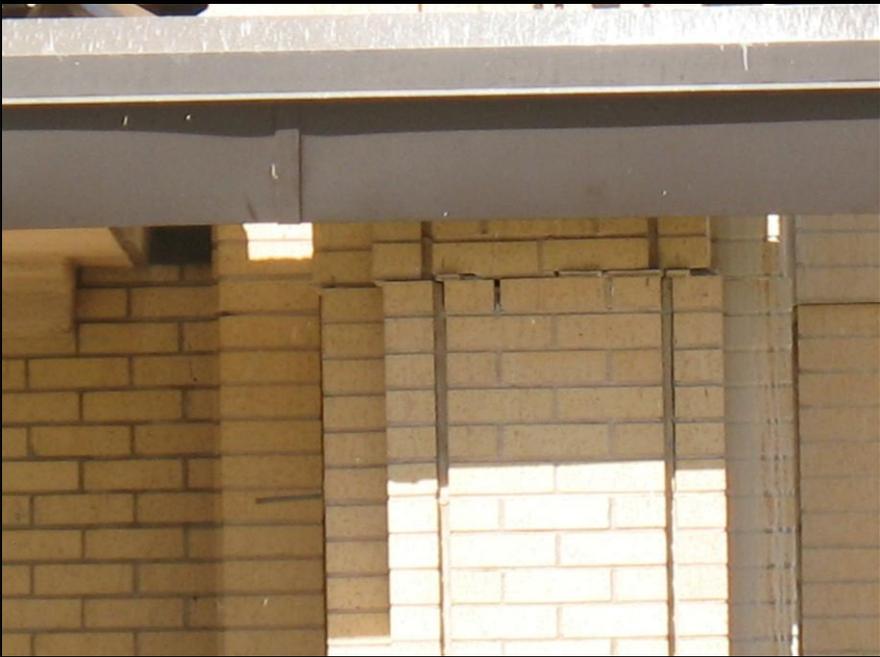
**Figure 3.84:** Steeple shifted and rotated approximately 25 mm (1 inch) horizontally across the horizontal mortar joint.

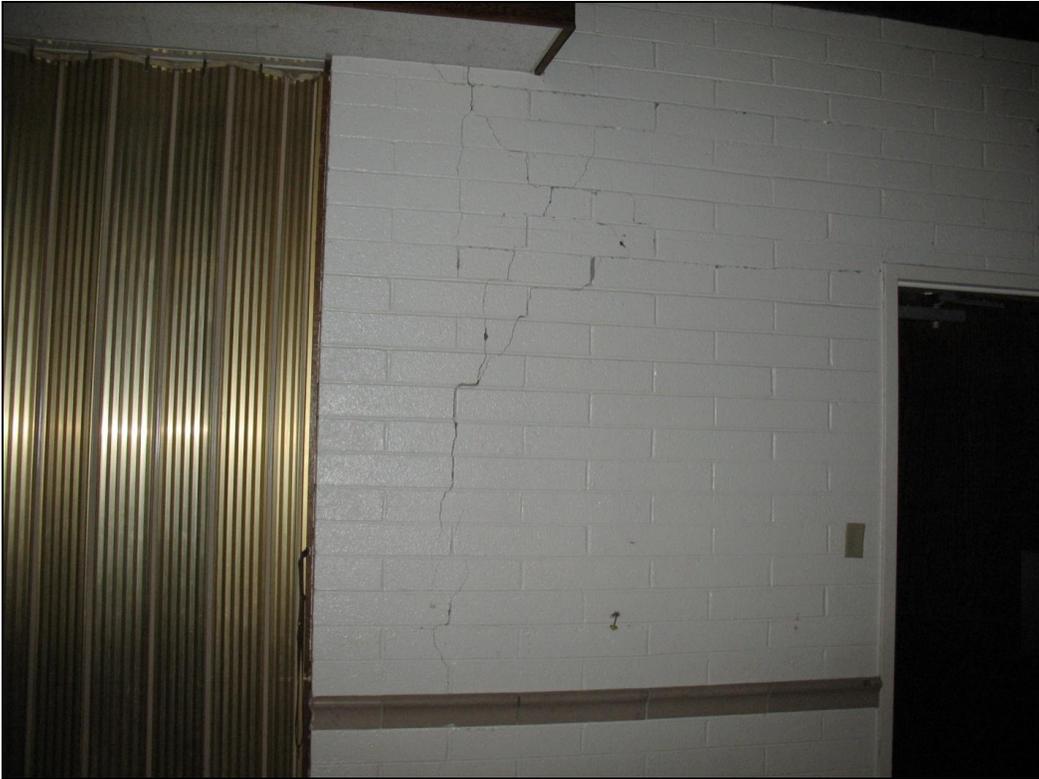
**Figure 3.86:** Damage to interior masonry shear wall.

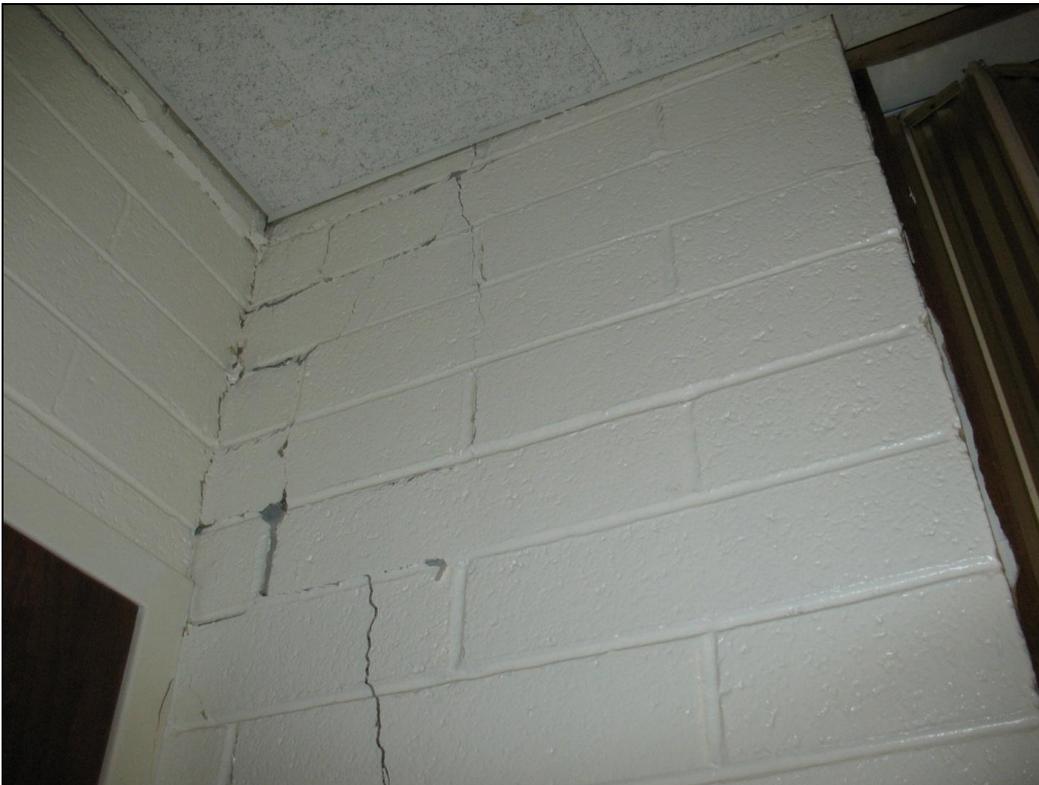
**Figure 3.87:** Damage at interior masonry shear wall and intersecting masonry wall.
