# The El Mayor Cucapah, Baja California Earthquake April 4, 2010

An EERI Learning from Earthquakes Reconnaissance Report

## An EERI Reconnaissance Report

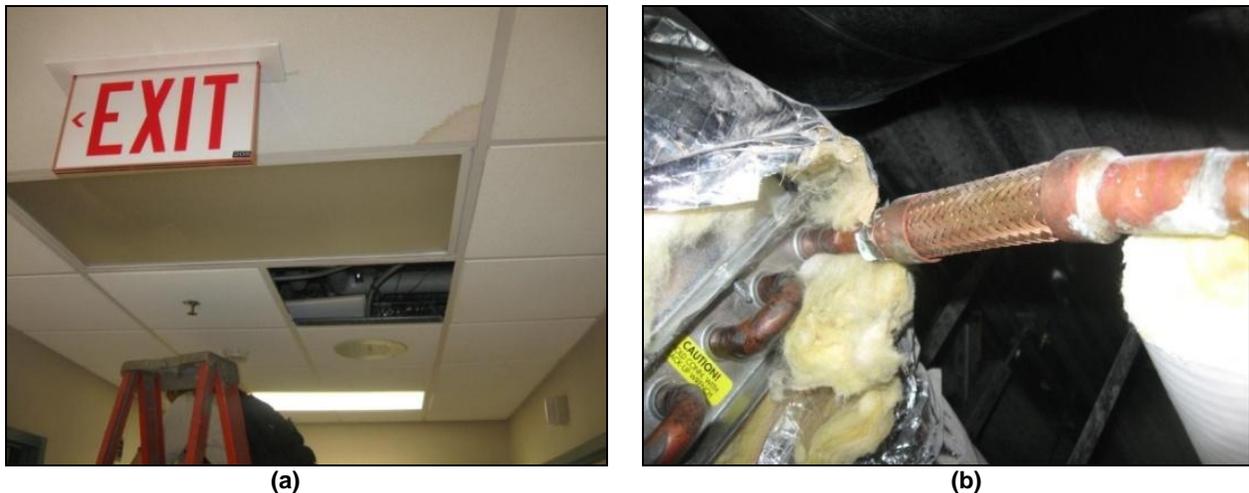
**Figure 3.94:** Damage to HVAC re-heater in Building B (Figure 3.88): (a) ceiling tile with water stain; (b) repaired re-heater line (braided copper hose).

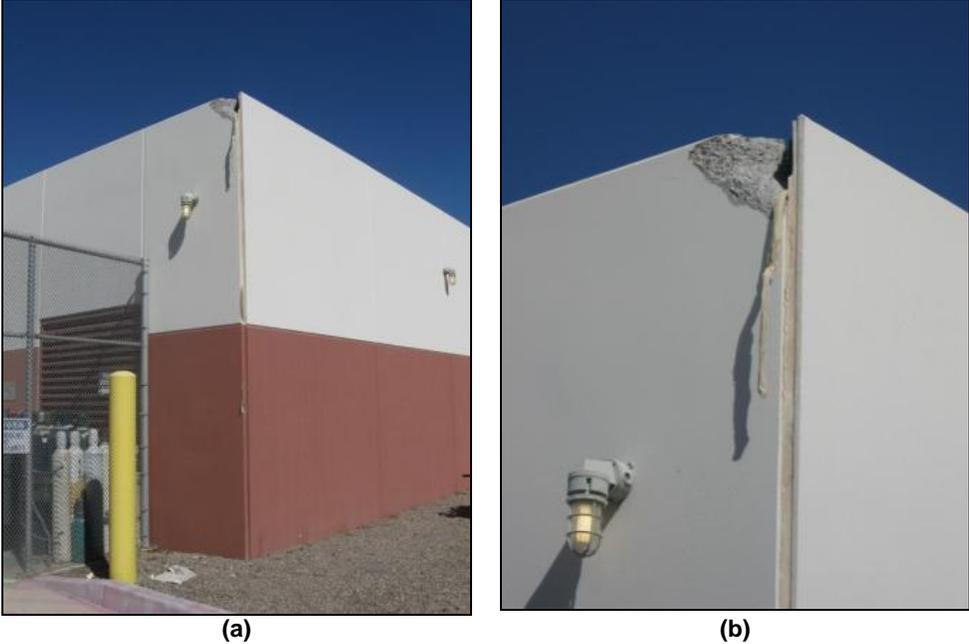
**Figure 3.95:** Damage to precast concrete screen walls in southeast corner of Building C in Figure 3.88.

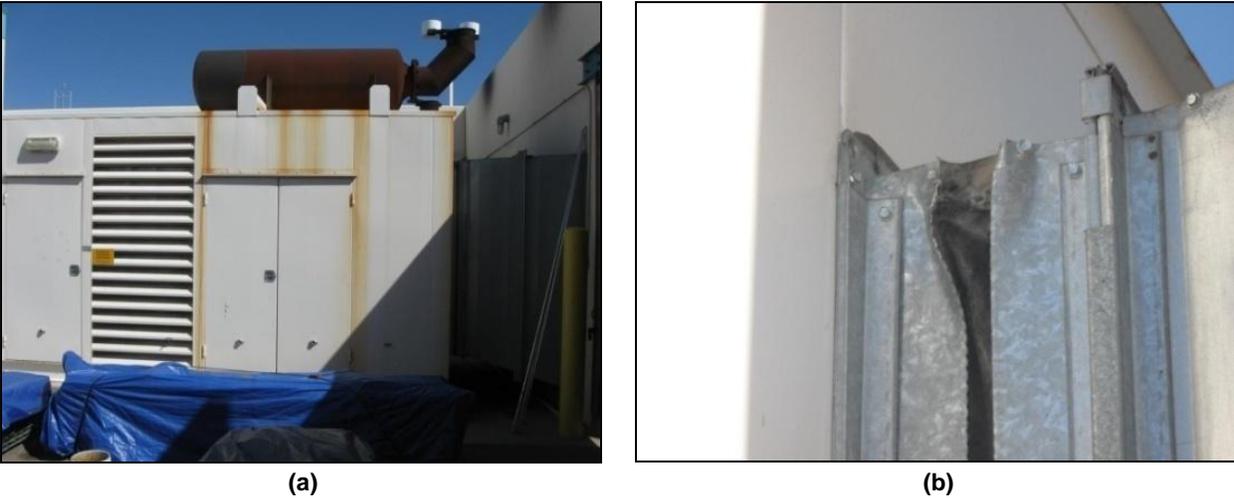
**Figure 3.96:** Equipment in Building C in Figure 3.88: (a) mechanical equipment; (b) damage to duct.

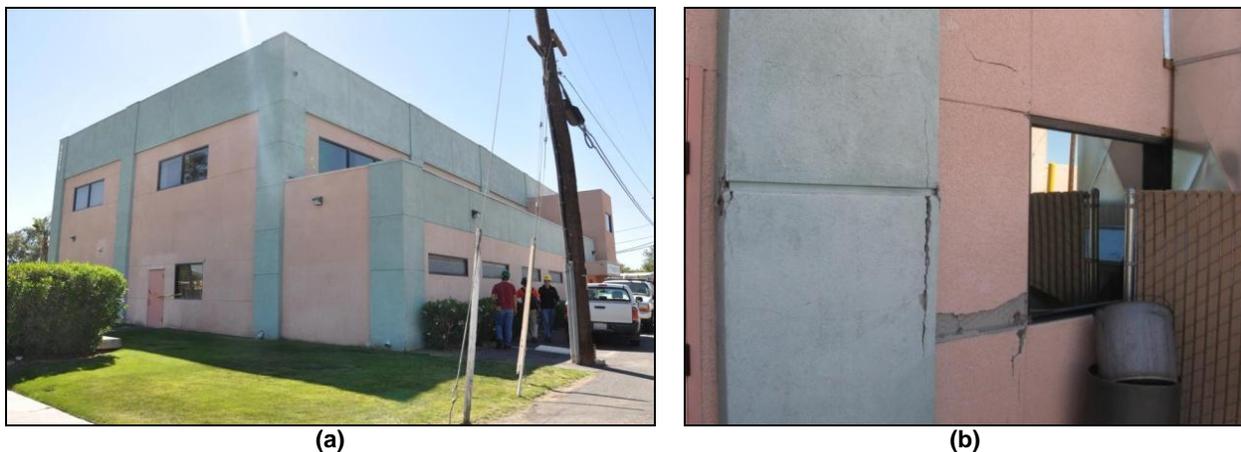
**Figure 3.98:** Medical Plaza (Building D): (a) northwest corner; (b) typical façade cracking (west side).

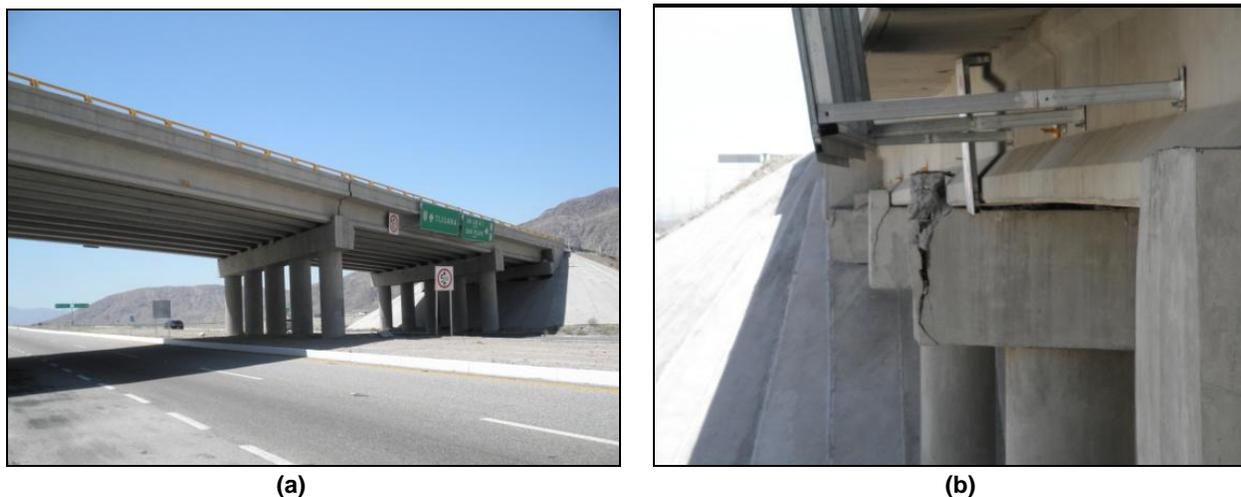
**Figure 4.2:** Overcrossing over Highway 2 (a) west view of the spans (b) damage to shear keys and bent cap.

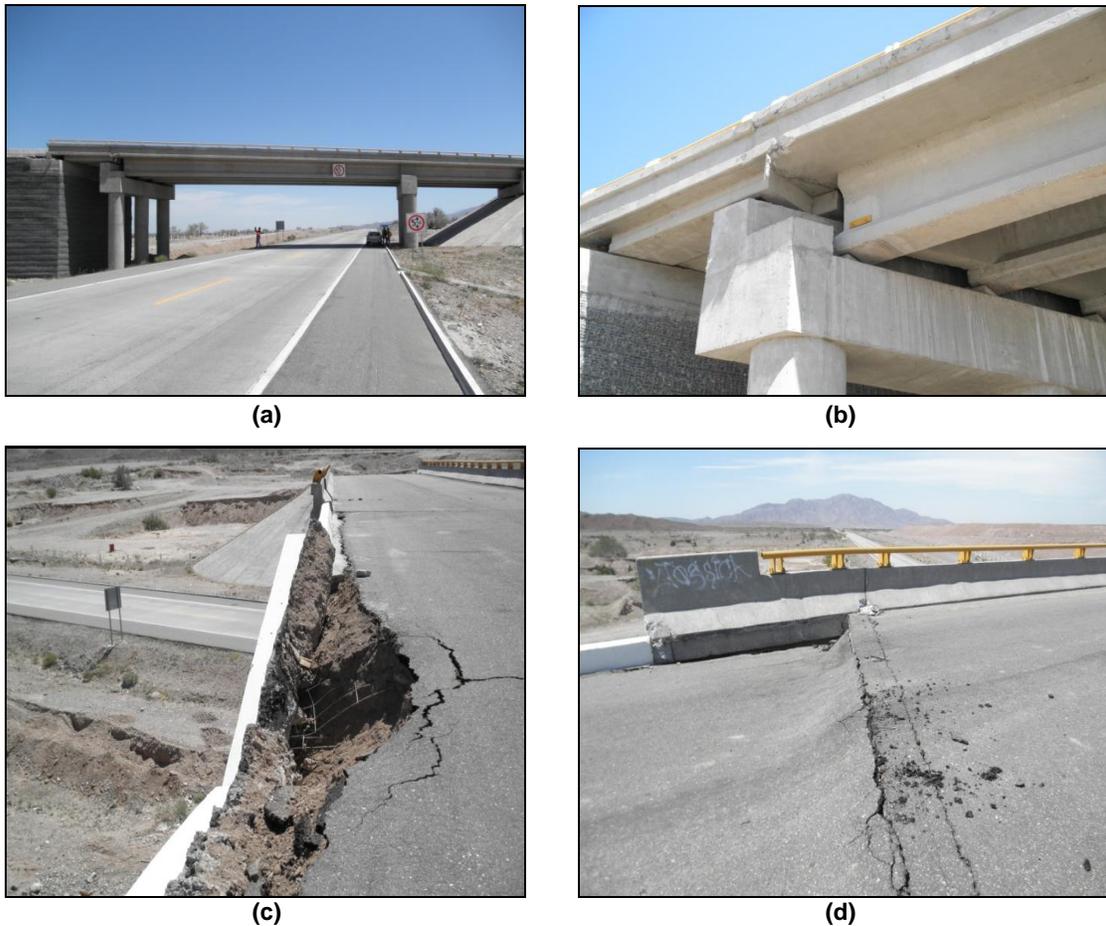
**Figure 4.3:** (a) Highway 5 overcrossing, (b) pending unseating of girders, (c) failure of reinforced high embankment fill, (d) approach roadway settlement.

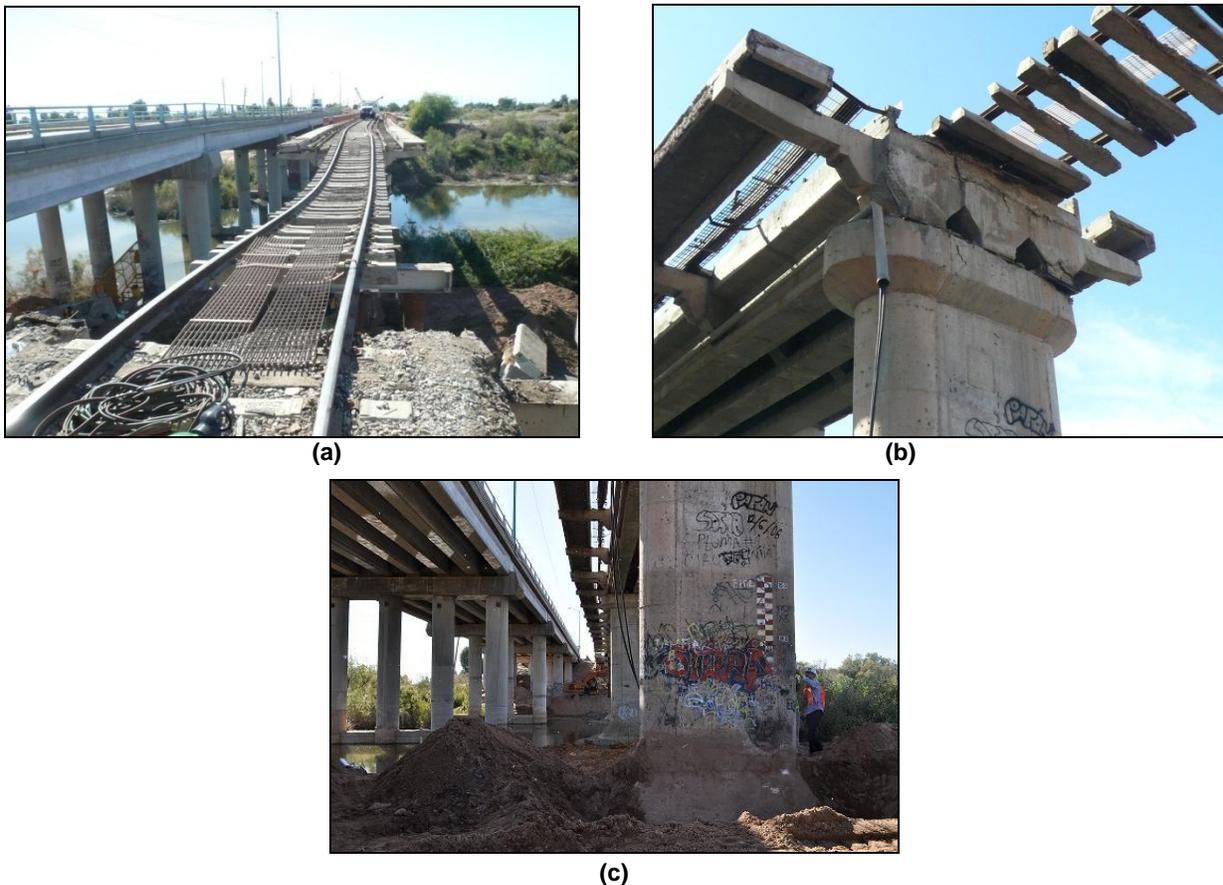
**Figure 4.4:** Puente San Felipe, Railroad Bridge: (a) collapsed span, (b) girder unseating, (c) transverse misalignment.

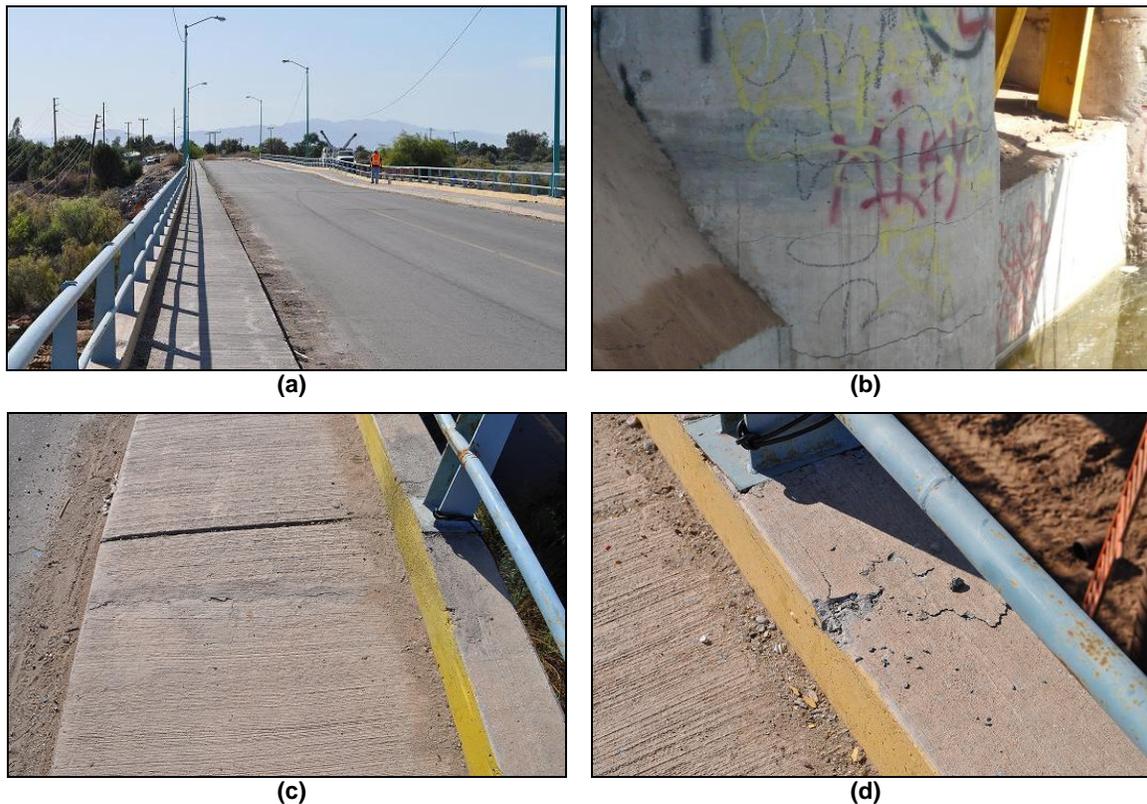
**Figure 4.5:** Highway bridge next to Puente Del Ferrocarril: (a) overview of deck deformations, (b) column tension cracking in the plastic region, (c) repaired, re-cracked sidewalk, (d) spalling in curb.

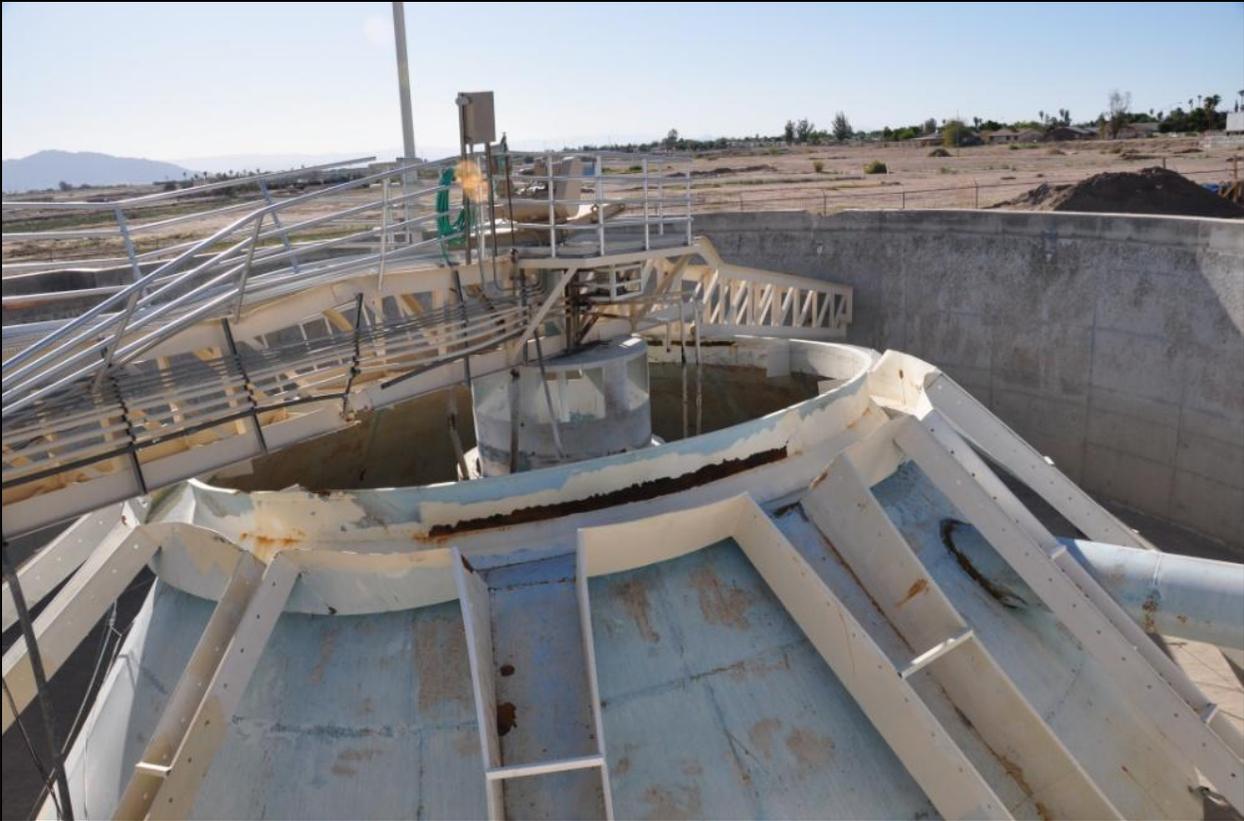
Figure 5.3: Damaged water clarifier at the Calexico Water Treatment Plant.

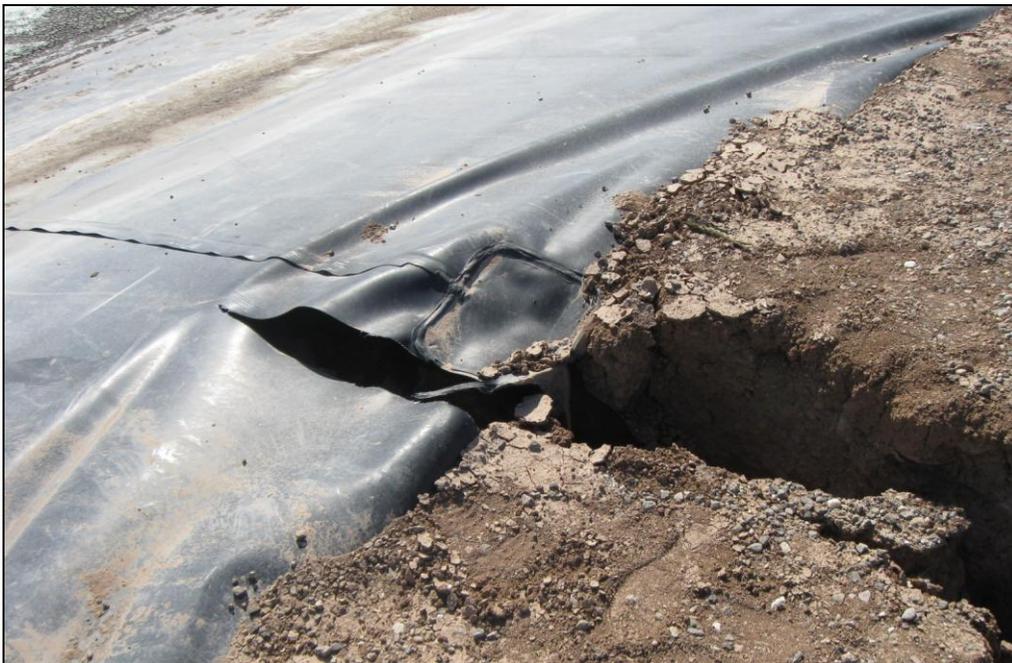
**Figure 5.10:** Leakage of pond.

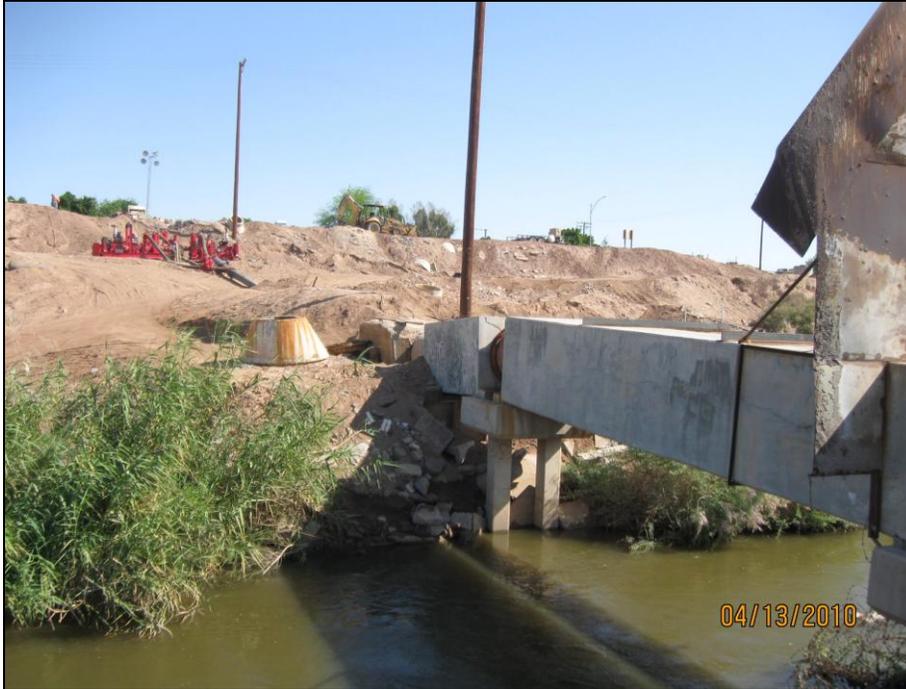
**Figure 5.11:** Breakage of pipe on both sides of river (32.6726°N, 115.5149°W).

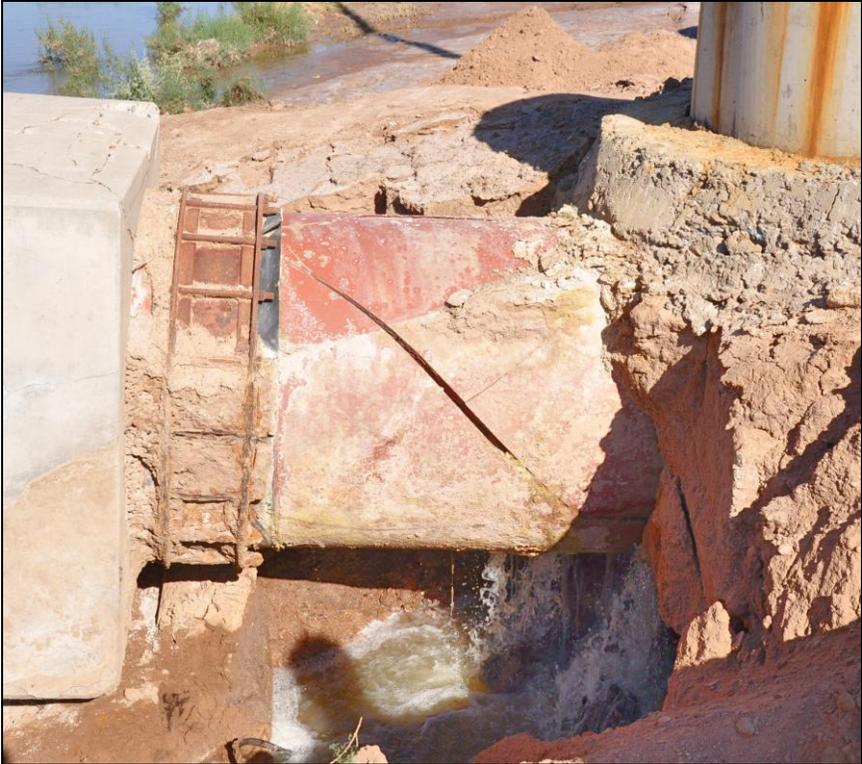
**Figure 5.14:** Damaged 1 m (36 in) diameter inlet mainline from Calexico to the Calexico Wastewater Treatment Plant (32.6726°N, 115.5149°W).

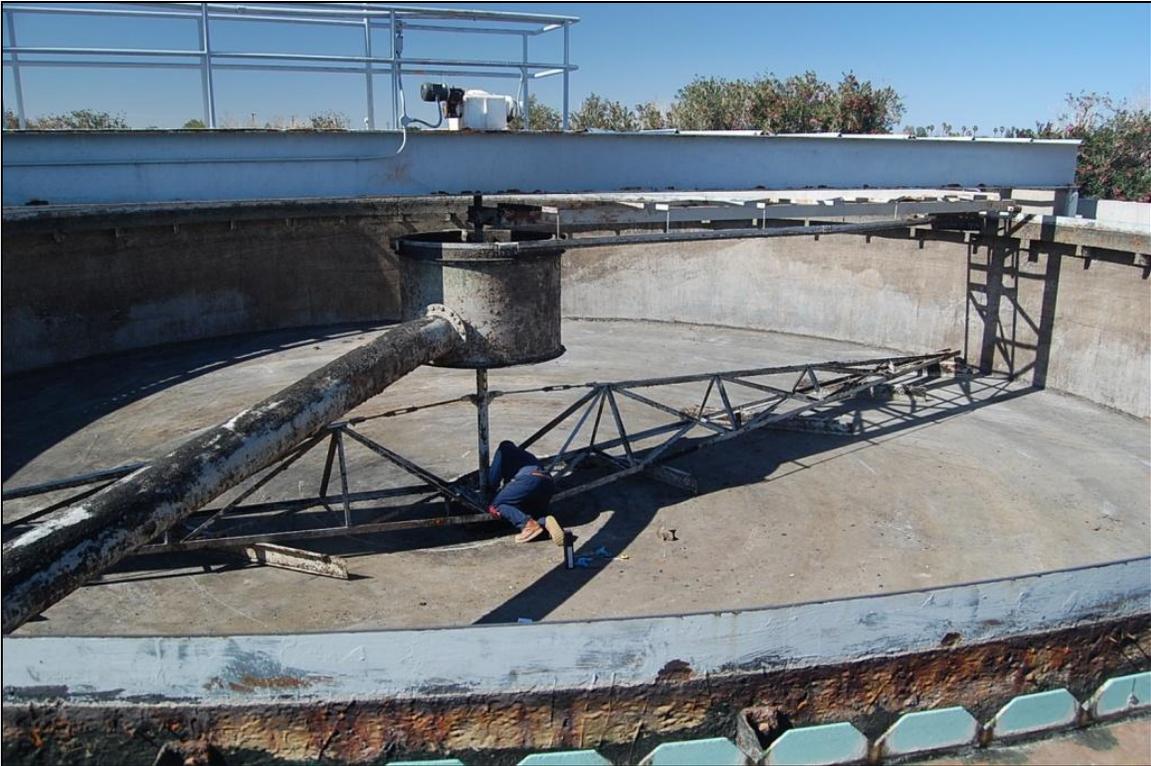
**Figure 5.15:** Damaged primary clarifier at Calexico Wastewater Treatment Plant.

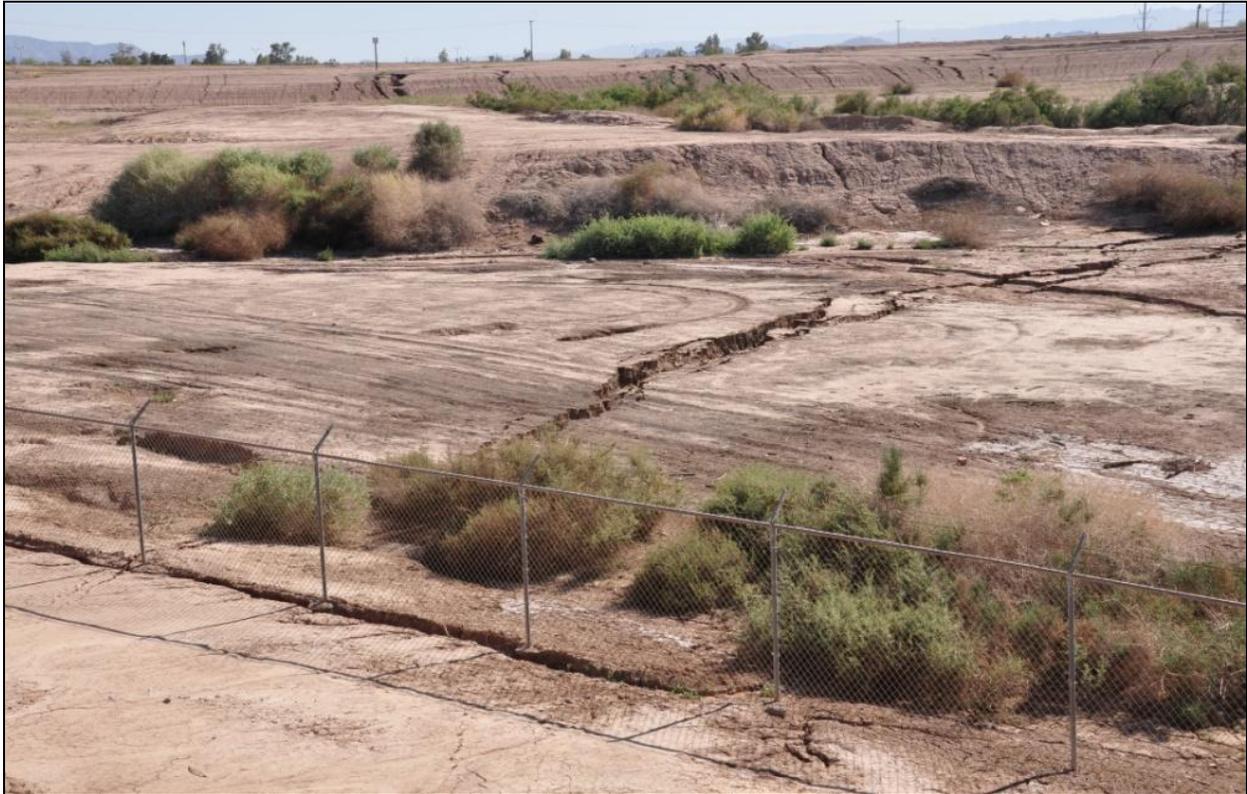
**Figure 5.16:** Lateral spreading and liquefaction near western side of Calexico Wastewater Treatment Plant.

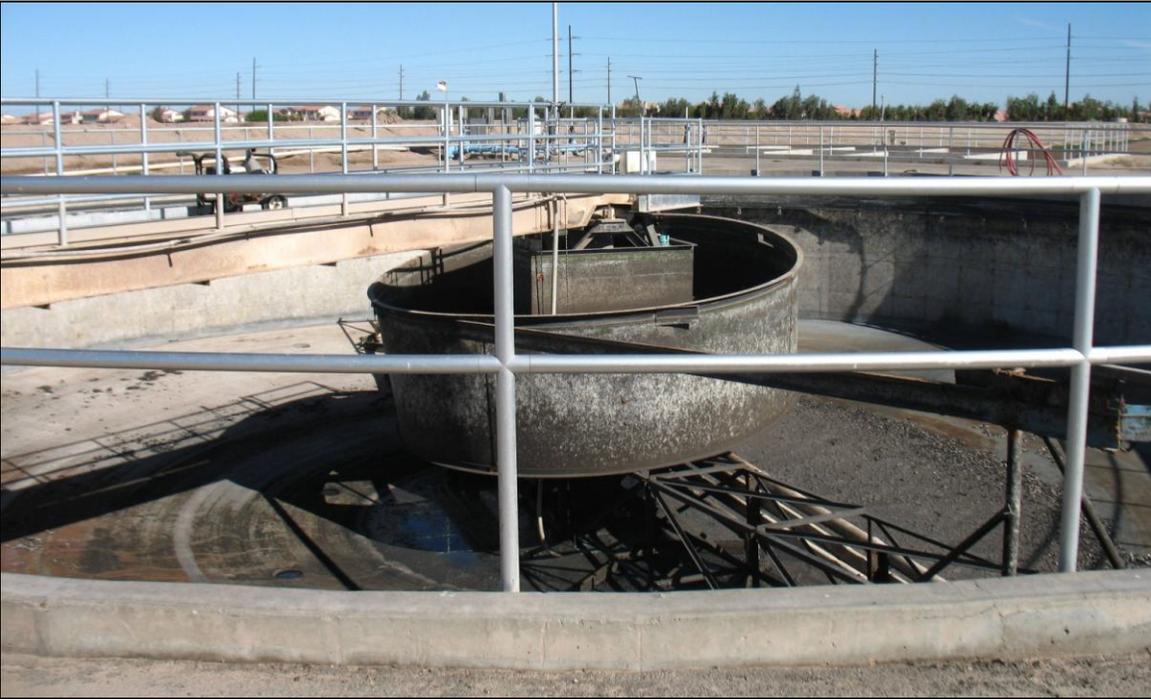
Figure 5.18: El Centro WWTP damaged secondary clarifier and well assembly.

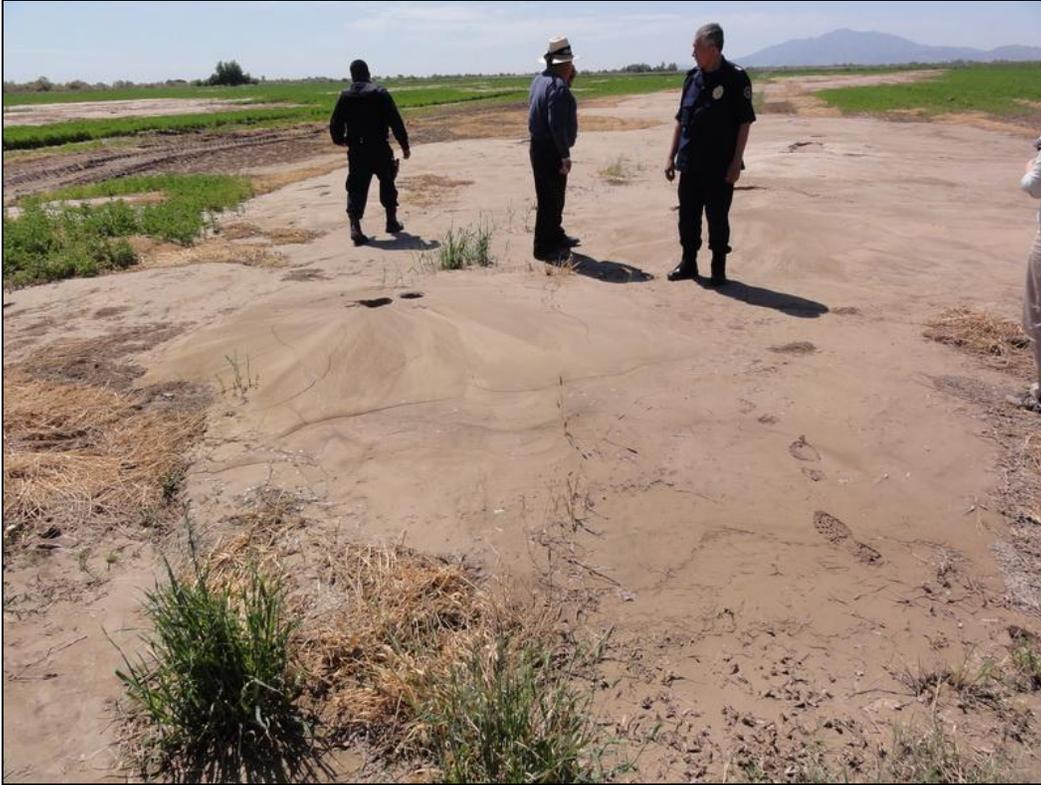
**Figure 6.10:** Sand boils in alfalfa field southeast of Cucapah, Baja California, Mexico.

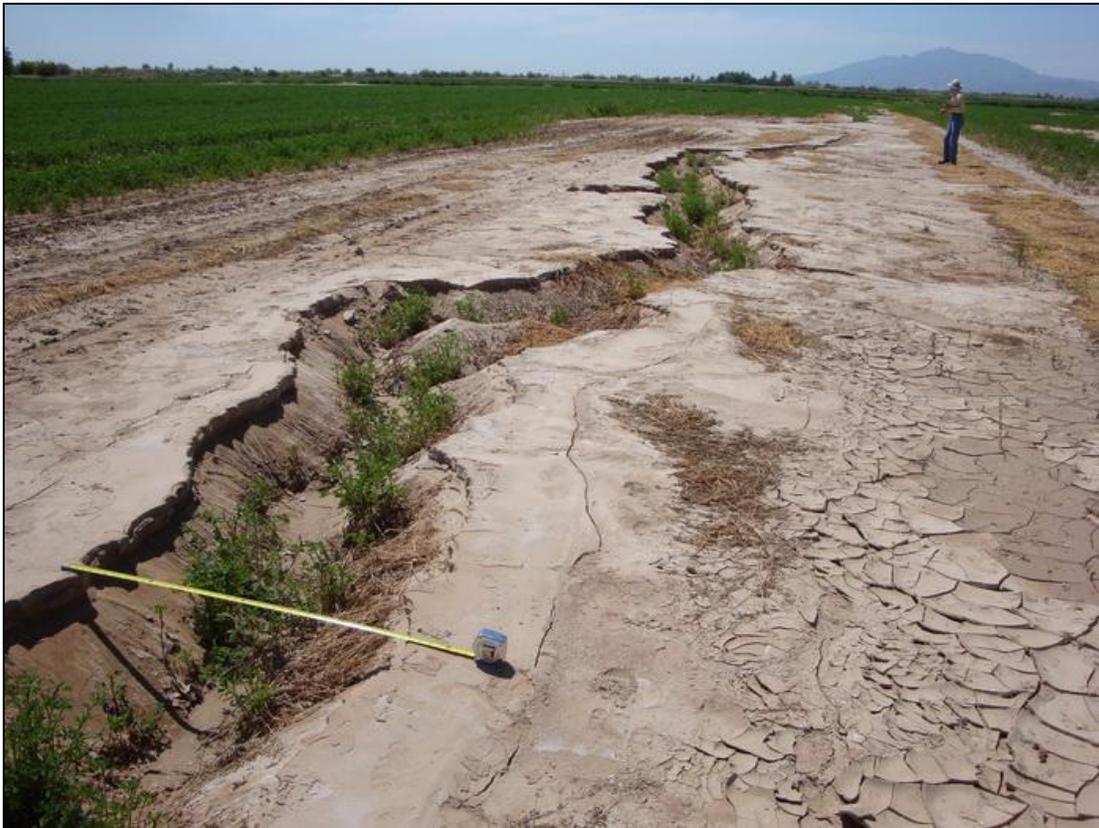
**Figure 6.14:** *Fissure and sand boils in alfalfa field southeast of Cucapah, Baja California, Mexico*

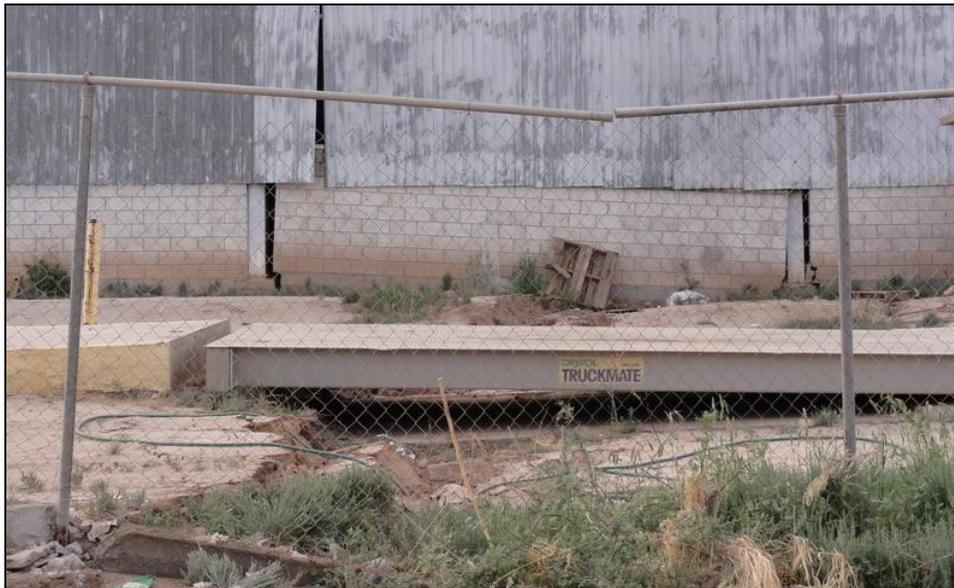
**Figure 6.16:** Ground fissure beneath building in Nayarit, Baja California, Mexico.
