POPAYAN EARTHQUAKE OF 31 MARCH 1983 GEOLOGIC AND SEISMOLOGIC ASPECTS

WILLIAM D. PAGE
Woodward Clyde Consultants
San Francisco Area Office
100 Pringle Avenue
Walnut Creek, California 94596

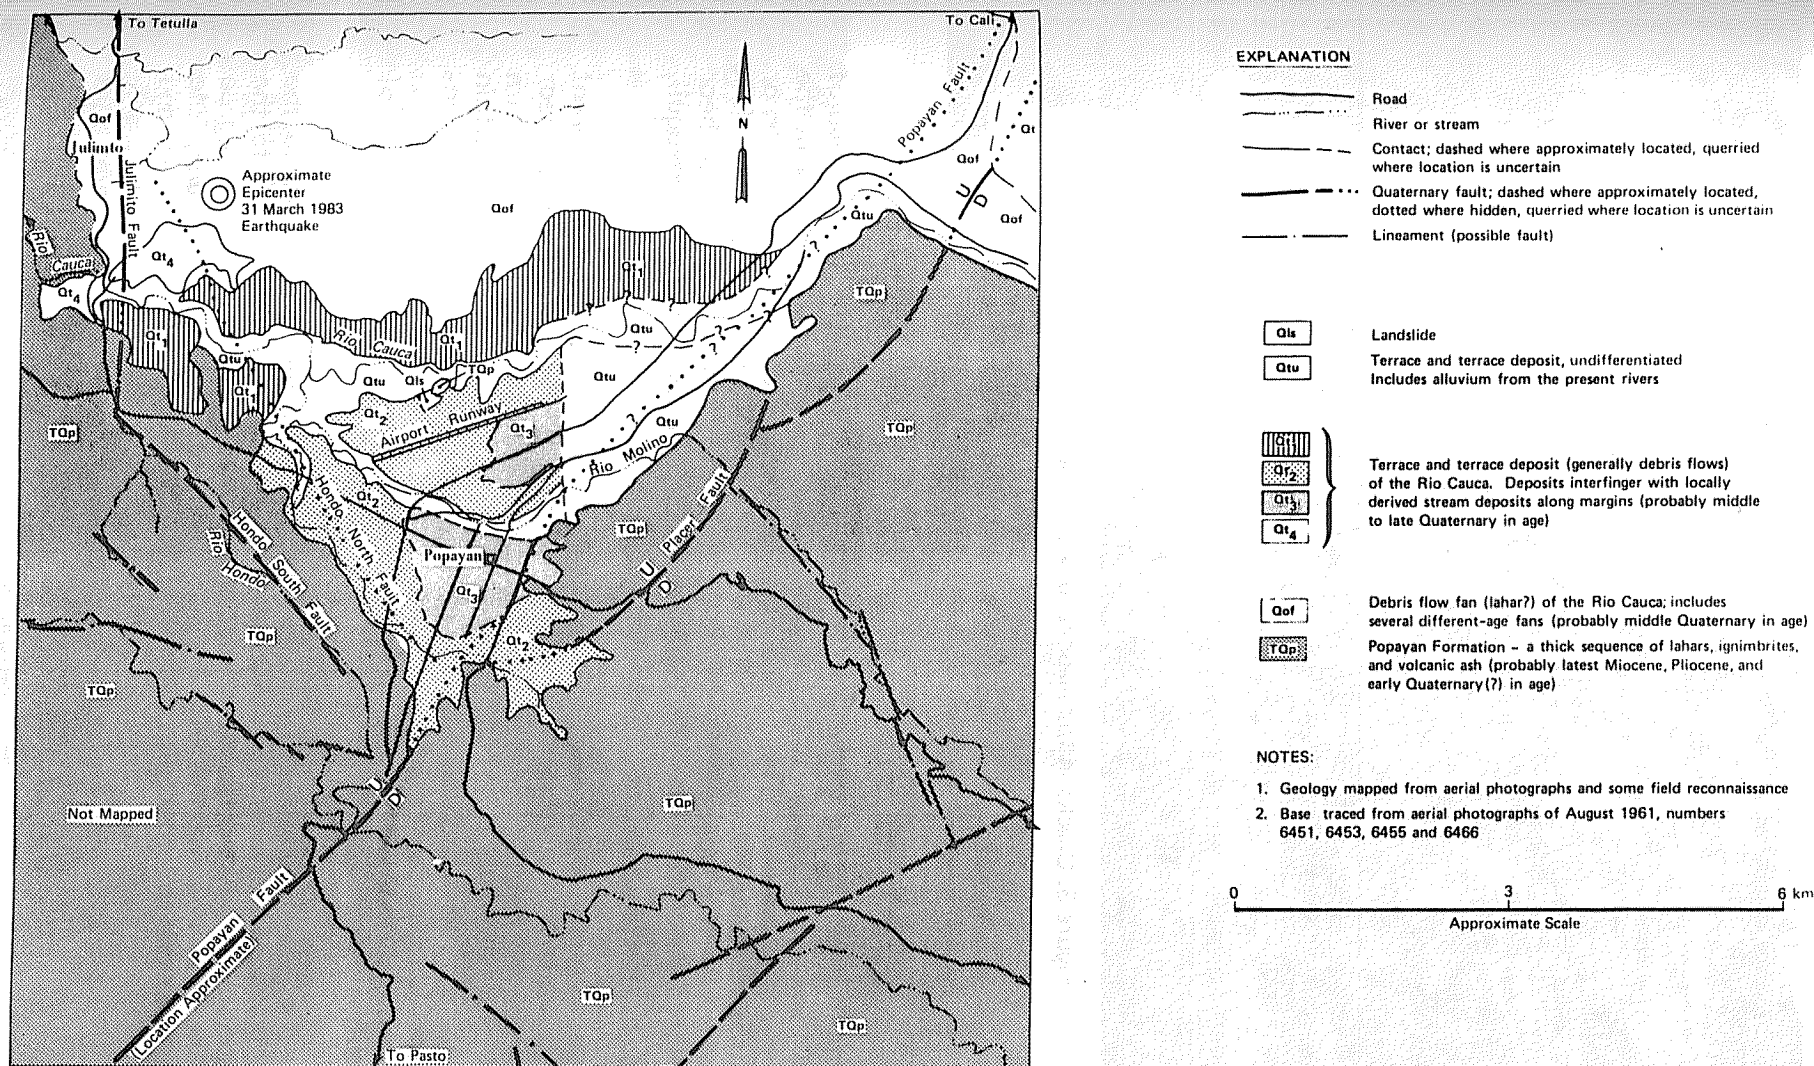
Figure 2 GEOLOGIC MAP OF POPAYAN, COLOMBIA, AND VICINITY

Preliminary mapping of the Quaternary deposits and preliminary analysis of soil borings made by the soils engineers in Popayan for buildings throughout the city indicate that soil conditions partly controlled the damage. At least some of the newer structures that were badly damaged appear to have been built on poorly consolidated soils, particularly soils that contained significant organic layers from old swamp deposits. These areas are on a specific alluvial terrace unit, shown as Qt_2 on Figure 2. No liquefaction occurred during the earthquake.

After the Popayan earthquake, when the Popayan area was examined in detail to locate specific active faults, the Placer, Popayan and Julimito-Hondo North faults were discovered (Figure 2). Other branches of the Romeral fault are present east of the mapped area and through the town of Silvia. Faulting of the Popayan Formation by a secondary fault of the Placer fault was found west of Popayan (Figure 7). The displacements in the surface of the Popayan Formation are evident when they are of a few tens of meters (Figure 8); near Piendamó the displacement is approximately 500 m. At Popayan, the Popayan fault and the Julimito-Hondo North fault displace the Popayan Formation down to the north and west an unknown amount, forming the alluvium-filled depositional basin at Popayan. In addition, the Rio Cauca alluvial and debris-flow fans, which are middle to late Quaternary in age, are faulted and warped where they overlie the Placer and Julimito-Hondo North faults. The Rio Cauca fan deposits over the Placer fault are faulted and warped approximately 10 m, east side down. The same deposits over the Julimito fault are also displaced approximately 10 m, north side down.

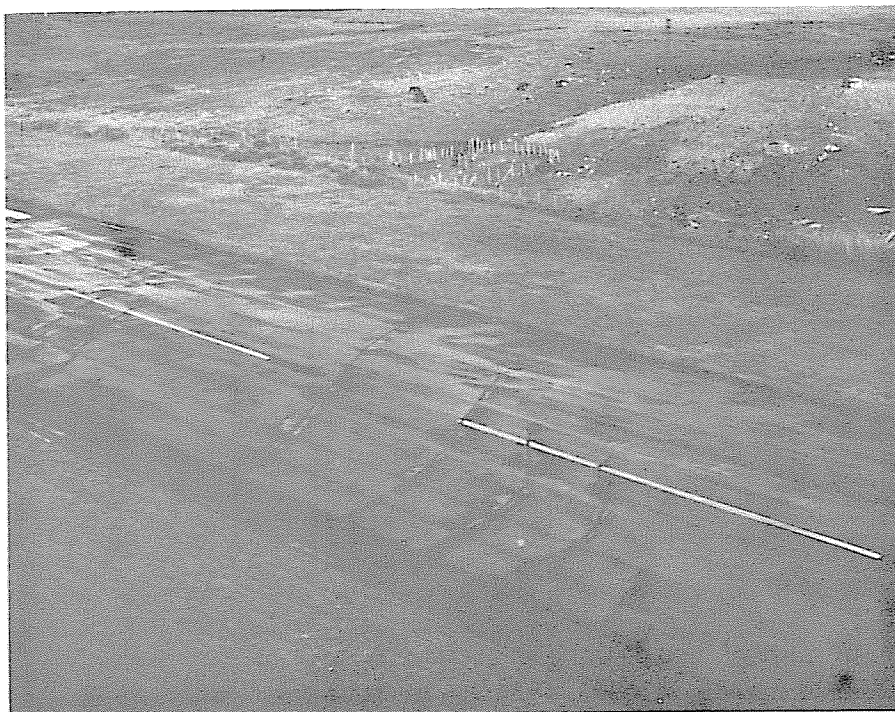
The earthquake was accompanied by extensive surface cracking. Most cracks, as mapped by Michael James, are in the area north of Popayan in a north-trending zone at least 2 km wide and 2 1/2 km long. Tens of cracks have been mapped by INGEOMINAS in the airport runway (Figure 3), at the army base north of the runway (Figures 4 and 5), and in the streets between the airport and the city. Each of the cracks are a few meters to tens of meters long and are open as much as a few millimeters. Displacements generally are consistent: northeast side up a few millimeters, and left slip, also of a few millimeters. Heavy damage to the buildings at the army base, and possibly elsewhere, in part may have been due to cracking of the foundations and walls along these cracks. The cracks were probably caused by a combination of subsidence within alluvial deposits (unit Qt_2 on Figure 2), and propagation and dispersion of the displacement of the fault that is below the sediments in the basin at Popayan.

Figure 3. Cracks in the airport runway, Popayan

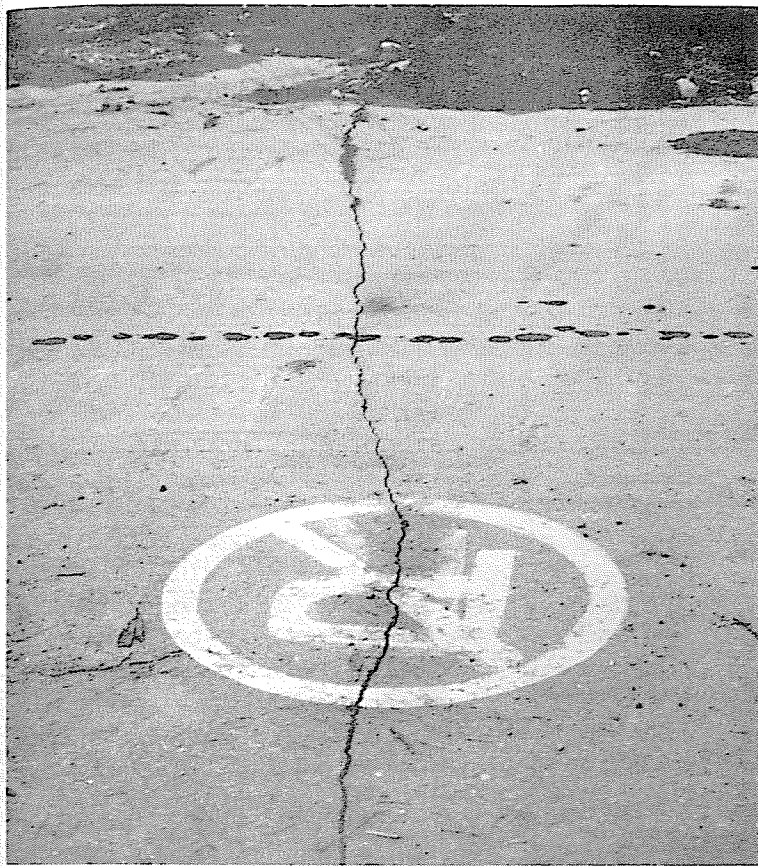
Figure 4. Crack in the street at the army base, Popayan. The water pipe below the street, where the hole is located, was ruptured.

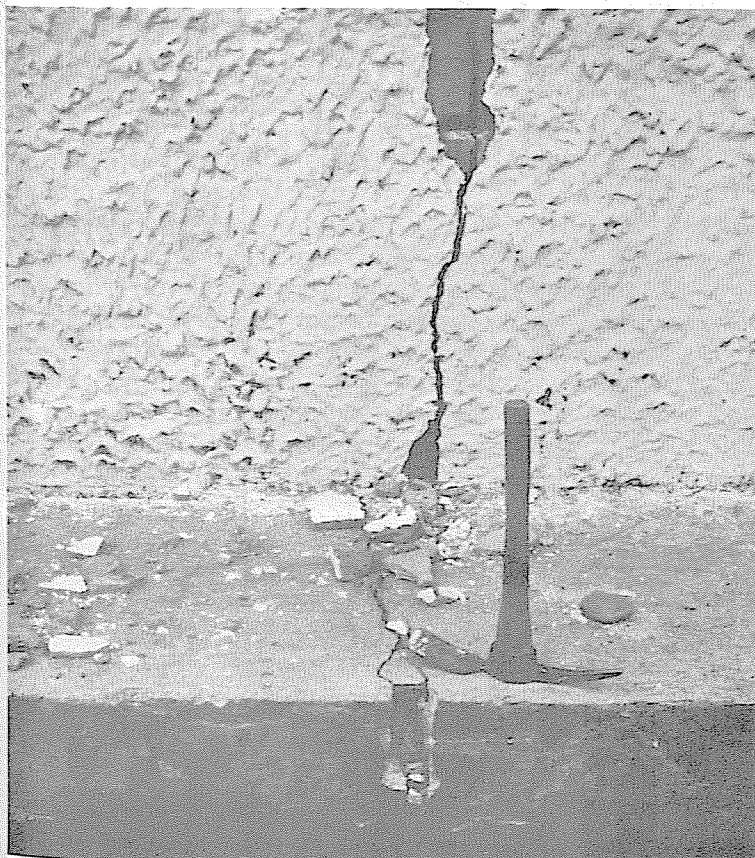
Figure 5. Crack in cement foundation and brick wall of house at the army base, Popayan.

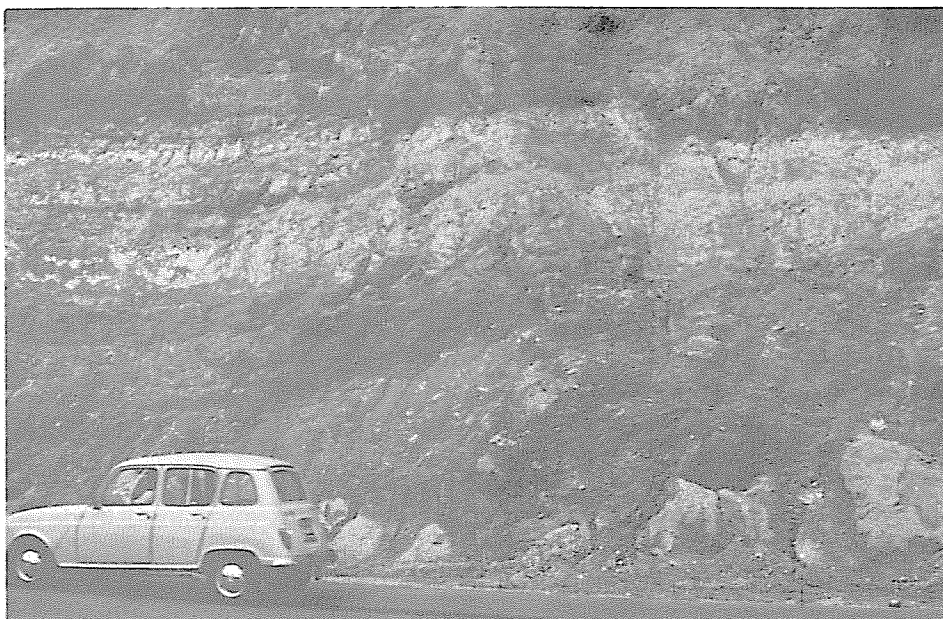
Figure 7. Secondary fault of the Placer fault displacing volcanic units in the Popayan Formation. The photograph was taken on the road to Purace, east of Popayan.

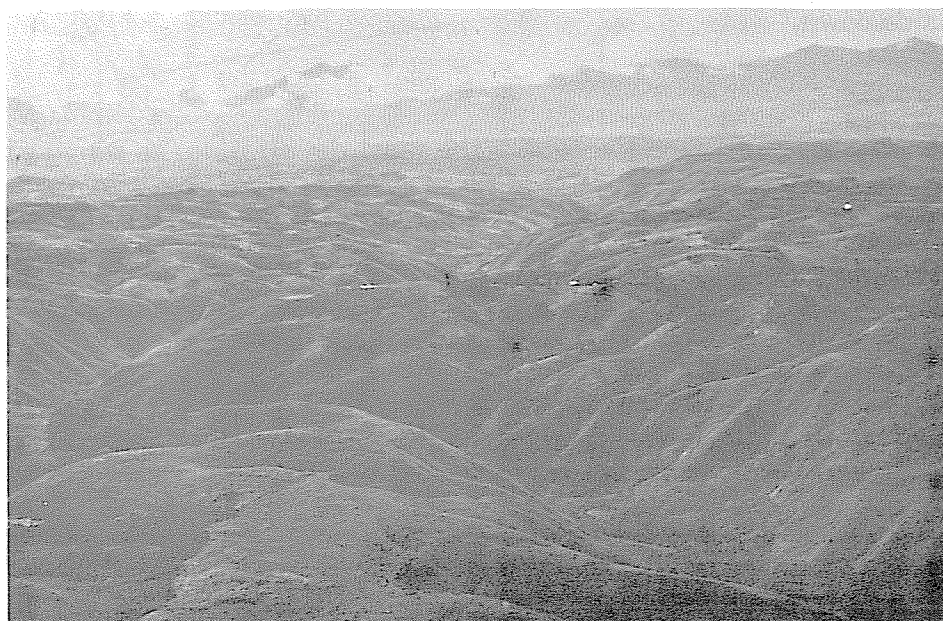
Figure 8. Fault (middle distance) that displaces the surface of the Popayan Formation south of Popayan.
