## Learning from Earthquakes

# Observations on the Southern Sumatra Earthquakes of September 12-13, 2007

This report is derived from a longer version by Elizabeth Hausler and Aaron Anderson of Build Change, currently based in Banda Aceh, Indonesia. They conducted site visits to Indonesia's provinces of Bengkulu and West Sumatra September 17-25, and to the Mentawai Islands October 6-9. Their full report is available at [http://www.eeri.org/life/indonesia\\_southern\\_sumatra.html](http://www.eeri.org/life/indonesia_southern_sumatra.html). Two additional reports are available at the same URL: one by consulting engineer Teddy Boen of Jakarta, Indonesia, and the other by Dwikorita Karnawati, Iman Satyarno, and Subagyo Pramumijoyo of Gadjah Mada University in Indonesia.

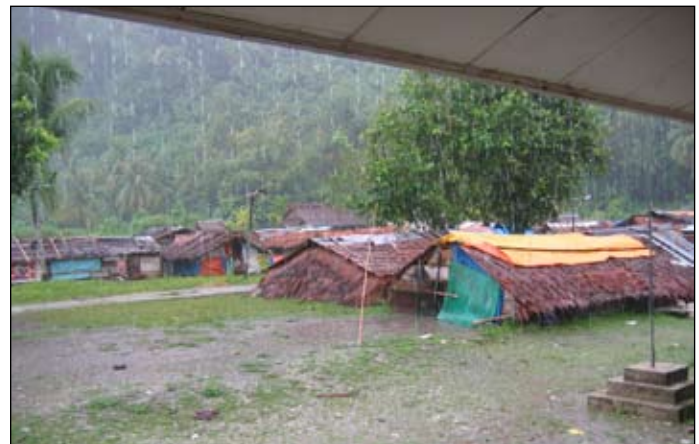
**Figure 14.** Temporary houses, Barimanua Village (Mentawai Islands).

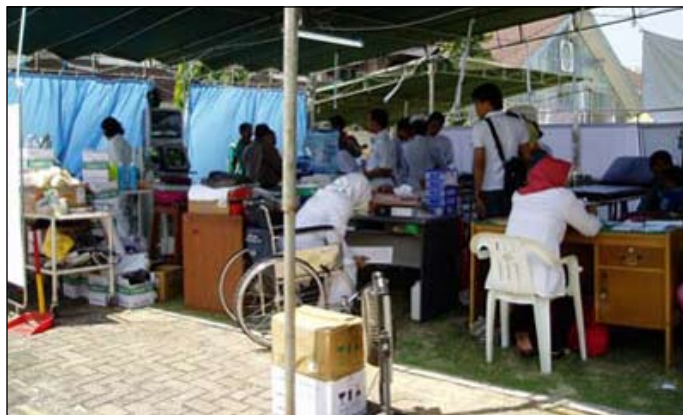
**Hospitals:** Nonstructural damage to hospital buildings in Bengkulu and Padang resulted in cracked masonry in fill walls, chipped plaster, and dust (Figure 21); patients were evacuated to tents (Figure 22). The M. Yunus hospital in Bengkulu was not operational right after the earthquake due to repair work needed. The building code considers masonry infill walls to be nonstructural elements, which has important implications for critical facilities that need to remain operational after earthquakes.

**Figure 22.** Patients were evacuated to tents (photo: Boen).
