Learning from Earthquakes

Preliminary Observations on the Taiwan Earthquake of December 26, 2006

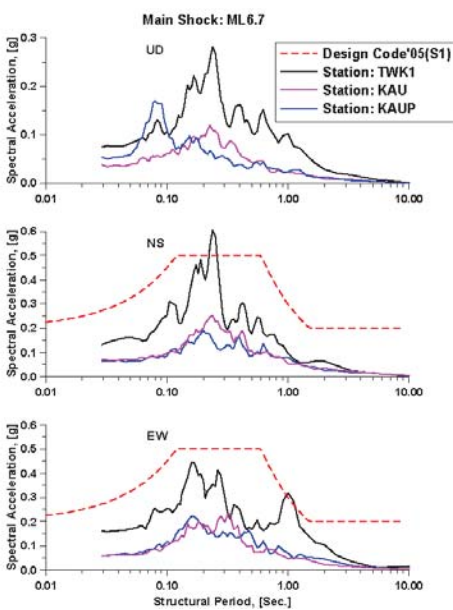
response spectra of three RTD stations that experienced the largest ground acceleration (159.88 gal at Kenting) in the main shock. The design spectrum of the current Taiwan building code (TBC '05) for Hengchun, the most damaged site, is also shown for comparison. The spectral acceleration is a little

higher than that of the design earthquake for the TWK1 station, which is located at Hengchun and near the damaged area. Figure 5 shows a similar comparison for the largest aftershock (156.42 gal at Kaohsiung Harbor).

Figure 4. The comparisons of response spectra (5% damping) at selected RTD stations in main shock ($M_L 6.7$).

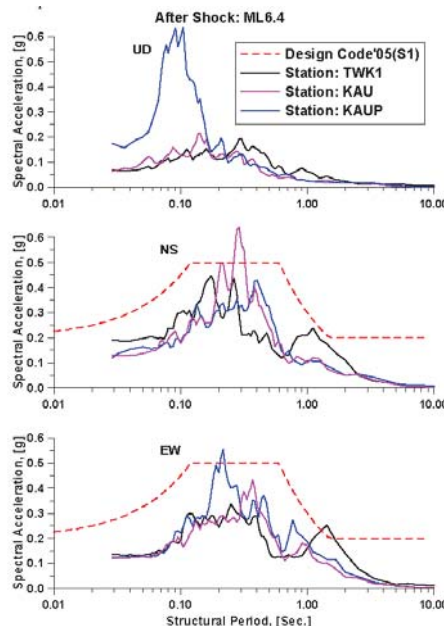
Figure 5. The comparisons of response spectra (5% damping) at selected RTD stations in largest aftershock ($M_L 6.7$).
