## SULTANDAGI EARTHQUAKE – TURKEY

Report by the Department of Earthquake Engineering, Kandilli Obs. and Earthquake Res. Ins., Bogazici University.

Prof. Dr. M. Erdik, K. Sesetyan, M.B. Demircioglu, U.Celep, Y.Biro; E. Uckan

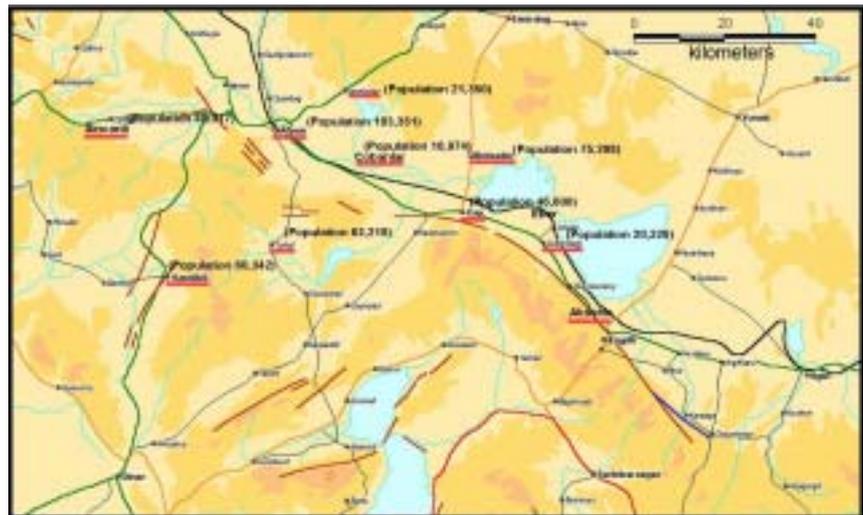
The earthquake caused damage in Aksehir, Bolvadin, Cay, Cobanlar, Iscehisar, Eber, Sincanli, Sultandagi, Suhut and Merkez districts of Afyon. The distribution of casualties and damaged buildings are given in the tables below.

Figure 5. Damage distribution

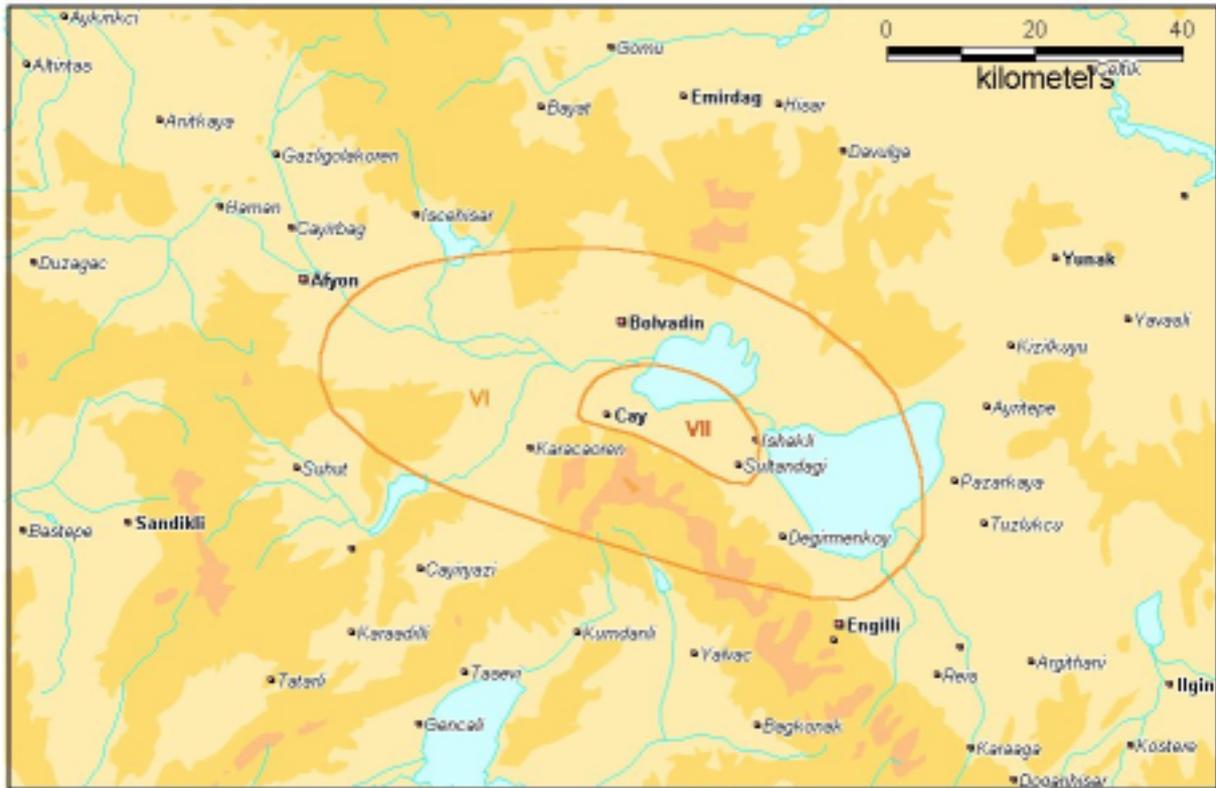
The intensity map compiled with the help of the above mentioned damages and field observations is given in Figure 6.

Figure 6. Intensity Distribution
