# The El Mayor Cucapah, Baja California Earthquake April 4, 2010

An EERI Learning from Earthquakes Reconnaissance Report

## An EERI Reconnaissance Report

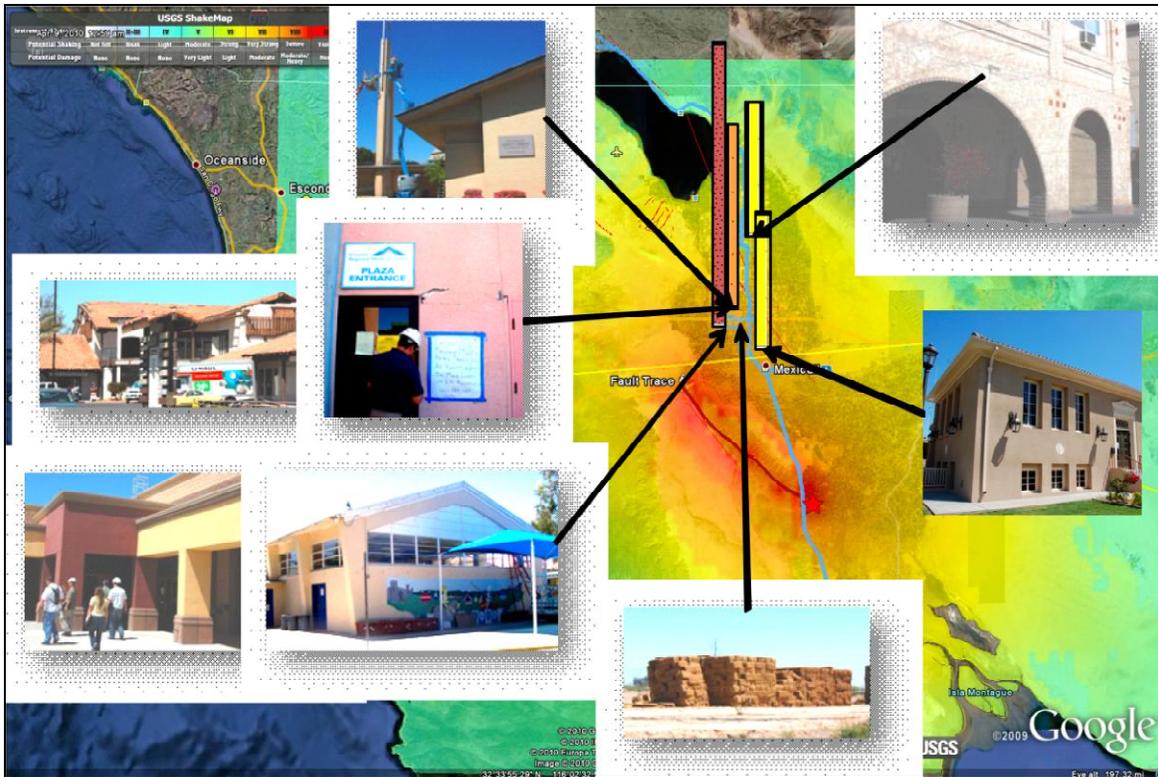
Figure 2.5: Images of structures near the USGS strong motion recording stations in the cities of El Centro and Calexico.

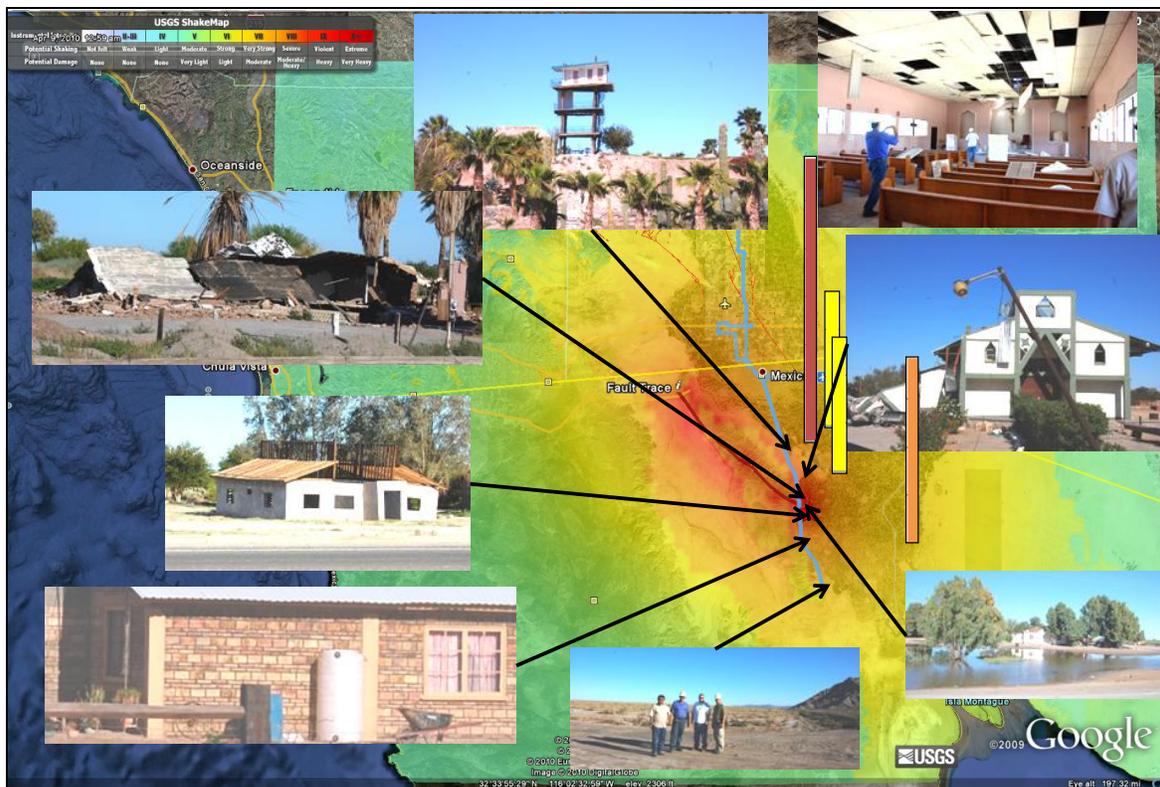
Figure 2.6: Images taken at sites near the epicenter.

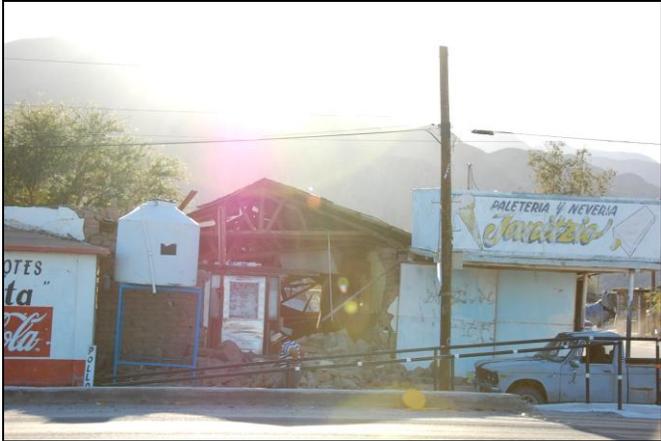
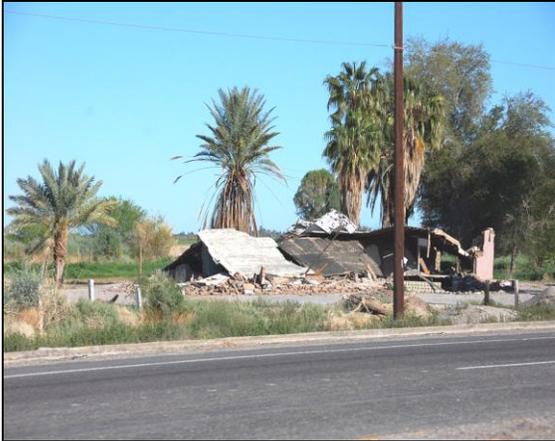
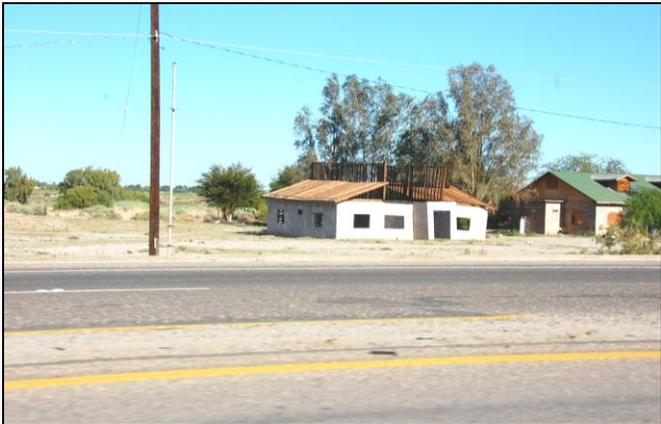
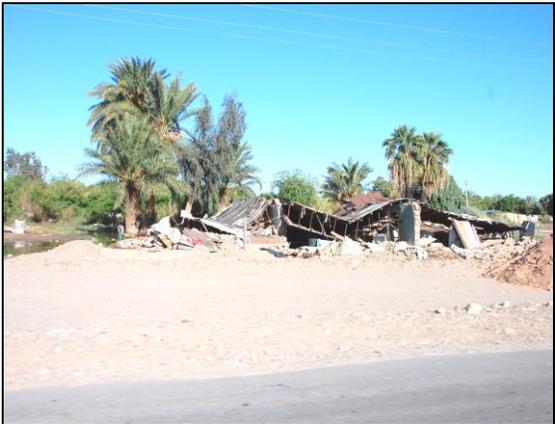
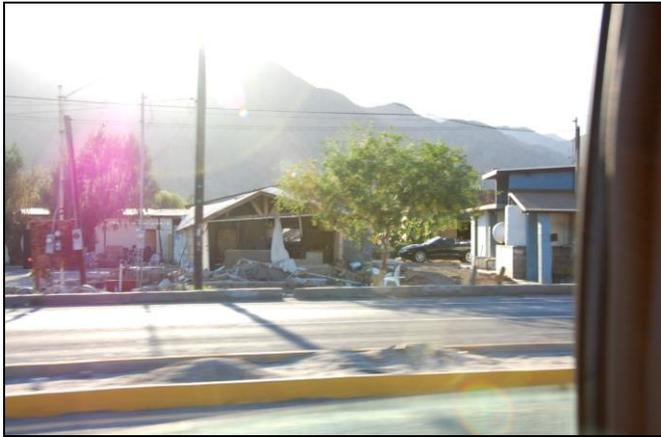
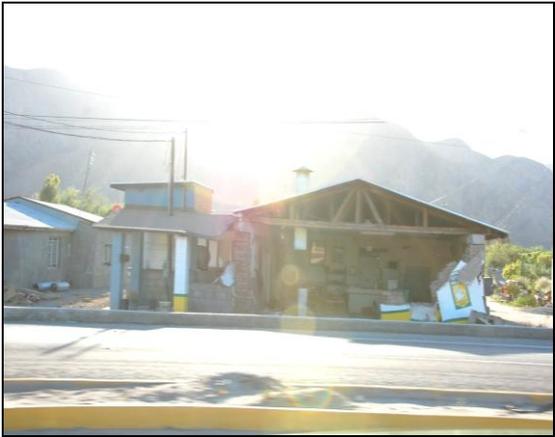
During the trip to Mexicali, the lack of visible damage affecting the city was noticeable. The city was functioning as if nothing had happened. Very few buildings in Mexicali had visible cracks. However, while driving on Highway 5 towards the epicenter, more damage to residential housing was apparent. In speaking with residents, they reported damage to five neighboring communities: Zacamoto, Nayarit, Oaxaca, Cucapá, and La Puerta. They described homes that were destroyed by soil liquefaction and lateral spreading, and people affected by the earthquake were living in tents. There were rumors that the government will not let the residents re-build in the same areas due to fear of future soil failures. Aside from the reported damage caused by soil liquefaction and lateral spreading, some damage due to poor construction quality was observed. It was apparent that most of the older residential homes, especially outside of the city, are not engineered and therefore do not possess proper structural detailing. However, most of the newer homes had no visible signs of distress. Figures 3.1 and 3.2 show images of damaged and undamaged houses, respectively.

Figure 3.1: Damaged homes in Mexicali.

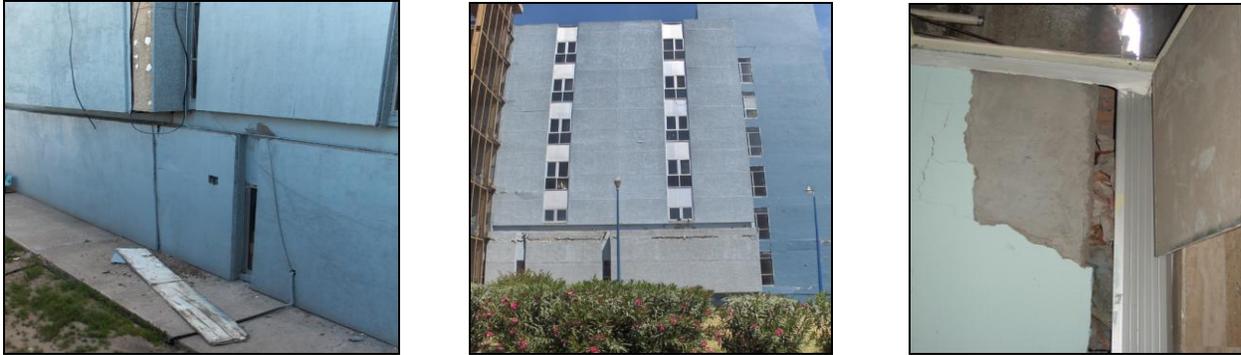
The Hospital General “5 de Diciembre” has a six-story reinforced concrete frame tower building with brick infill, and several one- and two-story wings. No structural damage was observed, but damage to exterior cladding, interior finishes, suspended ceilings, and mechanical equipment was visible. Damage to exterior cladding was concentrated in the first two floors, as shown in Figure 3.4. Suspended ceiling damage was minor, with most damage occurring adjacent to walls. Some medical records fell from shelves, but pharmaceuticals and supplies stored on open shelves did not fall (Figure 3.5).

**Figure 3.4:** Fallen exterior cladding panel (left); cladding damage (center); and finish damage due to differential motion at joint between tower and single-story east wing (right).

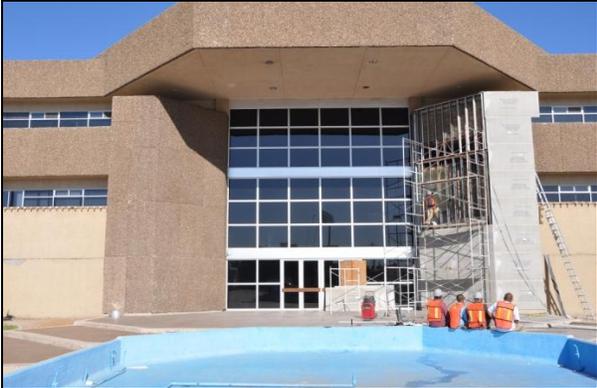
The administrative building, denoted as A on the campus map (Figure 3.9) is shown in Figure 3.13a. The function of this building is to host the office of the campus rector, other administrative business and campus security. The interior of this building is dedicated to office space. An interior inspection was conducted of this structure. This structure is a three-story building, whose load resisting system appeared to be a concrete frame with infill. The front of the building presents a large open area with a heavy cobblestone façade, which was significantly damaged (Figure 3.13b). Similar damage to the stone façade was observed at the west end of the building. Interestingly, with the exception of significant glass damage, interior nonstructural components presented only moderate damage, given the severity of structural damage. For example at a given floor only 20% or so of the ceiling system was damaged (Figure 3.13c). Although the services for the building were not turned at the time of the reconnaissance team’s visit, no significant damage was observed in the basement area to any of the mechanical, plumbing, or other units or their connections or piping (Figure 3.13d).

**Figure 3.13:** Administrative building at the Mexicali campus of UABC; (a) building overview (b) damage at front entry façade, (c) moderate interior damage, and (d) typical service equipment in basement in good condition (32.6337°N, 115.4442°W) (Building A in Figure 3.9).

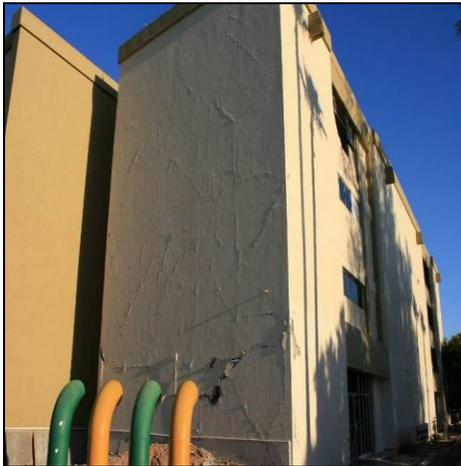
The Engineering Building is a reinforced concrete moment frame infilled with reinforced hollow concrete masonry units. The partial-height infill walls were isolated from the reinforced concrete columns with gaps thus preventing the occurrence of the short-column effect. The east and west sides of the building have confined masonry enclosure walls constructed of hollow concrete masonry units. Figures 3.14 through 3.17 show different aspects of the damage to this building.

**Figure 3.14:** Partially collapsed infill panel at fourth story

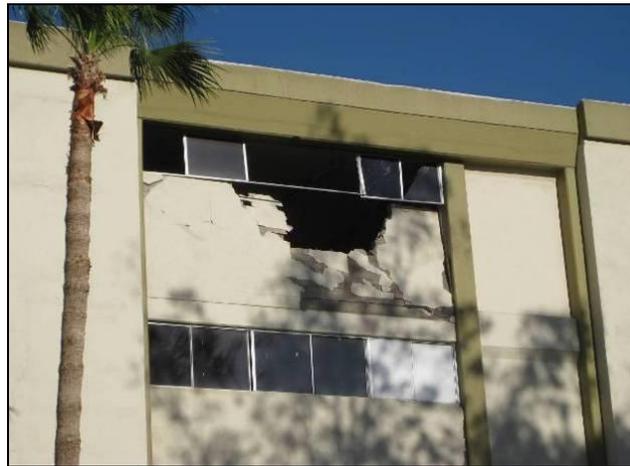
**Figure 3.15:** Damage in enclosure wall on the northwest side.

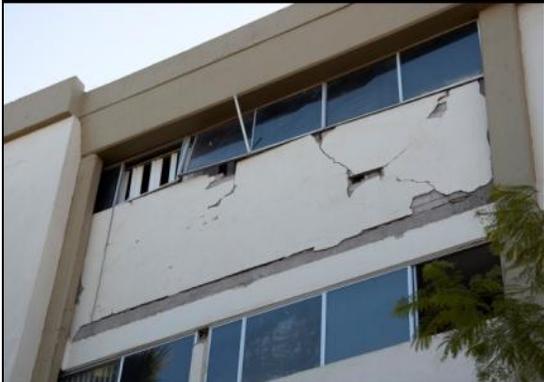
As early as of Monday 4/5/2010 (the day after the main earthquake), the UABC administration had mobilized crews to start clean up and repair work as they were about to start the new school year and did not want to delay significantly the beginning of the classes. As a result some exterior wall partitions were not observed at the Engineering Building, which collapsed due to out-of-plane forces and inadequate anchorage, because the walls had already been removed. These walls had some restraint in the form of steel angles at the vertical wall ends and some small braces at the top of wall; however, the wall itself was not strong enough to resist out-of-plane forces when restrained at the few support points. In addition, there were some very large cracks observed in the masonry infill of the stair shaft and some pounding

damage observed along the building joints. The main lateral load resisting system for this 4-story building appears to be reinforced concrete moment frames with masonry infill walls in the transverse direction and concrete shear walls in the longitudinal direction. Some spalling was observed at the base of columns.

Figure 3.16: Engineering faculty building at the Mexicali campus of UABC: Exterior damage on east wall

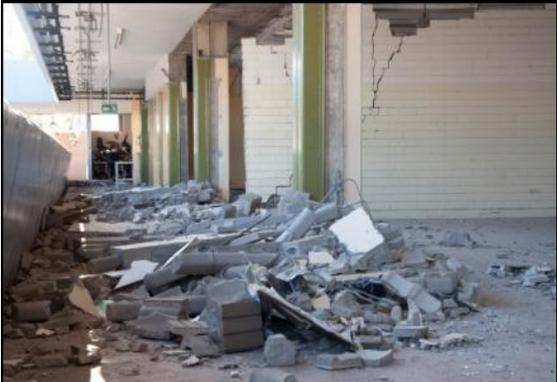
Figure 3.17: Collapsed wall (north side on 4<sup>th</sup> floor) (32.6321°N, 115.4439W°).

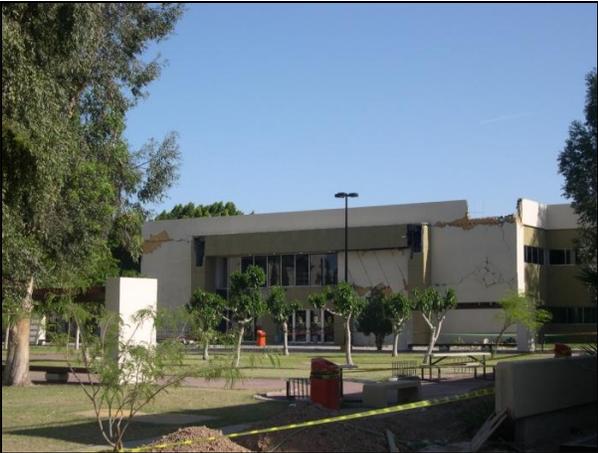
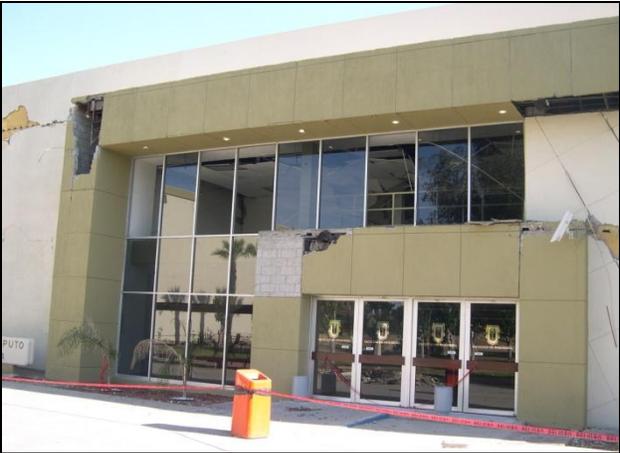
This building is a two-story moment frame with partially grouted masonry infill. This building had parapet failure as well as masonry wall failure at one side of the entrance at the second story level. Because the damaged portion was already cleared at the time of the reconnaissance visit, it is not certain if it was due to lack of out-of-plane anchorage or caused by excessive shear. There were many windows broken at the main entrance. A very noticeable pattern of horizontal cracks was noted at the joint locations. Figures 3.18 and 3.19 show damage to the building.

Figure 3.18: Damage to UABC Computer Science and Electronics Laboratory Building.

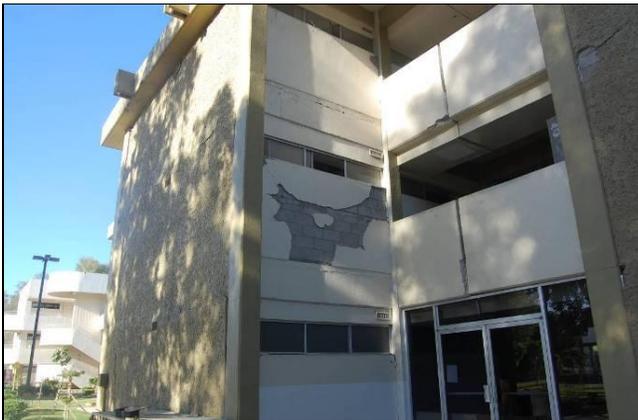
This three-story reinforced concrete moment frame has unreinforced hollow concrete unit masonry infill panels along the perimeter (32.6326°N, 115.4431°W). Several bays are partially infilled up to 50%-70% of the column story height. There are no separation joints between columns and infill panels. Shear cracks formed in one column of the building perimeter as a result of the short-column effect. Diagonal and sliding cracks formed in the masonry infill panels. Figures 3.20 through 3.22 present the damage to this building.

**Figure 3.20:** Severely damaged infill panels and plaster.

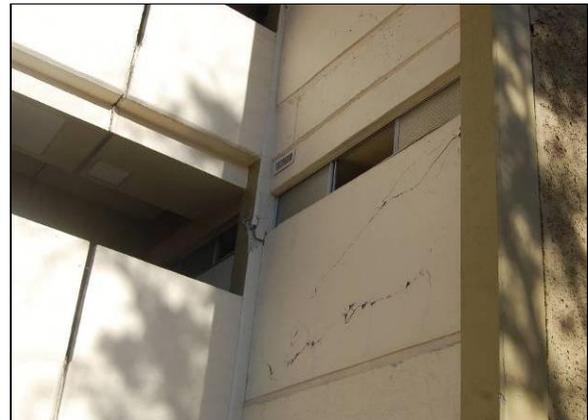
**Figure 3.21:** Shear cracks in the infill panels and in a short column.

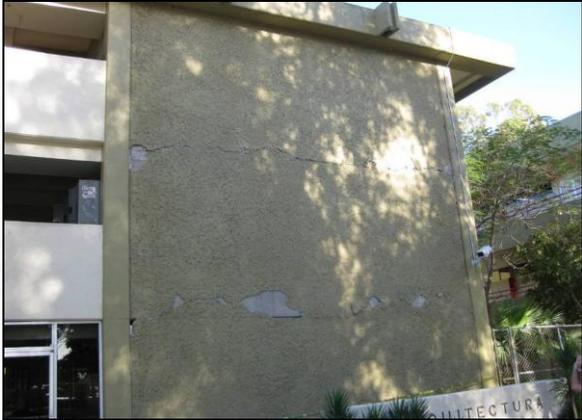
Figure 3.22: Damaged infill panels and plaster.

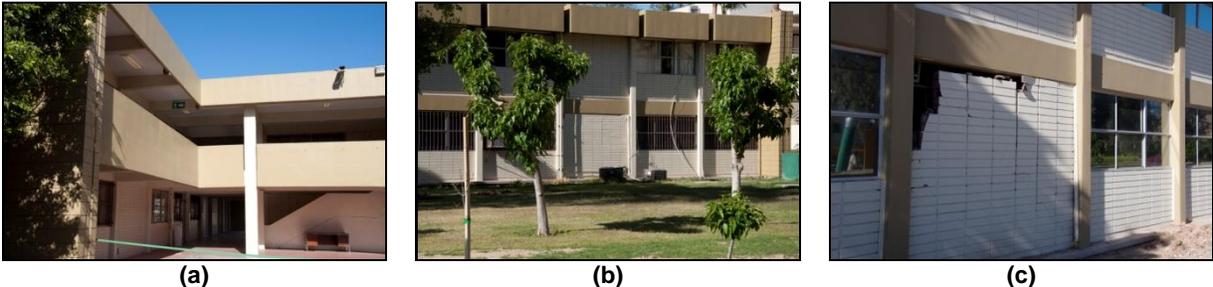
Two office buildings of similar configuration are located in the center of campus (E in Figure 3.9). Both of the buildings are I-shape in plan. The buildings are two-story reinforced concrete frames with reinforced concrete masonry unit (CMU) walls (Figure 3.23a). Exterior damage was observed to be more substantial on the west building. The only structural difference noted was that the CMU infill in the eastern building ran the entire height of the building (Figure 3.23b). In the western building, shear cracking was observed in second story columns and within the CMU walls. The south side masonry units were damaged in the out-of-plane (north-south) direction (Figure 3.23c). Interior access to the building was restricted, but ceiling tiles were observed to have fallen.

Figure 3.23: Office buildings at the Mexicali campus of UABC: (a) west building (looking east); (b) out-of-plane failures of the reinforced CMU in the west building; (c) east building (full building height infill) (32.6330°N, 115.4439°W) (Building E in Figure 3.9).

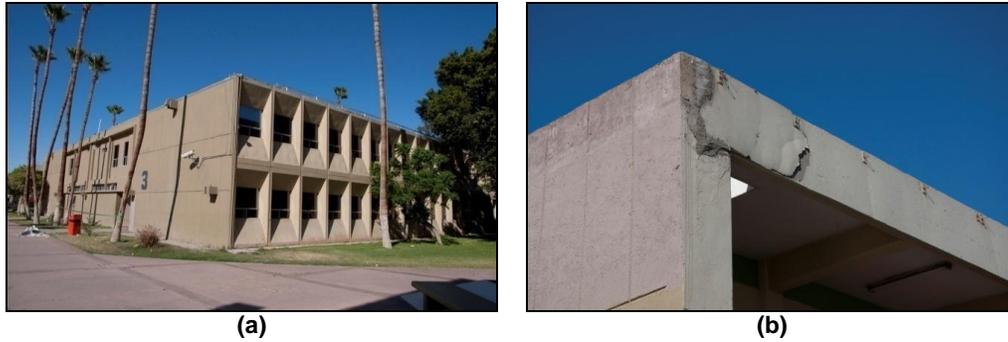
The north law building is denoted as B on the campus map, whereas the south law building is denoted as J in Figure 3.9. These two-story buildings appeared to be modern construction with masonry infill walls (Figures 3.24a and 3.25a). Building B exhibited very limited concrete spalling on the exterior of the building; an example of a beam-column connection is shown in Figure 3.24b. In contrast the exterior of building J on both the east and west faces was observed to be peeling away at the roof and second floor levels from the structural core (Figure 3.25b). Interior ceiling damage in building J was observed from the exterior to be significant (Figure 3.25c). Access to both buildings' interiors was prohibited.

**Figure 3.24:** Law building (north) at the Mexicali campus of UABC: (a) building overview from the southwest corner; (b) spalling on the concrete frame in the northwest corner on the second floor (32.6330°N, 115.4453°W) (Building B in Figure 3.9).

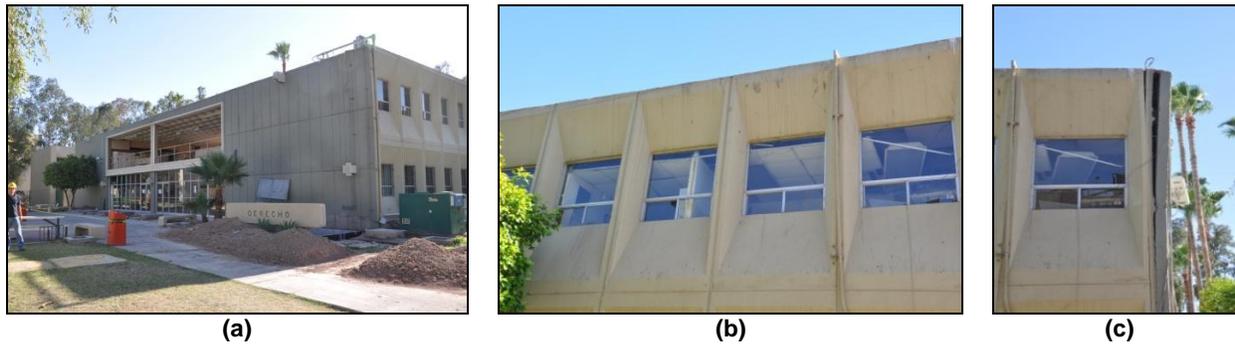
**Figure 3.25:** Law building (south) at the Mexicali campus of UABC: (a) building overview from the northeast corner; (b) peeling away of the east front face and (c) extensive ceiling damage in the interior (32.6320°N, 115.4453°W) (Building J in Figure 3.9).

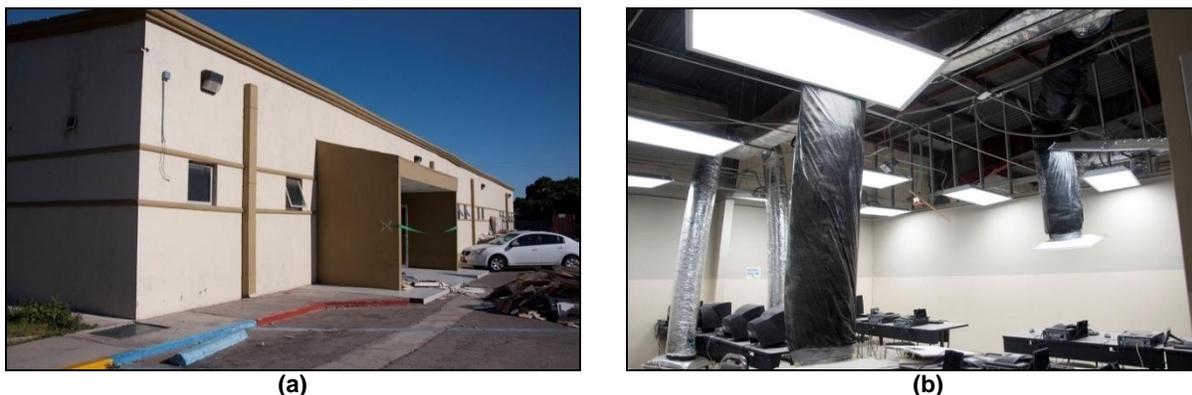
In the lower southeast corner of campus (I in Figure 3.9), another one-story building with a steel frame and CMU infill houses the industrial engineering laboratory (Figure 3.27a). While no exterior damage was observed, an interior assessment found extensive ceiling tile loss (Figure 3.27b). The ceilings were typically damaged at their interface with ducts and lighting fixtures. The building was still operational and personnel were in the offices.

**Figure 3.27:** Industrial engineering laboratory building at the Mexicali campus of UABC: (a) building overview; (b) ceiling failure in computer lab (32.6308°N, 115.4431°W) (Building I in Figure 3.9).

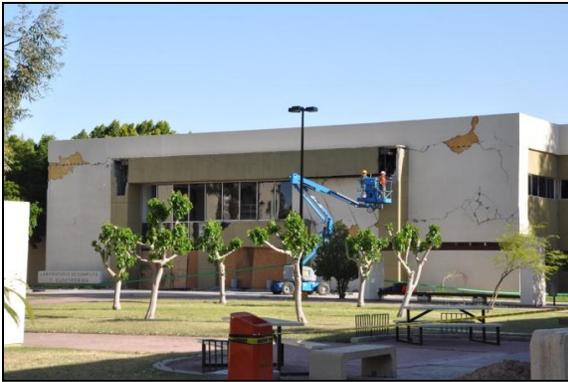
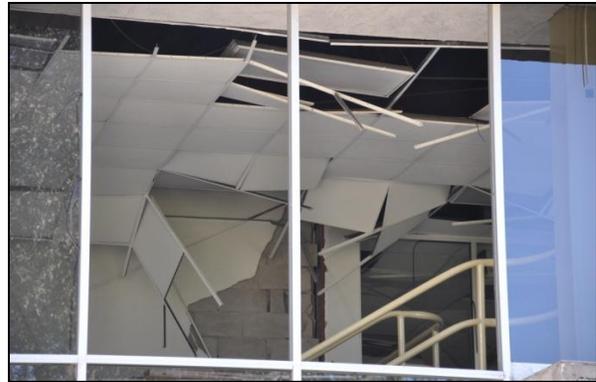
The electronics and computer laboratory and the Engineering Institute buildings are of like construction, located at the southern end of the campus, and denoted as buildings K and L, respectively, in Figure 3.9. Not depicted in Figure 3.9, however, is a new addition that had recently been constructed connecting these two buildings on their east ends. The new addition was isolated from the other two existing wings and interestingly interior damage was observed to be more significant. The north entrance of building K suffered significant shear and horizontal cracks and throughout this building structural and nonstructural damage was extensive (Figure 3.28). Similar observations were noted in Building L to the south; however, the front (south) entrance did not sustain nearly as much damage as the northern main entrance of Building K. Both of these structures are frame buildings with partially grouted masonry infill. The CMU appeared to have limited connectivity with the primary frame system (Figure 3.29). Infill wall damage, to all buildings, but particularly in the new annex building, was extensive, and often left large regions of exposed areas at the perimeter (Figure 3.30).

**Figure 3.28:** Electronics and Computer Lab at the Mexicali campus of UABC: (a) exterior damage at north entrance; (b) extensive interior ceiling system damage (32.6314°N, 115.4447°W) (Building K in Figure 3.9).

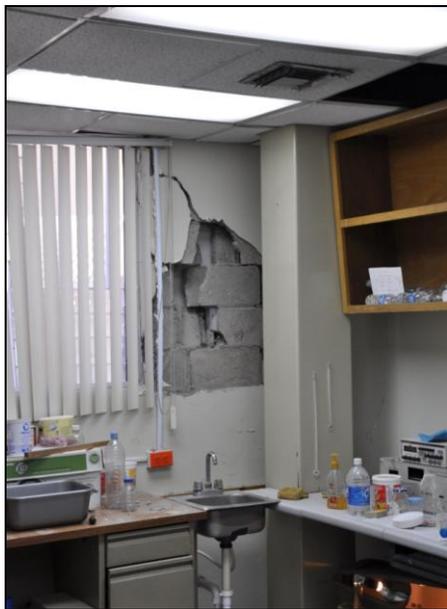
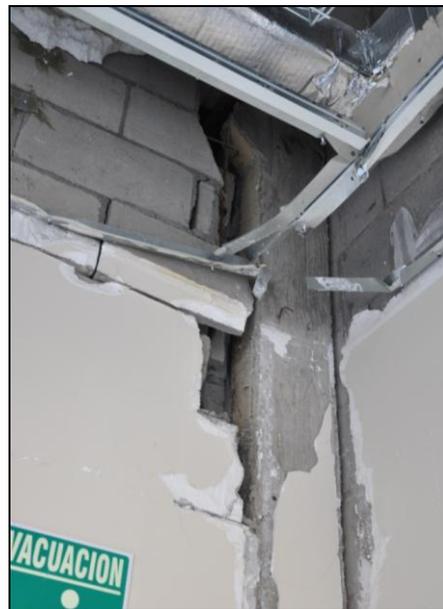
**Figure 3.29:** Interior damage in the Electronics and Computer Lab at the Mexicali campus of UABC. Limited connectivity between CMU and primary structural frame (32.6314°N, 115.4447°W) (Building K in Figure 3.9).

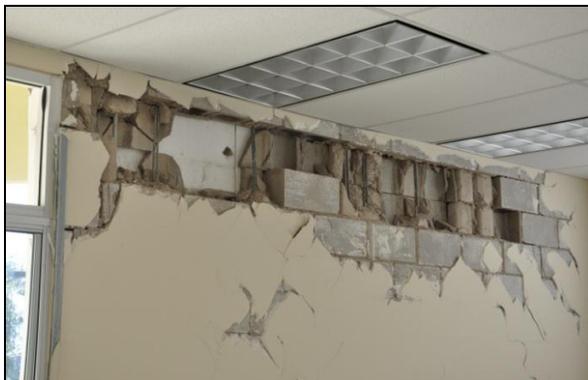
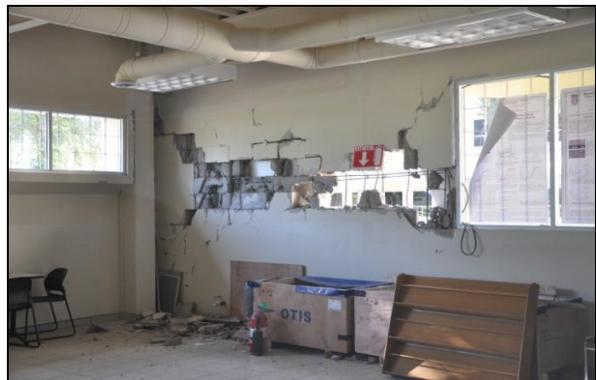
**Figure 3.30:** Damaged CMU infill in the new eastern annex building connecting buildings K and L on the Mexicali campus of UABC (32.6314°N, 115.4451°W).

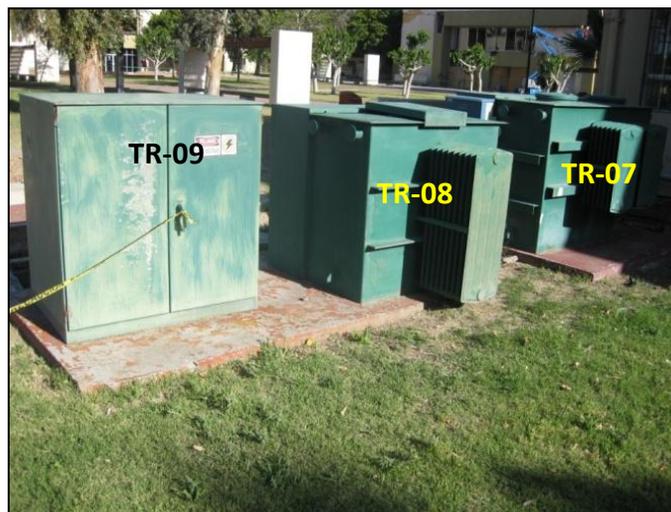
Three transformers denoted as TR-07, TR-08, and TR-09 from south to north respectively in Figure 3.31 are suspected to have slid significantly in plane during the earthquake. The transformers are located north of building J, as M in Figure 3.9. The transformers appeared to be liquid-filled. Figure 3.32 shows a sliding displacement of TR-07 to the east approximately 25 mm (1 inch). Although the anchorage could not be observed from the outside, it is suspected that the transformers are unanchored based on the large sliding displacement of 25 mm (1 inch). The transformers bear directly on a concrete pad with a rough surface. Figure 3.33 shows the outline of the transformers before and after sliding. The average sliding displacement of the center of gravity was approximately 25 mm (1 inch) in the east-west direction coupled with a maximum rotation of approximately three degrees clockwise. The weight of the transformers is estimated as 27 kN (6000 lbs), 22 kN (5000 lbs), and 13 kN (3000 lbs) respectively for TR-07, TR-08, and TR-09. Sliding of the transformers indicates strong shaking occurred at the site with a large enough peak ground acceleration to overcome the static friction between the transformers and the concrete pad, possibly coupled with vertical accelerations.

Figure 3.31: Liquid-filled transformers (32.6323°N, 115.4451°W).

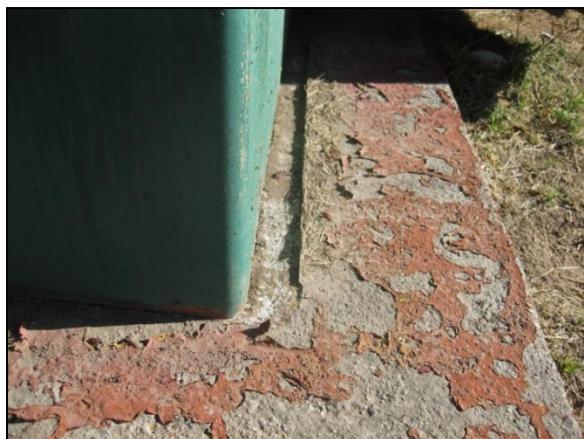
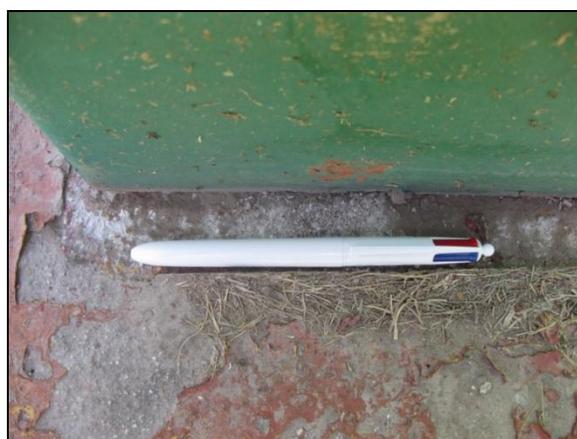
Figure 3.32: Movement of transformer TR-07 of approximately 25 mm (1 in) (32.6323°N, 115.4451°W).

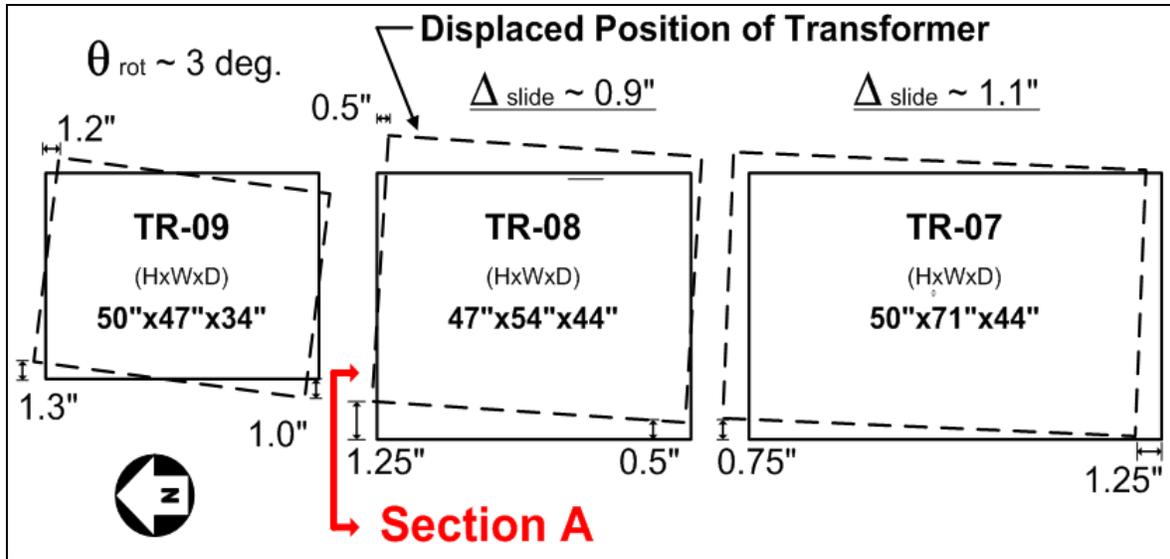
Figure 3.33: Suspected movement of liquid filled transformers (1" = 25 mm) (32.6323°N, 115.4451°W).

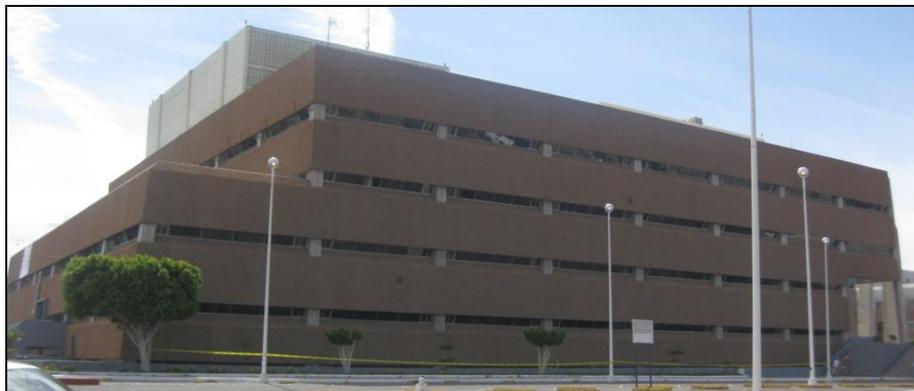
The Governor's building is a five-story structure with two penthouses and a footprint of approximately 55 m by 72 m (179 ft by 235 ft). The top two stories are offset approximately 9 m (30 ft) from the lower two stories. There is also a 14 m by 27 m (45 ft by 89 ft) diaphragm opening at the center of the building (Figure 3.35). The building is founded on drilled piers. This building contained an accelerometer at the roof level and at the lowest level. The reconnaissance team was unable to access the room that housed the instrument at the roof; however, the team did observe the instrument at the lowest level. It seems to be that no records were obtained.

**Figure 3.35:** Governor's Building: Exterior west elevation illustrating vertical plan irregularity.

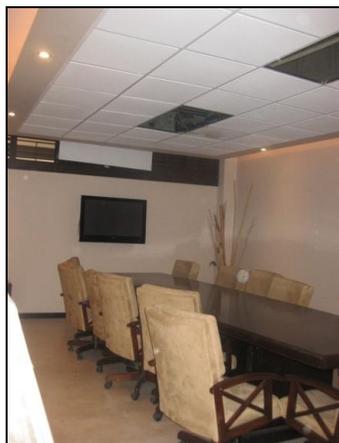
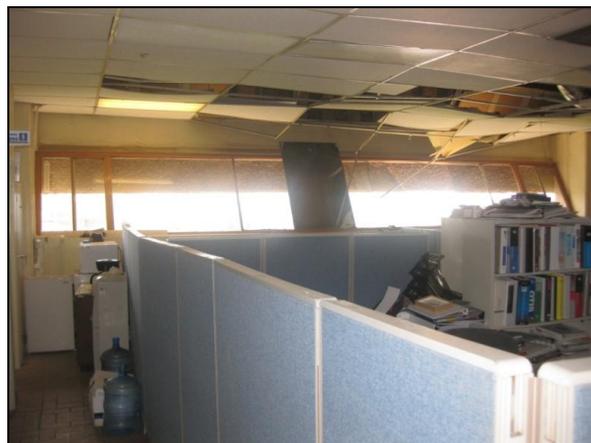
A visual inspection was performed to observe the interior damage. The damage appeared to be primarily nonstructural. It was noted that some ceilings may have been damaged due to the vertical displacement of above-ceiling mounted mechanical units (Figure 3.36). The damaged ceilings of the Governor's office had been removed and replaced. It did not appear that diagonal wires had been installed in the new ceiling.

**Figure 3.36:** Governor's Building: A conference room in the Governor's office with the ceiling repaired on the left. On the right, a ceiling damaged due to excessive vertical displacement of an isolated mechanical unit mounted above the ceiling.

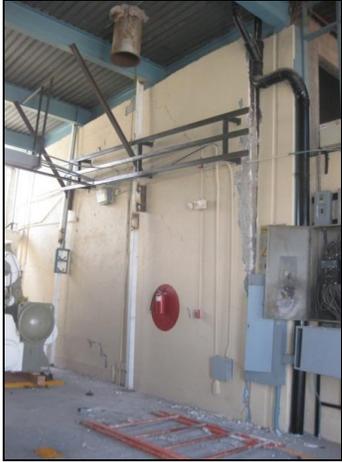
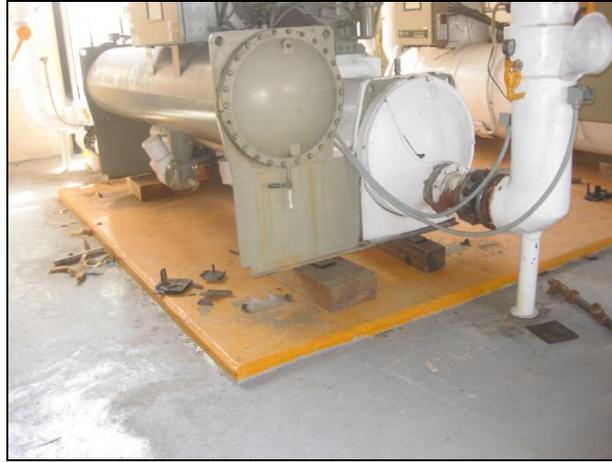
Additional nonstructural damage was observed at the penthouse level of the Governor's building (Figure 3.37). It appeared to be a pattern of damage in the north/south direction.

**Figure 3.37:** Governor's Building: On the left, a partition wall at the penthouse level has displaced approximately 150 mm (6 inches) out-of-plane in the north direction. On the right, mechanical units at the penthouse are supported temporarily due to damaged anchorage. The longitudinal axis of these units was oriented in the east/west direction.

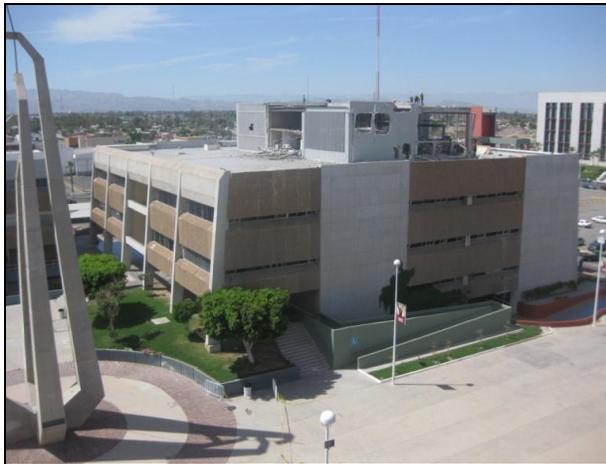
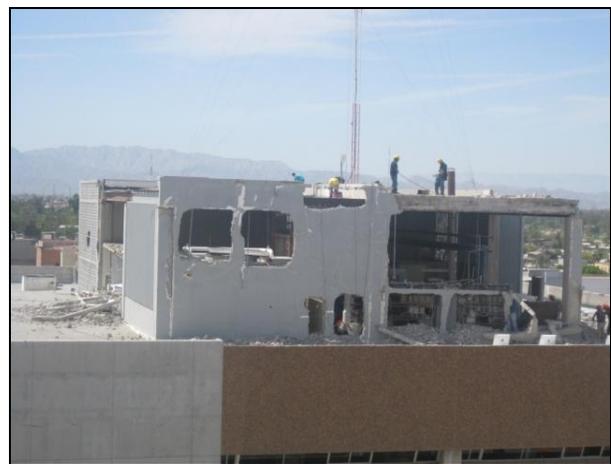
**Figure 3.38:** State Congressional Building: Damage observed at the exterior penthouse walls. This photo was taken during repair of the exterior north and east walls.

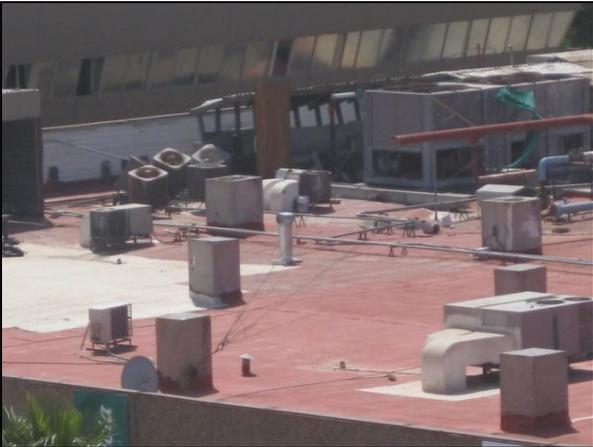
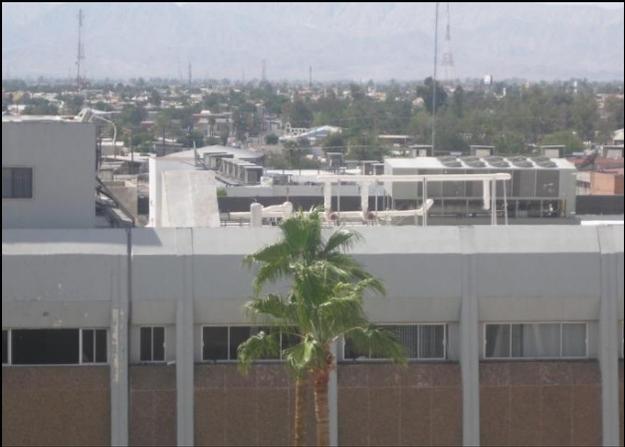
**Figure 3.40:** Displaced rooftop units at the City Government Building (left) and at the State Judiciary Building (right). The mechanical unit on the State Judiciary Building has displaced in the northerly direction.

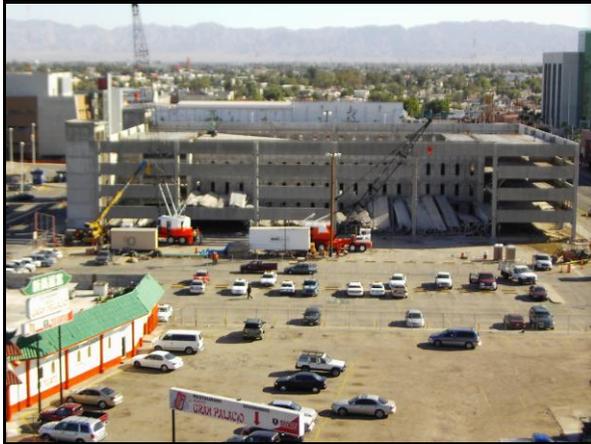
This precast concrete parking structure (32.64116°N, 115.47745°W) suffered a partial collapse during the earthquake. The building was under construction; the precast units had been placed on the building, but the diaphragms had not been cast. The building is a 4-story plus ground floor precast concrete parking structure (Figure 3.41), with cast-in-place shear walls acting as the lateral-force resisting system (Figure 3.42).

**Figure 3.41:** View of the partially collapsed parking structure in Mexicali.

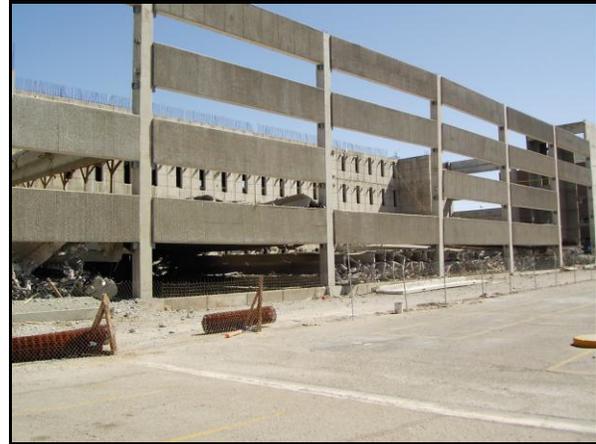
**Figure 3.42:** Perimeter precast frame (front) and interior cast-in-place shear wall (back).

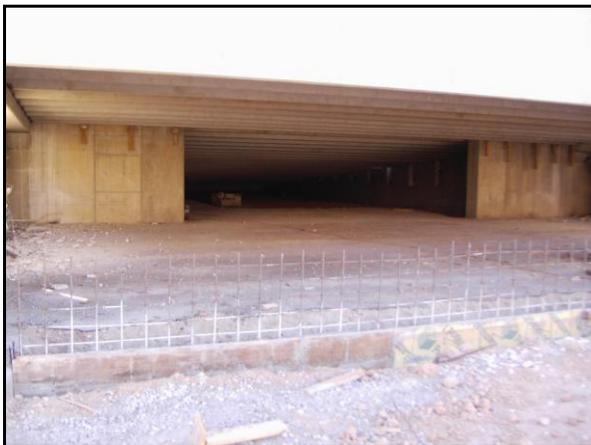
**Figure 3.43:** Central bays resisted the earthquake without damage.

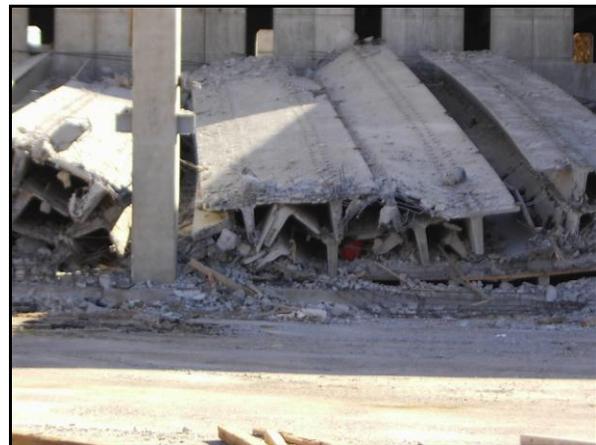
Precast double-tee units, connected through non-composite diaphragms, are used to form the floor system. According to the designers, the “PCI Connection Manual” specifications were followed. For financial reasons, the construction of this building was interrupted several times. Erection of the precast concrete units took place at the end of December 2009, but only the central bays (ramps) were completed with the diaphragm. Construction resumed on March 22<sup>nd</sup>, 2010, when concrete was poured on the first-floor lateral-bays. When the earthquake struck, the central bays suffered no damage (Figure 3.43). The precast units, which were erected but not connected through the diaphragm, bent the perimeter frames outwards (visible in Fig. 3.42) and collapsed on top of each other (Figure 3.44).

**Figure 3.44:** Lateral bay double-tee units collapsed on top of each other.

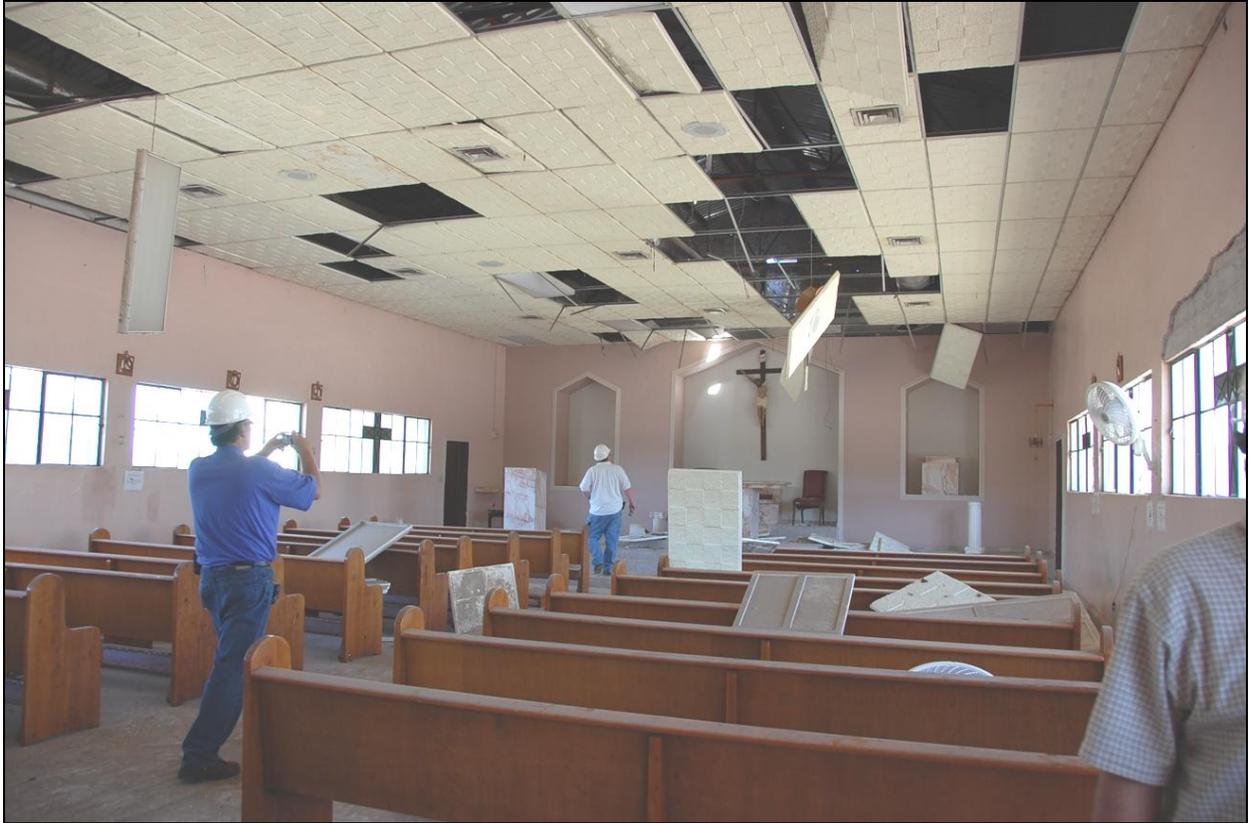
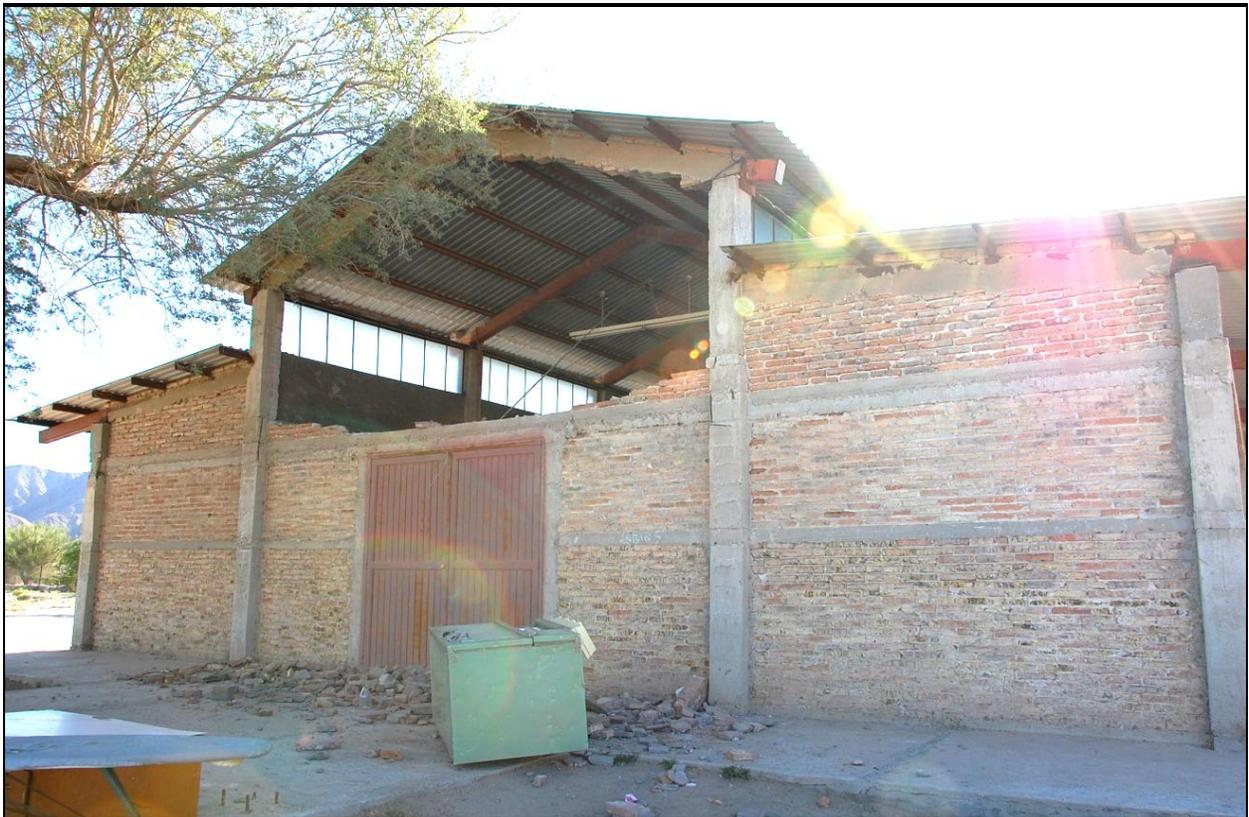
**Figure 3.46:** Ceiling falling (above) and collapse of infill walls (below).

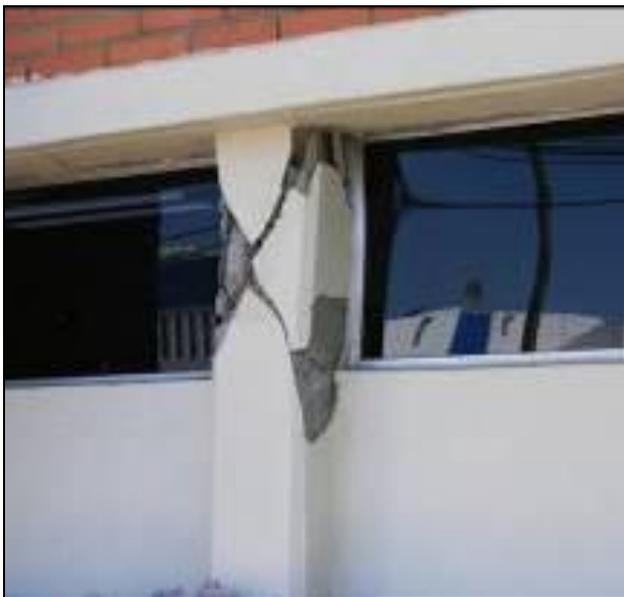
Severe damage was observed in the bottom story of the 1958 structure, which had shear cracks in the columns and infill walls. The shear failure of the exterior columns can be attributed to the short column effect introduced by the partial-height infill walls. The inspection of the severely cracked columns indicated inadequate shear reinforcement, which consisted of 6 mm (1/4 in) diameter stirrups spaced at 28 cm (11 in) at the damaged region. The exposed concrete inside some of the damaged columns indicated poor concrete quality including poor consolidation and the use of smooth aggregates. The retrofitted columns performed satisfactorily but in some cases had damage below the jacketed portion. The masonry infills were damaged by a combination of severe diagonal cracks and bed-joint sliding. Figures 3.47 through 3.51 show damage to the school building.

**Figure 3.47:** Shear failure of exterior unretrofitted bottom story column.

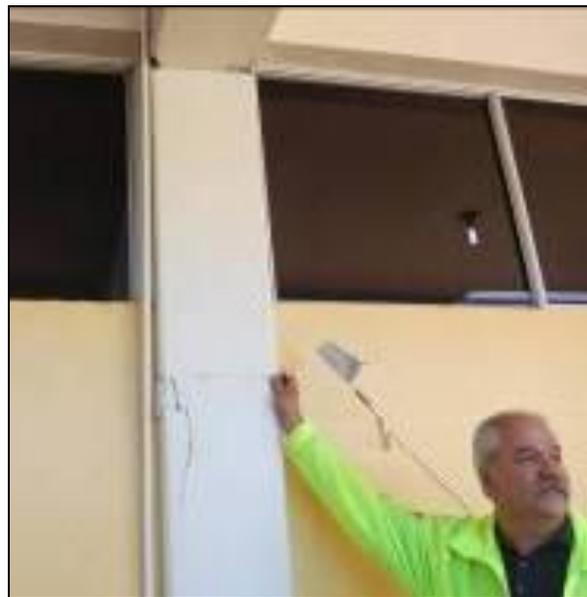
**Figure 3.48:** Steel jacket retrofit of a short column between partially infilled bays.

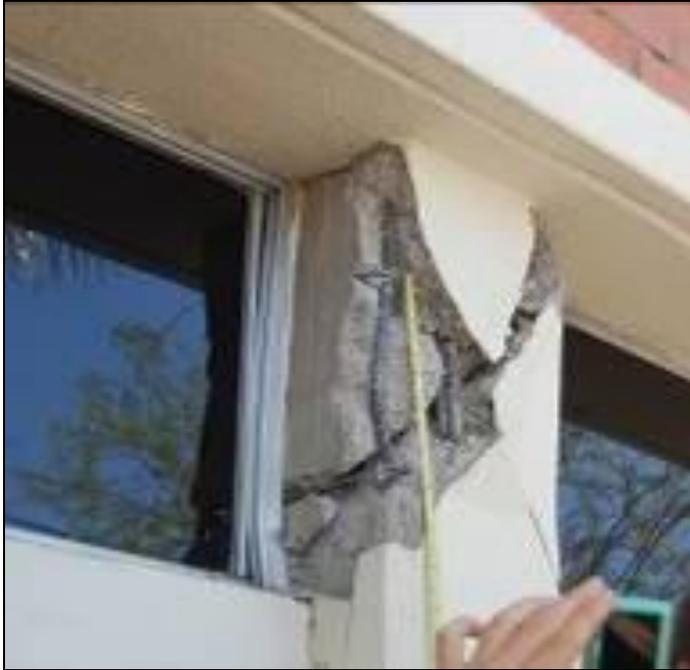
**Figure 3.49:** Column confinement – 6 mm (1/4 in) diameter stirrups spaced at 28 cm (11 in).
