# The El Mayor Cucapah, Baja California Earthquake April 4, 2010

An EERI Learning from Earthquakes Reconnaissance Report

## An EERI Reconnaissance Report

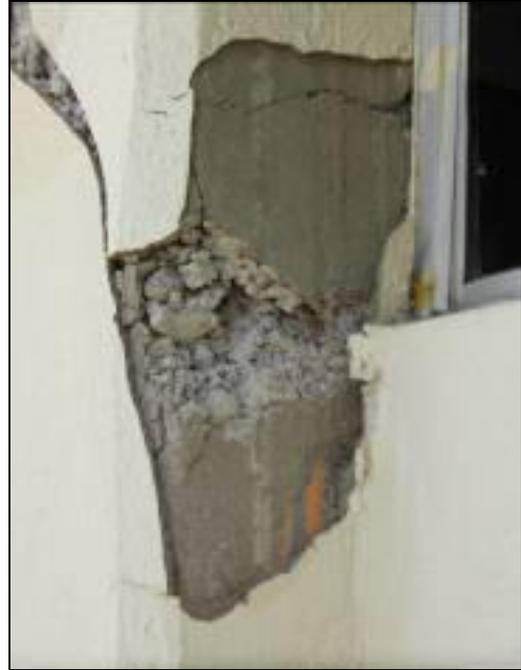
**Figure 3.50:** Poor concrete consolidation and smooth aggregates.

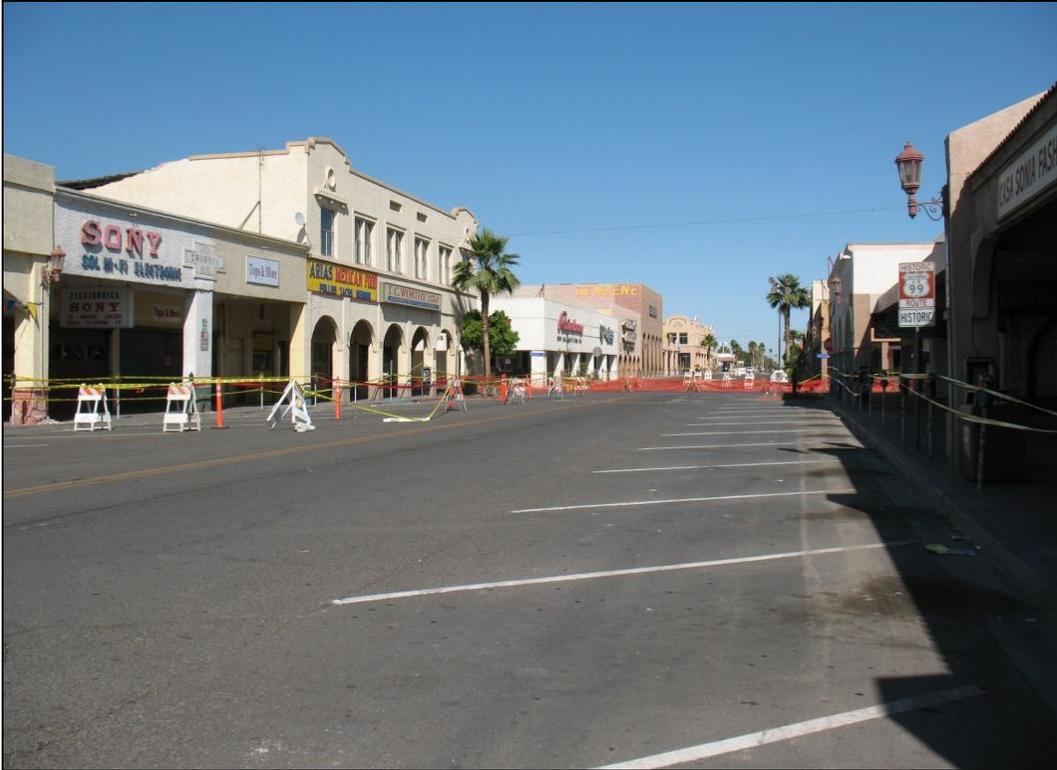
**Figure 3.53:** A view of 3<sup>rd</sup> Street in downtown Calexico looking towards the east. Damage to the two-story building on the left side of the photo is shown in Figures 3.56, 3.58 and 3.59.

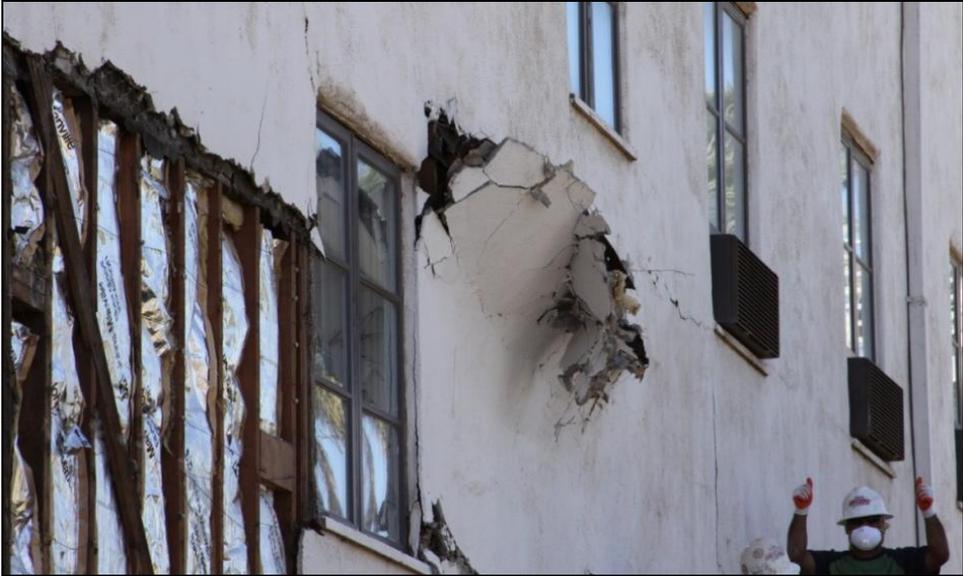
This structure had little load resistance, with its core consisting of wood framing and plaster overlay (Figure 3.66) and was therefore extensively damaged during the earthquake. At the time of the team's visit it was red tagged pending further inspection (Figure 3.67a). Most of the visual exterior damage is concentrated on the west side of the building. A wide diagonal crack appeared between the first and second stories in a shearing dominated mode terminating at the arch, denoted (1) on Figure 3.67b. One vertical crack spanning the entire height of the building (2) is located just west of the tower section, demonstrating that the tower section remained intact with the eastside of the building. Smaller horizontal cracks (3) were found on the west

**Figure 3.66:** Wood wall with plaster overlay construction of the Hotel de Anza in Calexico (image courtesy of professional photographer Joseph Llausas - taken April 6, 2010). (Note: the region on the left was exposed by contractors during post-event inspection.)

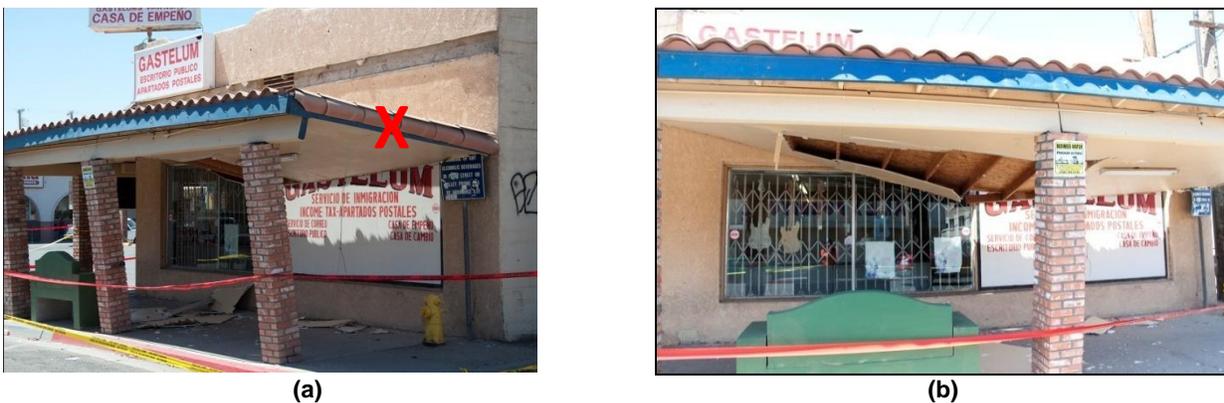
To the south of the Hotel de Anza, one storefront experienced significant damage to its front overhang (Figure 3.69a). The collapsed overhang at the store entrance of 317 Heffernan Avenue prompted city officials to red tag the business of Gastelum. This overhang was supported by the front columns and by two end connections into the main building. Failure occurred at mid-span of the overhang-building interface because the columns were leaning away from the building, causing the overhang to pull out the nails and consequently collapse (Figure 3.69b).

**Figure 3.69:** Damage observed at Gastelum within the city of Calexico, CA: (a) overview of entrance shown with leaning columns (X shows an end-support); (b) close-up of collapsed overhang (32.6683°N, 115.4950°W).

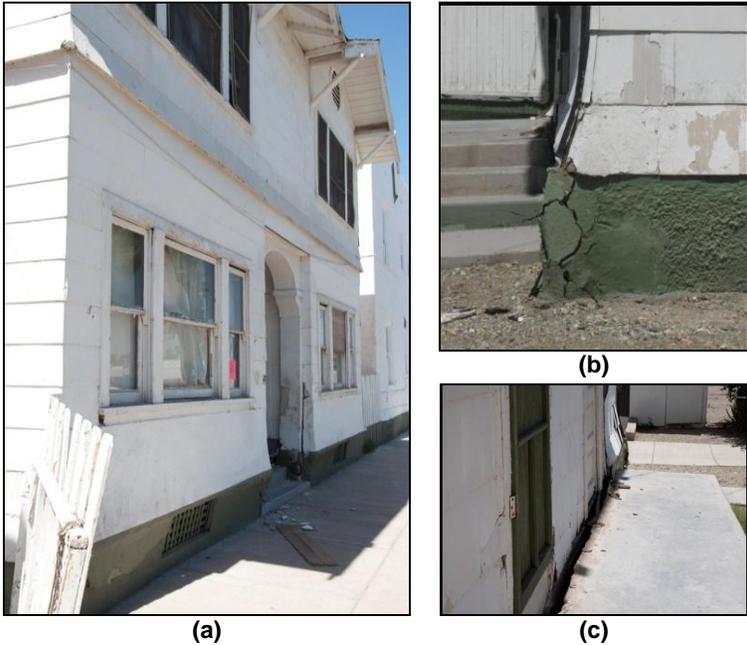
Two of the three units in a 2-story apartment complex located at 531 and 539 Paulin Avenue experienced significant structural damage (Figure 3.71). Two of these units were approximately 85 years old and suffered cripple wall failure, the age of the third unit was not known, however it appeared only slightly newer. The construction style of the units is unbraced wood-plaster. Due to the cripple wall failure, the buildings slid eastward towards Paulin Avenue about 5 in (12 cm). A residual shear deformation pattern of the cripple wall was visible at the exterior of the building. Inside the buildings, damage to the plaster and uneven floors was pervasive in the units.

**Figure 3.71:** Wood-plaster type constructed apartment units at 539 Paulin Ave that suffered cripple wall failure and extensive interior damage: (a) front entrance to apartment complex showing building offset to the east direction (right); (b) close-up of the cripple wall on the southwest corner; (c) approximate 12 cm (5 inches) gap exposed due to the cripple wall failure (32.6705°N, 115.4977°W).

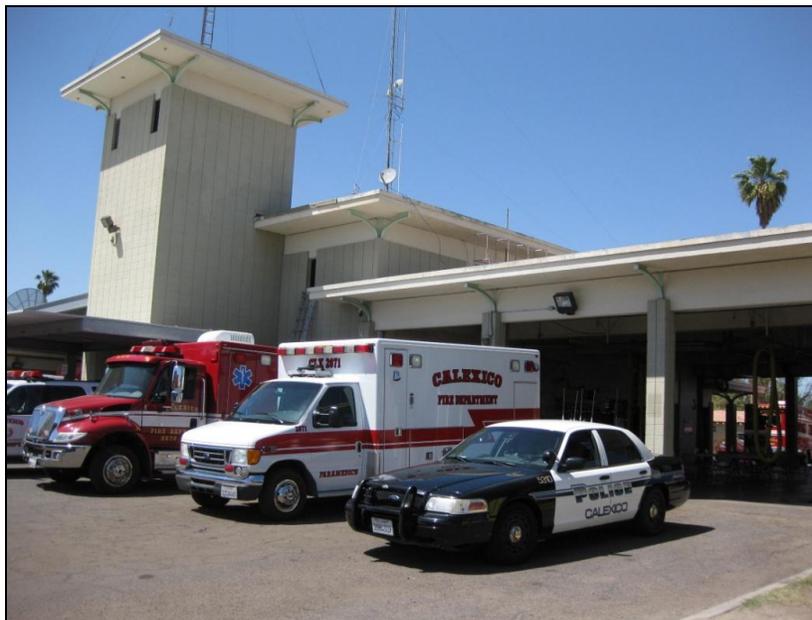
The fire station in Calexico (Figures 3.72 to 3.75), not more than 2 blocks from the closed off area of Calexico, houses USGS Station 5063. This location is approximately 49.5 km (30.8 mi) from the epicenter of the earthquake. The instrument is anchored on the slab of the structure and measured a peak ground acceleration of 0.272g (Figure 3.75). The station is a one-story reinforced CMU building with a two-story portion and a tower. The building sustained no damage in the earthquake.

**Figure 3.73:** Looking at the rear of the building towards the northwest.

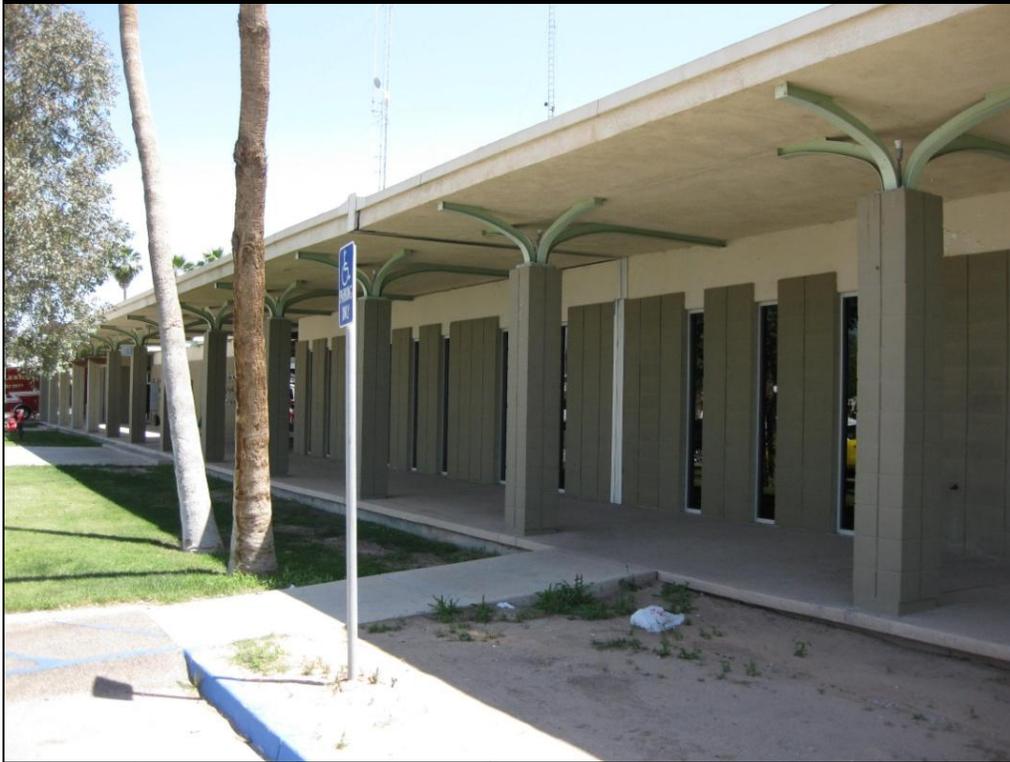
**Figure 3.74:** Looking at the front of the building towards the southeast.

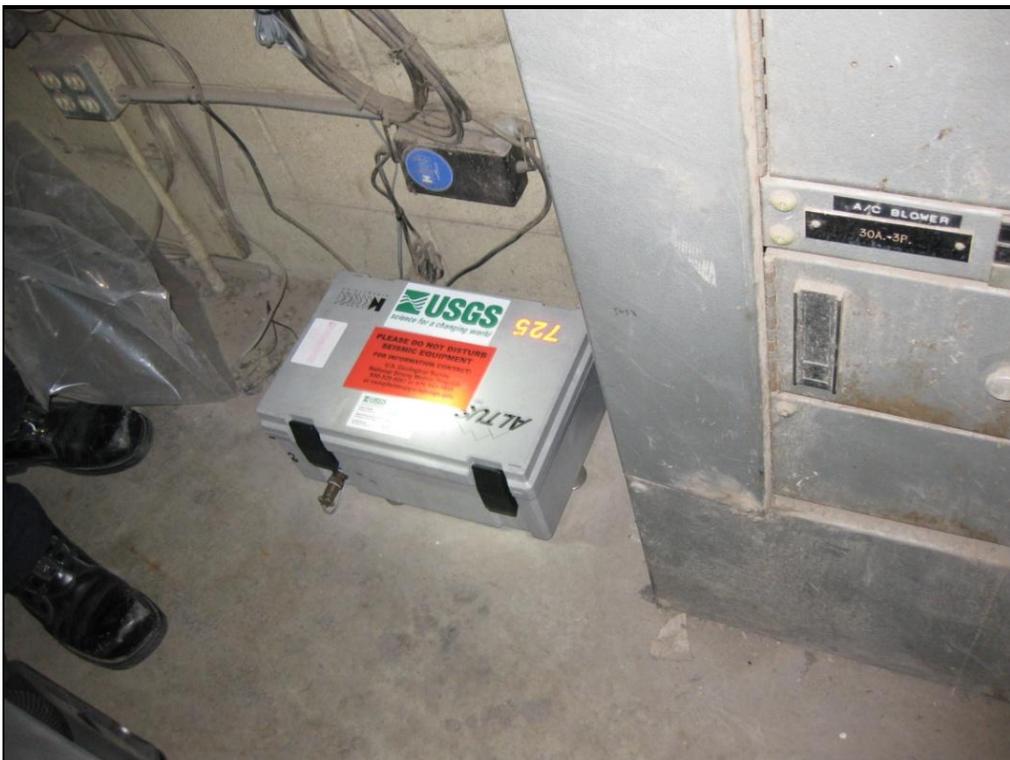
**Figure 3.75:** The USGS seismic sensor on the slab of the fire station in Calexico.

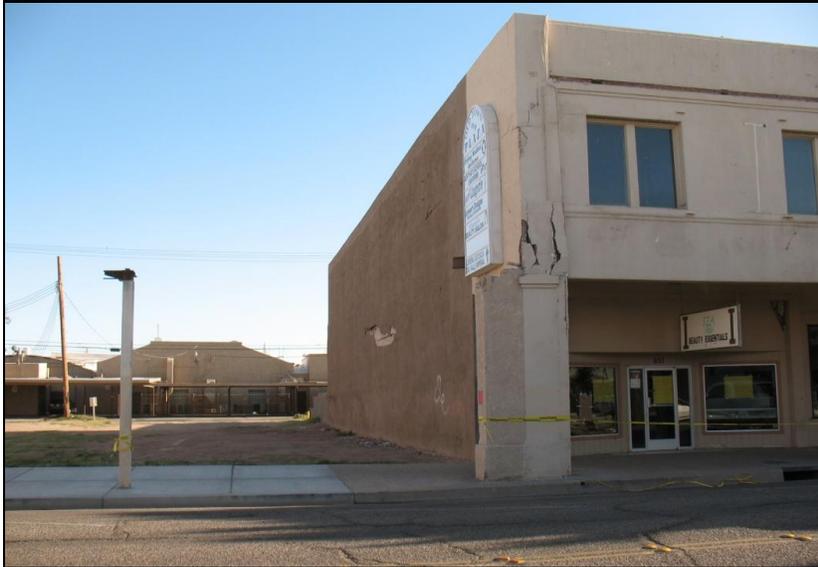
The URM buildings most susceptible to damage were those on corners, or those adjacent to open lots, where they did not have the advantage of an adjacent building to help limit building drifts. This was observed with the Old Town Plaza building on Main Street as seen in the photos below.

**Figure 3.79:** The Old Town Plaza on Main Street suffered considerable damage compared to nearby structures of similar age and construction type. The absence of an adjacent building may have contributed to its higher level of damage.

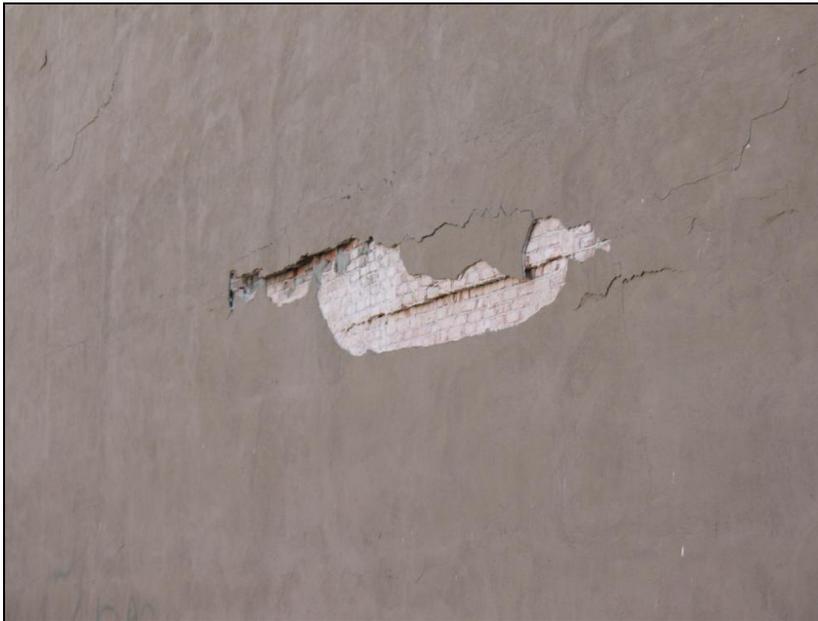
**Figure 3.80:** The out of plane loading on the masonry wall at the second floor level resulted in permanent out of plane shifting of the bricks across a horizontal mortar joint.

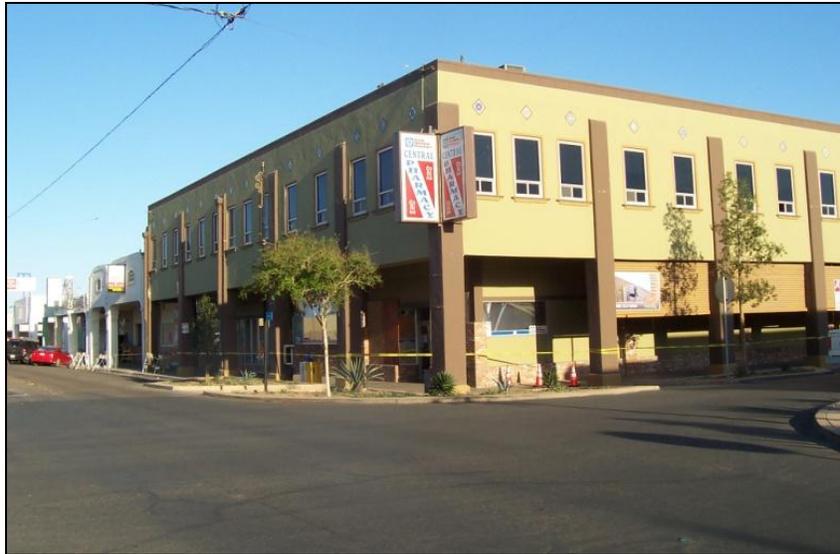
The Central Pharmacy building on the 400 block of Main Street was yellow tagged following the main earthquake on Sunday; however, on the following Friday the tag was revised to a red tag indicating structural damage at the second floor. The visible cracking to the exterior masonry walls did not appear to be typical unreinforced masonry diagonal cracking, although there were some. Instead, there was horizontal cracking that continued around the entire perimeter of the building; one distinct horizontal crack at the roof line, and another distinct horizontal crack at the mid-height of the second floor windows.

**Figure 3.81:** The Central Pharmacy building was originally yellow tagged, but was then red tagged five days later.

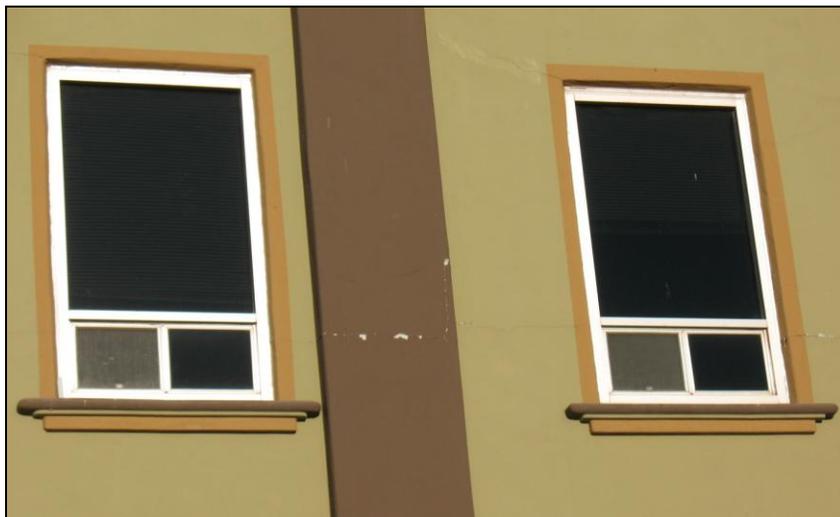
**Figure 3.82:** The horizontal crack can barely be seen in the photo; however, it occurs at the same elevation throughout all four sides of the building.

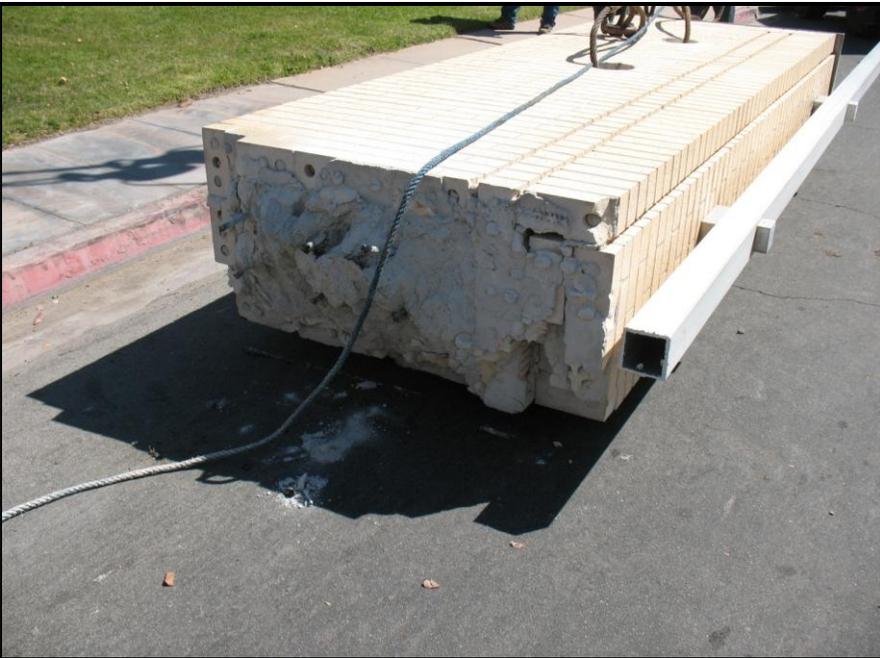
joint (Figure 3.83). This most likely occurred due to the T-shape section of the steeple contributing to a torsional response, combining with the high stresses at the plane where the steeple is tied into the main structure (Figures 3.84 and 3.85).

**Figure 3.85:** Segment of steeple removed by demolition team showing the cross section of the upper segment

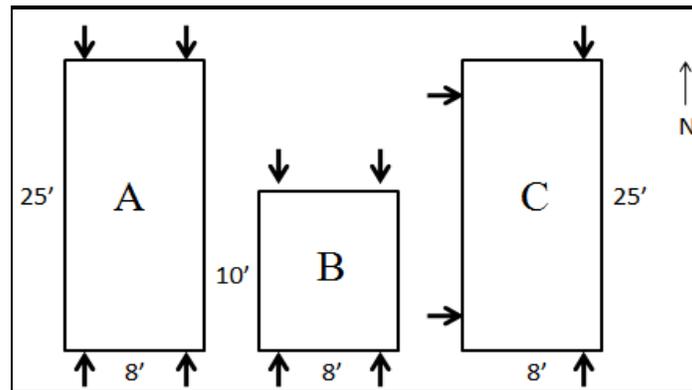
Three cooling towers (CT) were located between buildings A and C in an open yard (Figure 3.88; yard [32.7803°N, 115.5680°W]). Each CT was anchored to a concrete foundation using four post-installed anchors (Figures 3.89 and 3.90). The two larger cooling towers were anchored with 16 mm (5/8 in) diameter, 9 cm (3.5 in) to 10 cm (4 in) long (length code E) anchors. The smaller cooling tower was anchored with 12.5 mm (1/2 in) diameter, 10 cm (4 in) to 11.4 cm (4.5 in) long (length code F) anchors. The piping system used flexible connectors (Figure 3.91). There was no visual damage to the CTs and all were fully functional. All anchors were intact with no significant cracks in the concrete (Figure 3.92). Surrounding pipes showed no signs of damage or permanent displacement.

**Figure 3.89:** Anchor tie-down points for three cooling towers (plan view): (A) Trane cooling tower west (Model No. RTAA1254XH03B3D1B6KM); (B) Carrier cooling tower (Model No. 30GTN070 621KA); (C) Trane cooling tower east (Model No. RTAA1704XN01A3DOB).

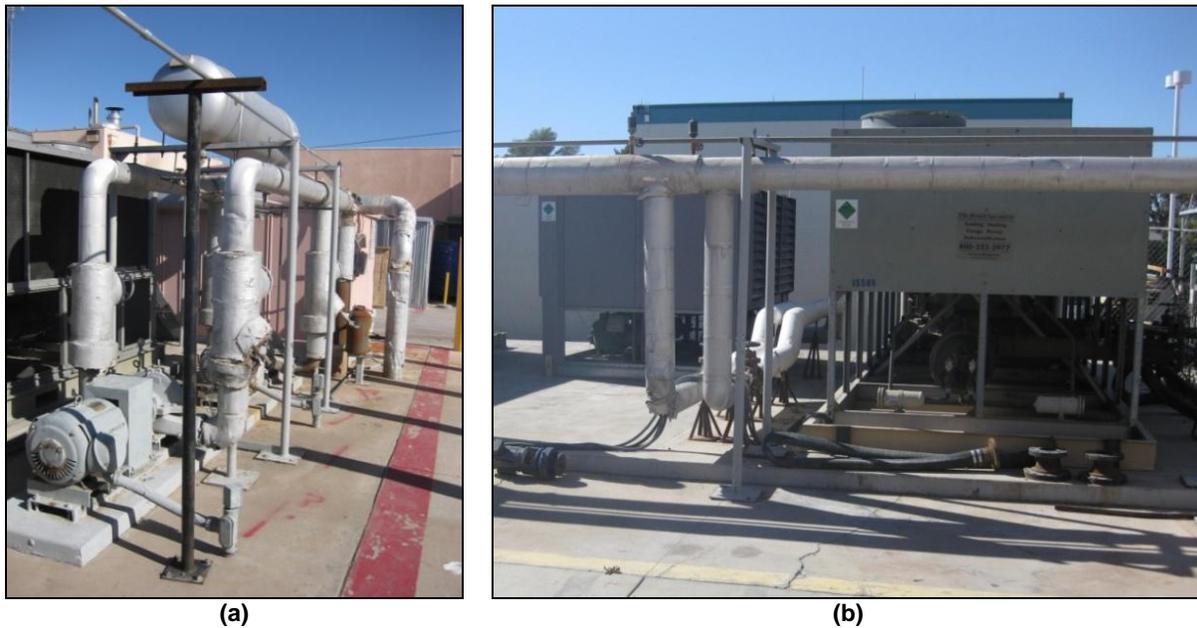
**Figure 3.90:** Photographs of cooling towers: (a) cooling tower pipes; (b) Carrier (left) and Trane (right).

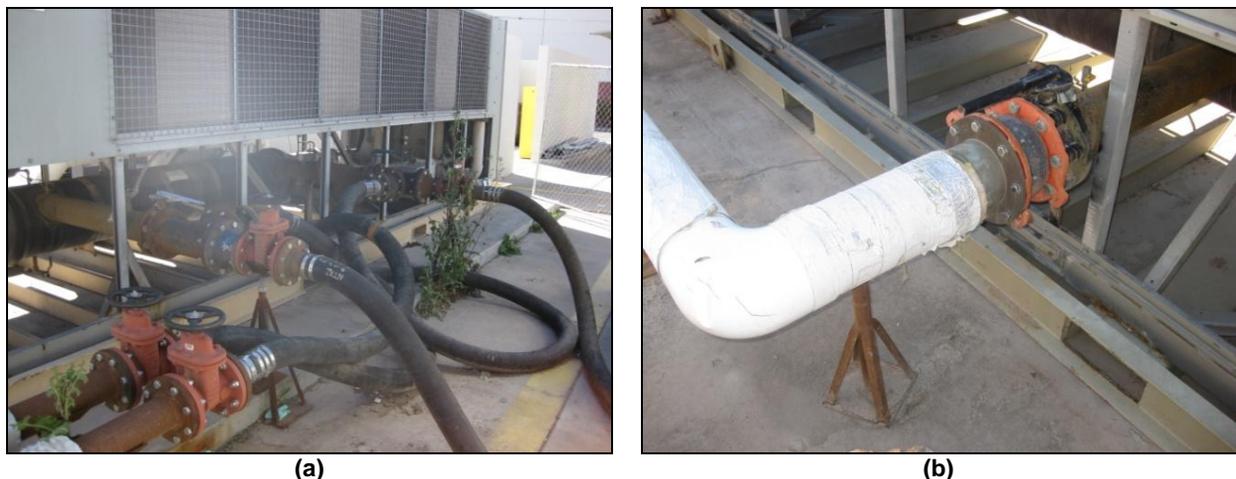
**Figure 3.91:** Flexible connectors: (a) Trane CT west; (b) Trane CT east.

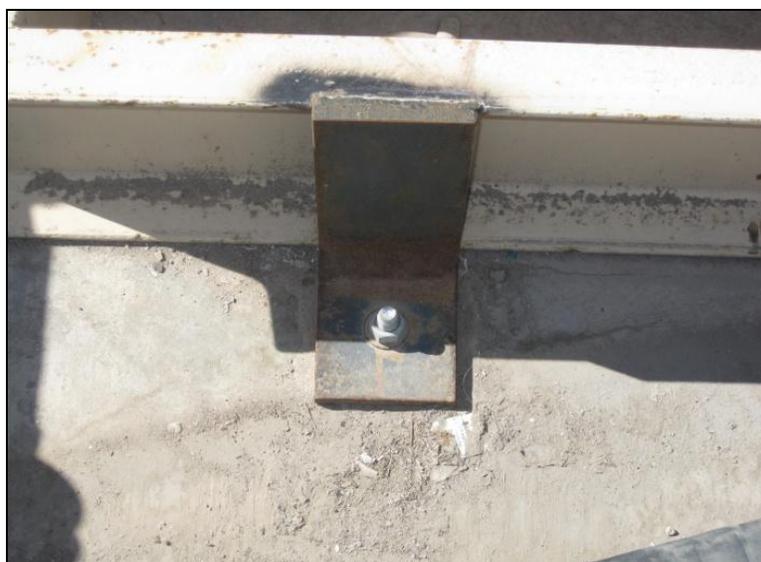
**Figure 3.92:** Typical CT anchorage.

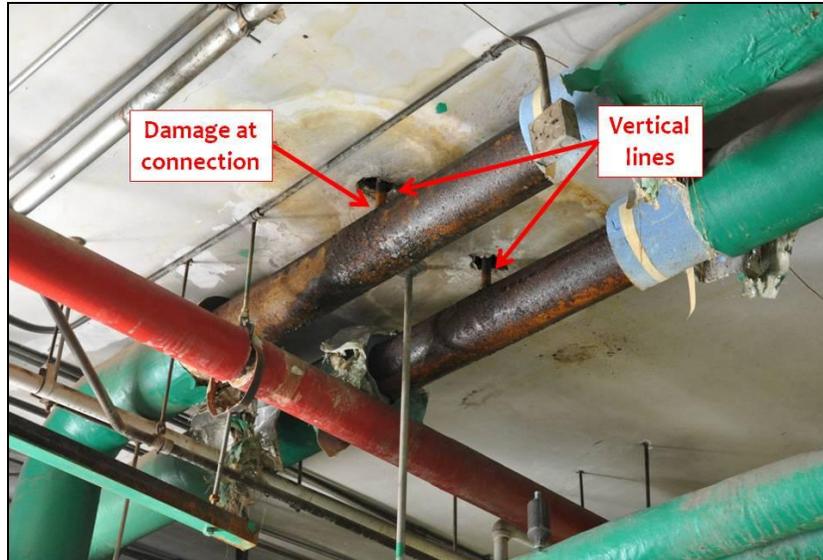
Two nonstructural failures were of primary concern for the hospital's immediate operability following the earthquake. The first involved chilled water supply lines located within the older region of the hospital (Building A, Figure 3.88). Two small metal chill lines that connected into larger main chill lines in the mechanical room in Building A ruptured at their connection points (Figure 3.93). The horizontal displacement of the small vertical branch lines was limited by the hole diameter in the ceiling slab through which they passed. The damage caused flooding in the mechanical room and the chiller lines had to be shut down during the repairs. Repair involved rewelding the vertical lines to the larger main lines and occurred within a period of approximately 6 hours following the earthquake.

**Figure 3.93:** Repaired chill lines in Building A (Figure 3.88) mechanical room.

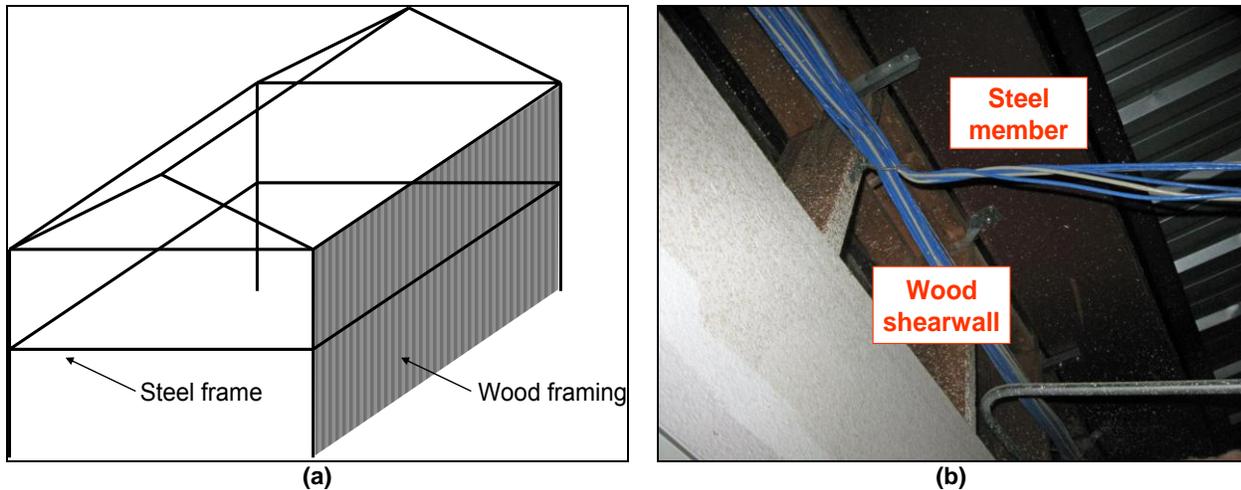
The Medical Plaza (Building D, Figure 3.88) located to the northeast of the hospital sustained the most significant damage. The two-story building is believed to be a combination of steel frame and wood shearwall construction (Figure 3.97). It had been red-tagged by City officials by the time the team arrived and was in the process of being emptied of its contents by hospital employees. One of the employees indicated that the building “made a lot of noise” when it was windy, which may suggest that it was a flexible structure. Moderate to extensive cracking and spalling was visible on the façade of Building D (Figure 3.98).

**Figure 3.97:** Structural system in Building D: (a) schematic; (b) outside wall at roof (looking up).

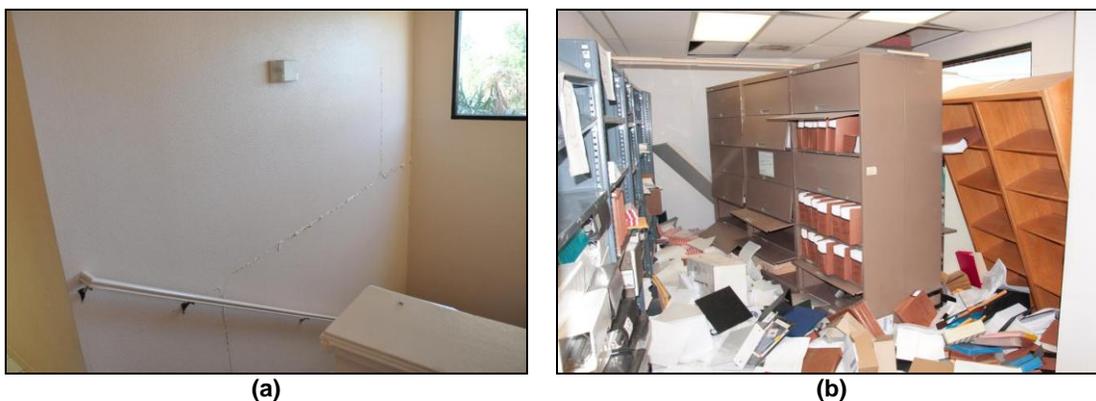
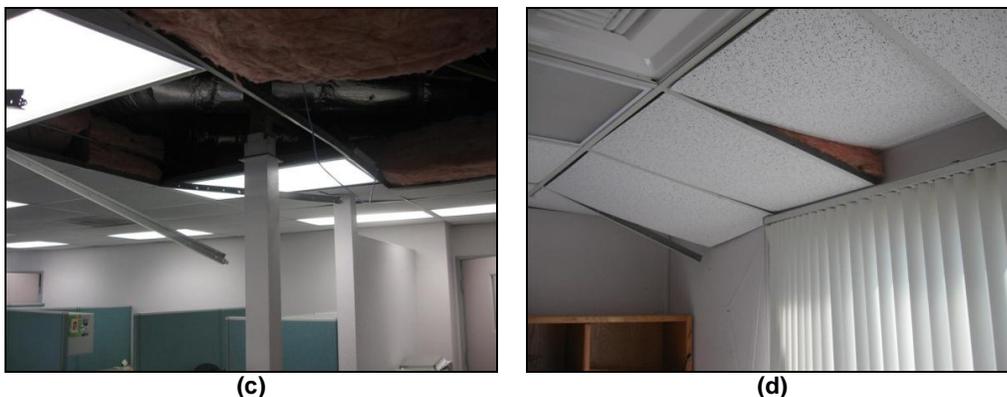
The nonstructural damage inside Building D was extensive. Cracking was visible in much of the drywall (Figure 3.99a). Unrestrained file cabinets and shelves located on the second floor of the building tipped over, emptying their contents (Figure 3.99b). Lightweight ceiling tiles fell in several sections of the ceiling (Figure 3.99c). Loss of ceiling tiles was prevalent along the perimeter walls (Figure 3.99d).

**Figure 3.99:** Nonstructural damage in Building D: (a) drywall cracking; (b) toppled shelves; (c) ceiling tile loss (center of room); (d) ceiling tile loss (perimeter of room).

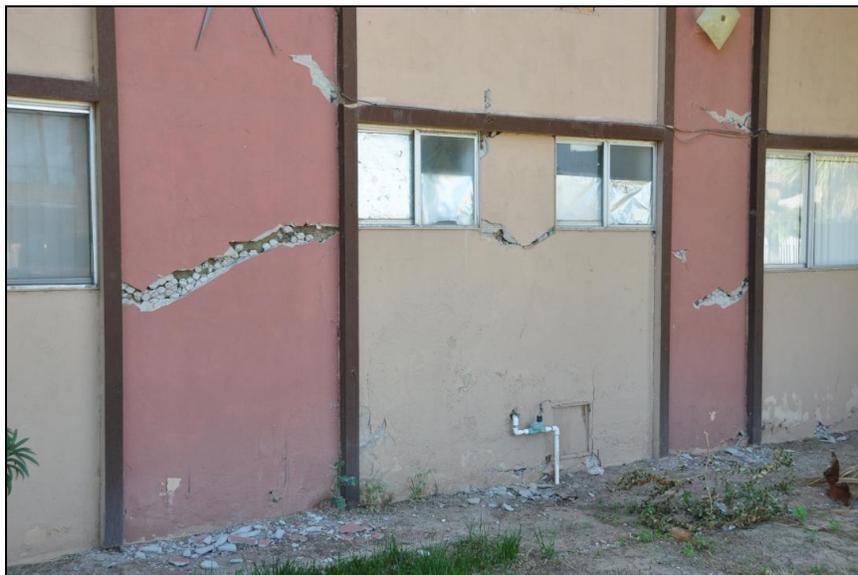
The Brighton Manor at the corner of W. Brighton Ave. and S. 5th St. in El Centro is a two-story light wood frame complex of multiple buildings in a cluster with an internal courtyard and connected by walkway canopies. Exterior and interior corridor walls consist of plaster over wood studs. The plaster was severely cracked particularly at the first floor (Figure 3.100). Patio screen walls consisting of unreinforced concrete blocks and wood posts toe-nailed to their supports had partially collapsed (Figure 3.101).

**Figure 3.100:** Typical severe plaster cracking along the base and at the wall piers next to first floor windows of the Brighton Manor Apartment Complex in El Centro.

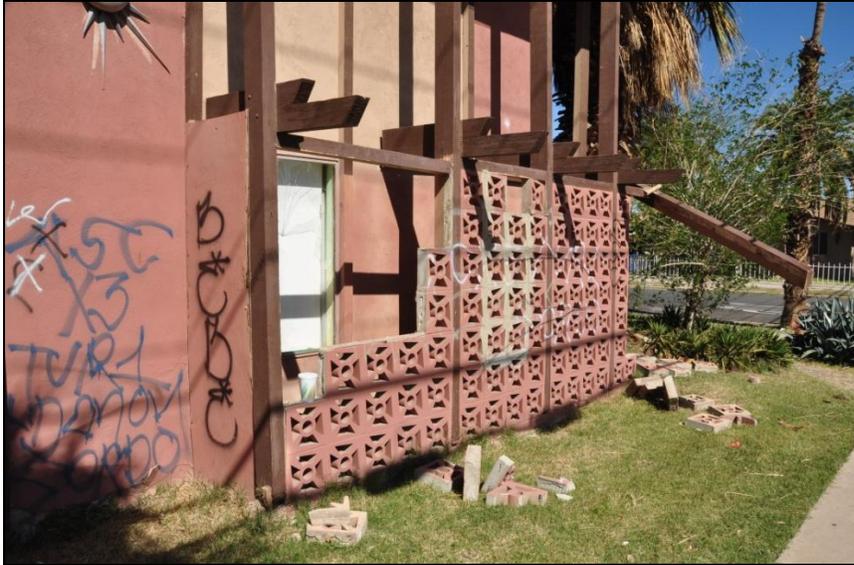
**Figure 3.101:** Partial collapse of patio screen walls and framing at the Brighton Manor Apartment Complex in El Centro.

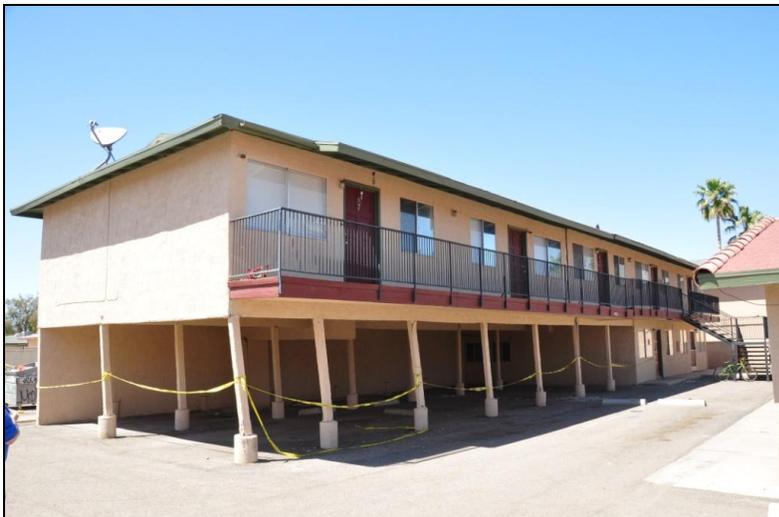
The apartment building at 1996 Cottonwood Circle, North Alley, near Ocotillo Dr. in south El Centro has an irregular configuration. The southern portion of the building appears to be an addition to the northern portion. Like the Brighton Manor, the building relies on light wood frame walls with plaster finishes to resist earthquake and wind forces (Figure 3.102). Extensional cracks at the framing where the southern portion of the building connected to the northern portion suggest collector failures at the floor and roof (Figure 3.103). Longitudinal plaster walls on the east side at the north end of the building experienced a residual drift between 25 to 50 mm (1 to 2 in). Irregularities included a soft and weak story along both axes of the building. The condition of the building was reported by neighbors as deteriorating with significant aftershocks and government officials were advised of inadequate barricading to discourage the public's access to the building's perimeter.

**Figure 3.102:** 1996 Cottonwood Circle apartment building in El Centro with an irregular configuration and near collapse.

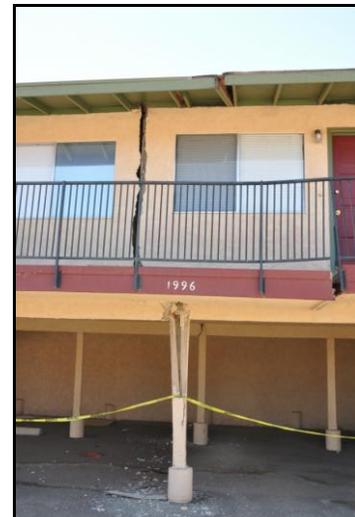
**Figure 3.103:** Gap between the south (left) and north (right) portions of the apartment building at 1996 Cottonwood Circle in El Centro.

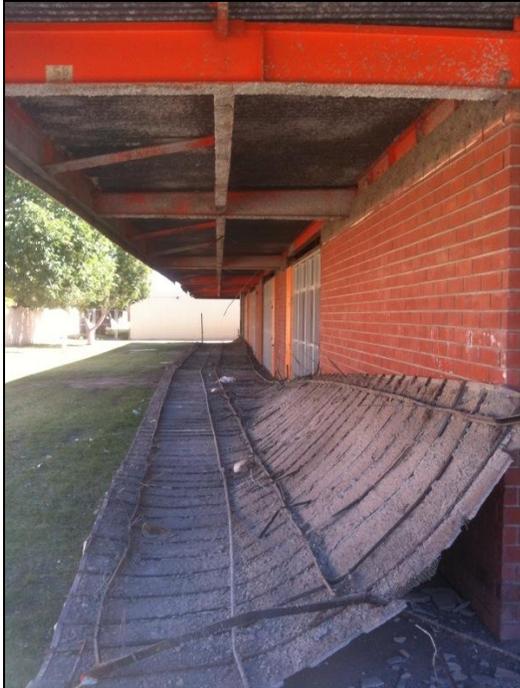
At Jefferson Elementary, approximately 46 m by 2.5 m (150 ft by 8 ft), 115 m<sup>2</sup> (1200 ft<sup>2</sup>) of plaster ceiling soffits fell in a progressive fashion. They were suspended on wires below steel canopies that overhung walkways between classrooms (Figure 3.104). Other buildings showed signs of plaster soffit distress, and while the soffits did not collapse, they will likely have to be retrofitted before reopening the school. The soffit collapses in some cases blocked classroom doors from opening and in three locations sheared off door knobs and a hose bib. In some of the classrooms and a multi-purpose room, light fixtures and parts of ceiling systems fell onto desktops and floors (Figure 3.105).

**Figure 3.104:** Fallen plaster ceiling soffits below steel canopies at Jefferson Elementary School in Calexico.

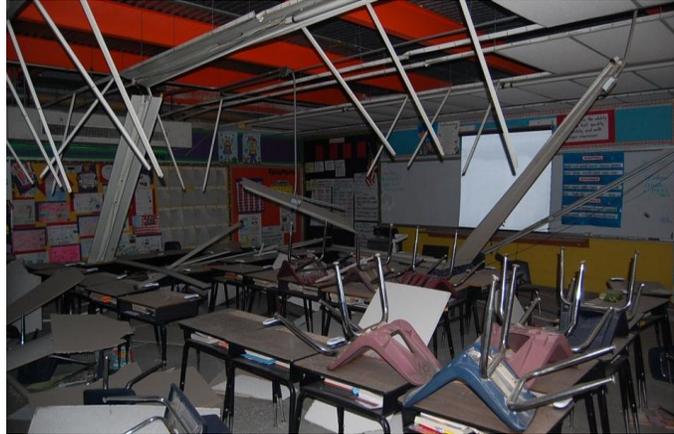
**Figure 3.105:** Fallen light fixtures in a Jefferson Elementary public school classroom in Calexico (32.67081°N, 115.48107°W).

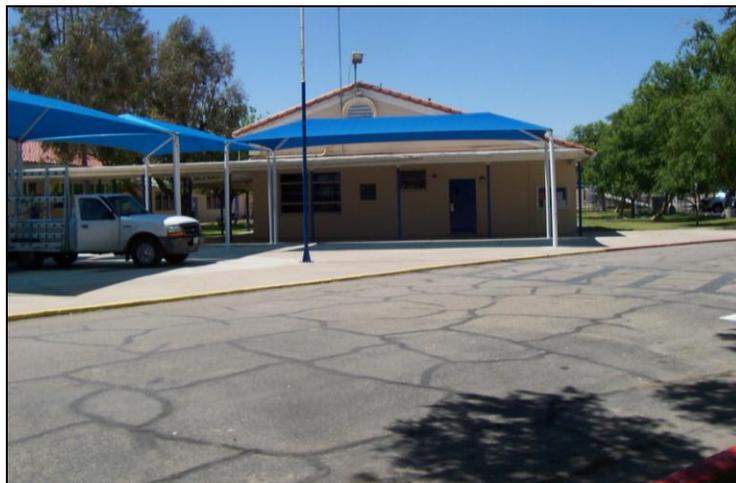
**Figure 3.106:** McCabe Elementary School (32.75173°N, 115.59557°W)

U.S. Geological Survey recording station 5058 is located on a slab on grade at the back of a building at the elementary school. Ground motions at the McCabe Elementary School were the highest recorded in the U.S. in this earthquake (PGA 0.59g and PGV 55 cm/sec, 1.8 ft/sec). Even with significant shaking, the buildings suffered no structural damage and only minimal nonstructural damage. During a regularly scheduled break the school district was able to complete clean up and repairs to avoid interruption to operation. The 2008 campus at that school recording suffered insignificant losses. The 1950's campus at McCabe experienced minor losses of ceiling systems and minor spalling of cover over tapered columns supporting the roof of a multi-purpose room (32.751820°N, 115.59534°W).

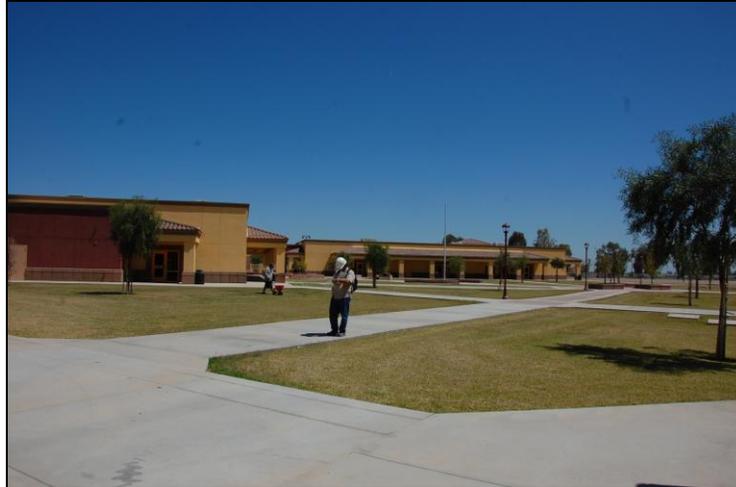
**Figure 3.107:** Junior High Campus at McCabe School.

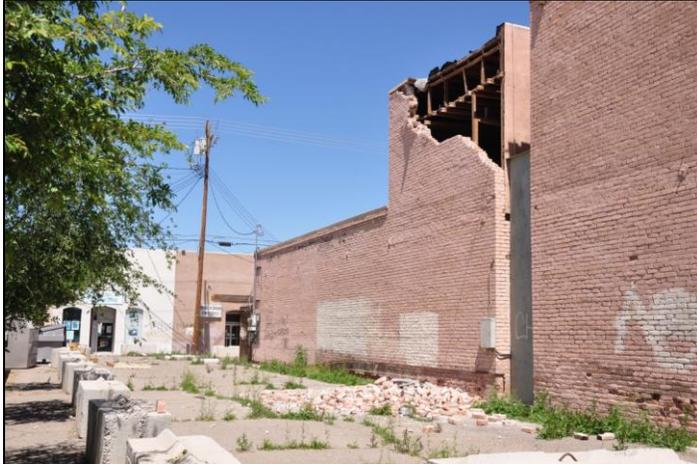
El Centro required mandatory parapet bracing and additional strengthening according to the 1991 Edition of the Uniform Code for Building Conservation Appendix Chapter 1 at the time of remodel. However, evidence of the lack of enforcement of the wall to roof anchorage requirements of the parapet bracing ordinance was observed in two buildings. See Figures 3.108 and 3.109 for an example.

**Figure 3.108:** Partial collapse of a Mortuary building wall in downtown El Centro (32.791958°N, 115.556042°W).

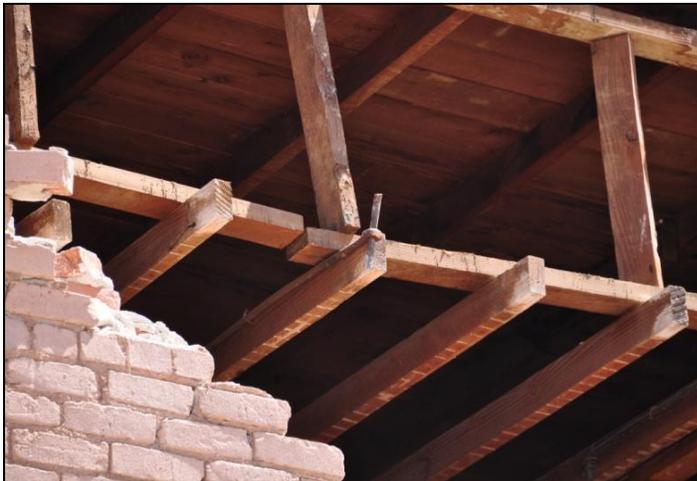
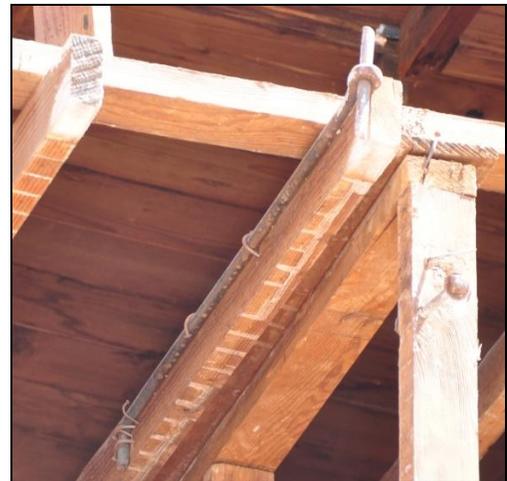
**Figure 3.109:** Close-ups of the wall anchor connecting the ceiling joists to the brick wall in the Mortuary Building in El Centro. No wall anchors were observed at the roof level.

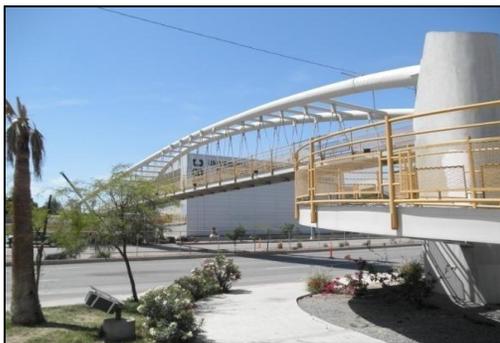
The first observation of a damaged bridge was Universidad Autónoma de Baja California (UABC) Pedestrian bridge over Monte Morelos Avenue (Fig. 4.1). This was a newly constructed 53 m (175 ft) steel arch tied to large diameter concrete piers. There are transverse tubular steel struts at the ends of the superstructure deck, which were designed to provide longitudinal resistance to seismic forces. The end plates of the struts were rigidly connected to the interior faces of the piers. All welds of the anchor bolts connecting one end of a strut to the concrete pier had completely fractured. Concrete columns supporting the spiral ramp structure were cracked. There were also signs of liquefaction of the soil surrounding the foundation. Excessive longitudinal seismic forces on the strut connections combined with rotational demands as a result of pier movement in liquefiable soil may have been the cause of this fracture. (Fig. 4.1.b) It is worth noting that the final position of the piers after the earthquake resulted in large gaps between the inside face and soil on both ends of the bridge (Fig. 4.1.c). Sidewalks were also cracked at the piers crossing the axis of the bridge. Further, hanger rods sloping away from the mid-span at both ends of the bridge in both planes of the hangers were buckled (Fig. 4.1.d). These residual deformations are clear indicators that the bridge elongated longitudinally between arch pins. It is also apparent that failure of the tie did not result in collapse, and therefore redundant load paths were active.

**Figure 4.1:** UABC pedestrian bridge over Monte Morelos Avenue, (a) overview of arch span, (b) strut-connection failure, (c) pier movements, (d) buckled hangers.

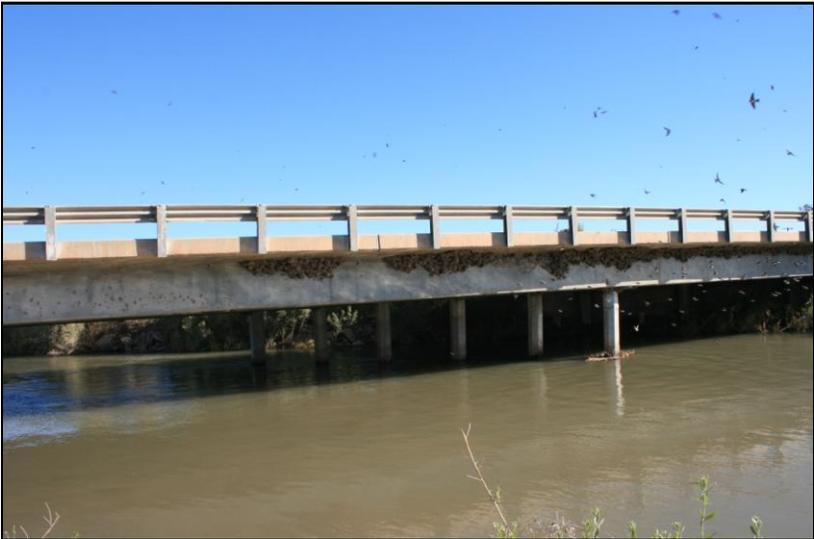
The bridge on CA-98 is located at milepost 22 along CA 98 over an irrigation canal. The GPS coordinates are 32.67852°N, 115.67324°W (Figure 4.6). According to the information provided by Caltrans, the bridge was constructed in 1955 and has a total length of 46 m (151 ft). The bridge deck is mildly skewed and has three spans supported on two intermediate bents and an abutment at each end. Each bent has six octagonal piles, and each abutment has four supporting piles.

**Figure 4.6:** View of the bridge on CA-98 at milepost 22.

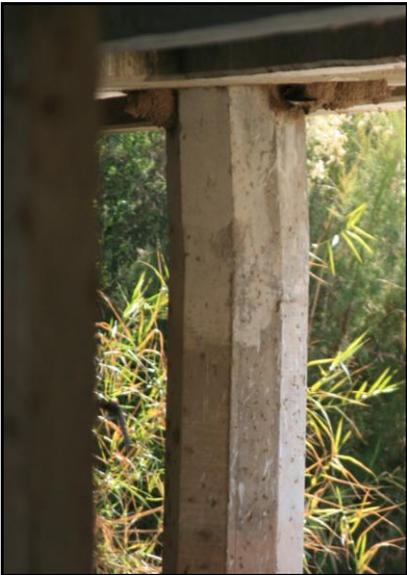
Only the west abutment was inspected due to the bank conditions and vegetation close to the east abutment. Cracks were observed in some of the piles. Some cracks appeared to be caused by the earthquake, while others could be pre-existing. Some of the piles appeared to be slightly tilted; according to Caltrans engineers the tilt was introduced in the original construction due to an alignment problem (Figure 4.7). In general, the damage caused by the earthquake was light with some mildly cracked columns (Figure 4.8) and some crushing of the nonstructural unreinforced slurry wall beneath the abutment wall (Figure 4.9).

**Figure 4.7:** Tilted exterior columns – a pre-existing condition.

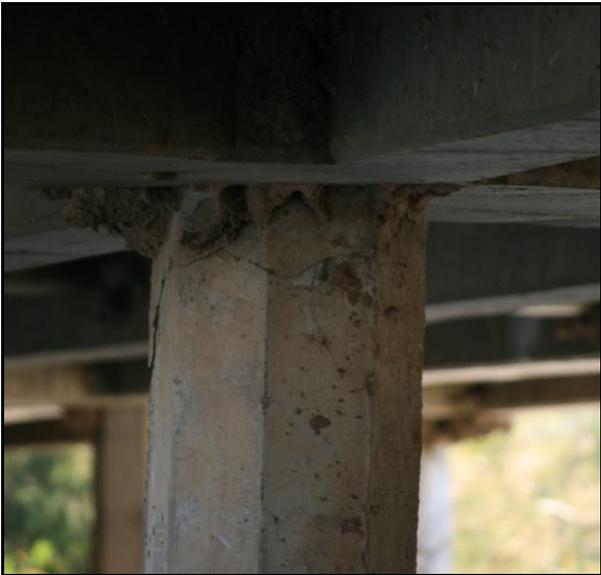
**Figure 4.8:** Cracked exterior column.

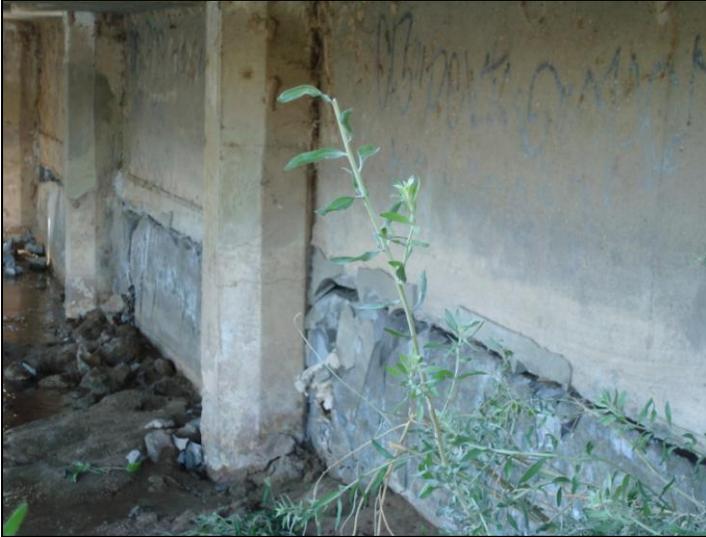
**Figure 4.9:** Crushing of nonstructural slurry wall beneath abutment wall.

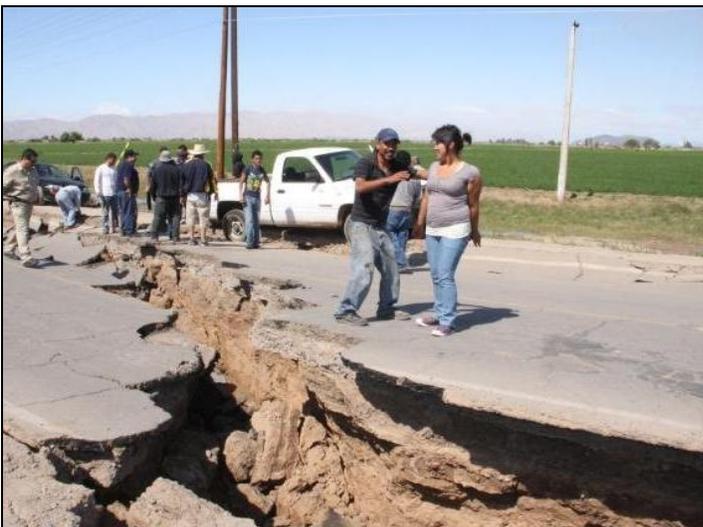
There was significant damage to roads in Mexico either due to lateral spreading or displacement from the actual fault (Figure 4.10). Further information can be found in the GEER report ([http://www.geerassociation.org/GEER\\_Post%20EQ%20Reports/Baja%20California\\_2010/Baja\\_10\\_Ch05.html](http://www.geerassociation.org/GEER_Post%20EQ%20Reports/Baja%20California_2010/Baja_10_Ch05.html)).

**Figure 4.10:** Damage to roads due to liquefaction and lateral spread.

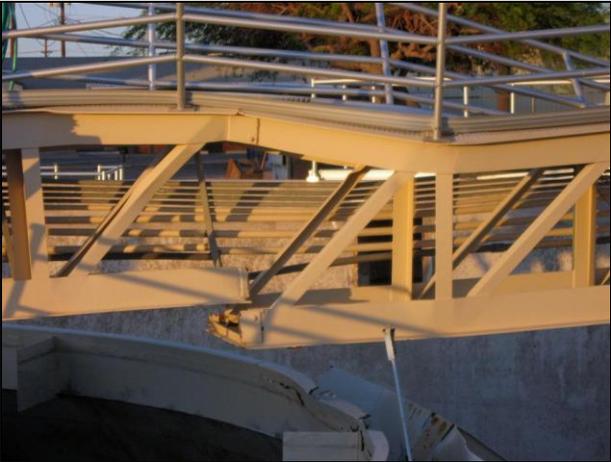
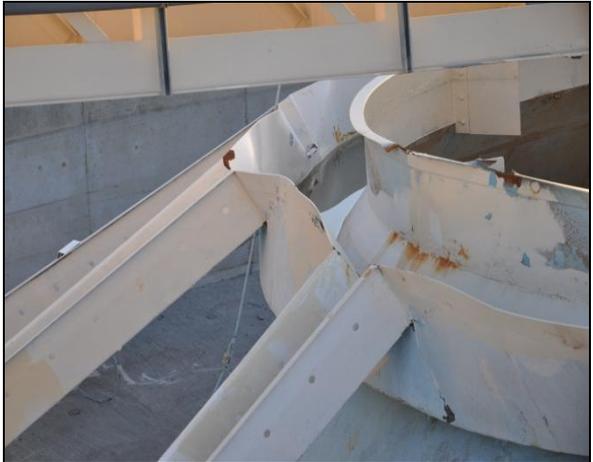
Damage to the northern clarifier was severe. The steel walkway ruptured at multiple points and the clarifier scraper structure and its central motor unit were damaged (Figure 5.4). The perimeter concrete wall of the clarifier tank was damaged at the walkway support on the north end (Figure 5.5). The walkway anchorages were severely deformed in bending and shear (Figure 5.6). The working clarifier is shown in Figure 5.7 for comparison. The northern clarifier was full of water when the earthquake occurred while the southern clarifier was empty, which accounts for the difference in performance. The clarifier as well as two large tanks (3MG and 1MG) will likely need to be demolished and replaced.

Figure 5.4: Damage to clarifier: (a) view of failed walkway (looking east); (b) buckled scraper central ring (looking west. (32.6709°N, 115.5053°W).

Work was underway less than a week after the earthquake to repair the clarifier components to get the capacity returned before the critical summer months.
