# The El Mayor Cucapah, Baja California Earthquake April 4, 2010

An EERI Learning from Earthquakes Reconnaissance Report

## An EERI Reconnaissance Report

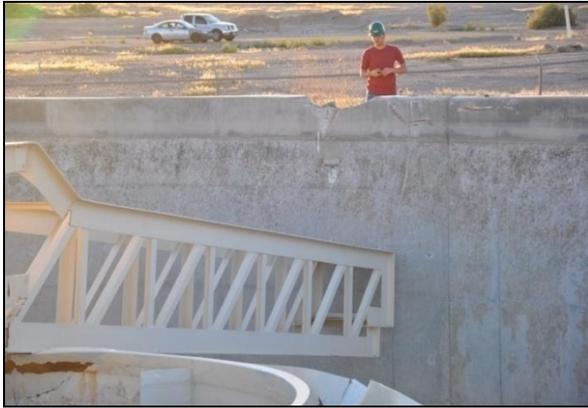
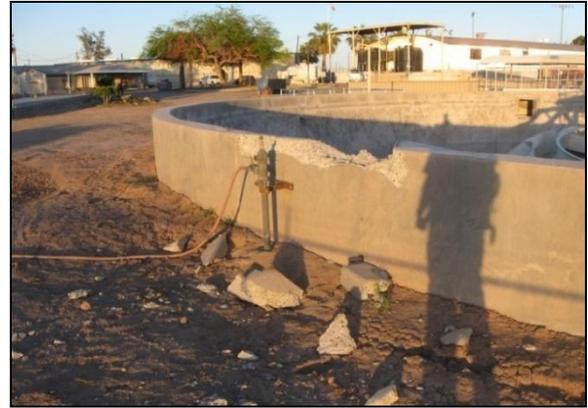
Damage to the northern clarifier was severe. The steel walkway ruptured at multiple points and the clarifier scraper structure and its central motor unit were damaged (Figure 5.4). The perimeter concrete wall of the clarifier tank was damaged at the walkway support on the north end (Figure 5.5). The walkway anchorages were severely deformed in bending and shear (Figure 5.6). The working clarifier is shown in Figure 5.7 for comparison. The northern clarifier was full of water when the earthquake occurred while the southern clarifier was empty, which accounts for the difference in performance. The clarifier as well as two large tanks (3MG and 1MG) will likely need to be demolished and replaced.

**Figure 5.5:** Damage to clarifier: (a) tank wall and walkway (looking north); (b) tank wall (looking south) (32.6709°N, 115.5053°W).

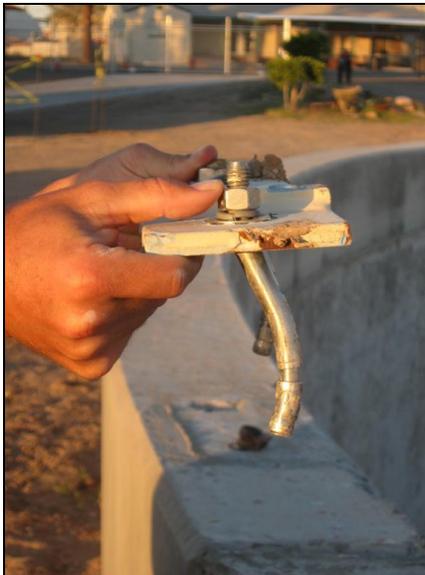
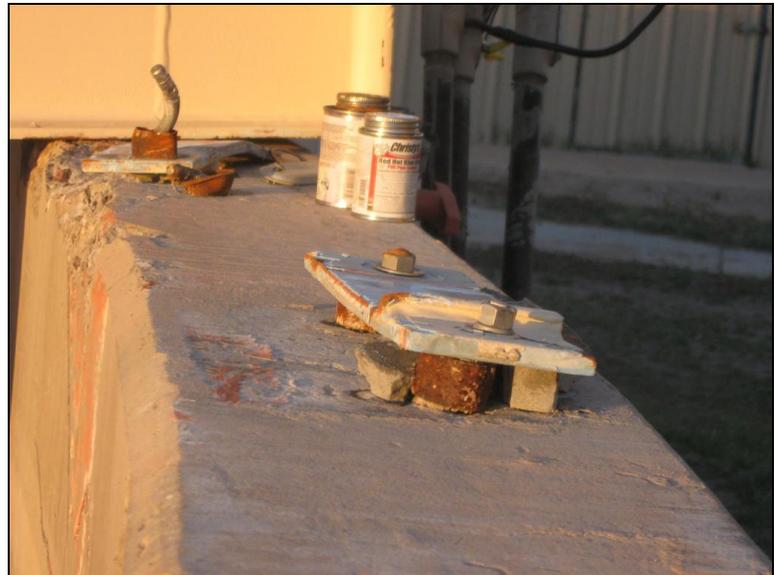
**Figure 5.6:** Damage to walkway anchorage: (a) north end; (b) south end.

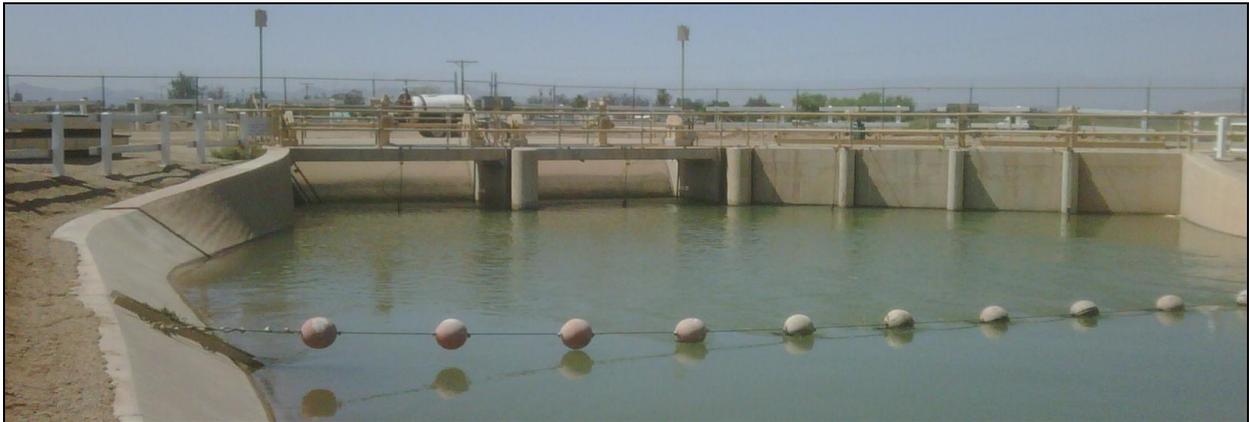
At the time of this writing the Imperial Irrigation District (IID) indicated that they had 160 sites that had suffered some damage; however, the IID did not offer the CSSC a copy of their findings. On April 14th, representatives from the IID told the CSSC that a leak was found between the northern headworks and the spillway adjacent to the All American Canal siphons crossing the New River upstream from the Calexico wastewater treatment plant (see Figure 5.1 for location of siphons and Figures 5.8 and 5.9 for the location of the damaged pier between headworks and the spillway, and the damaged pier between the headworks and the spillway). The CSSC field team observed the siphons from a distance during their tour of the sewer treatment plant on April 7th but did not observe the siphons or the headworks up close. The siphons are a critical component of the All American Canal since they allow water to cross over the New River, supplying the IID with water for the western one-third of their coverage area.

**Figure 5.8:** Location of damaged pier between northern headworks and spillway at the New River siphons on the All American Canal (source: Michael Kemp, Imperial Irrigation District).

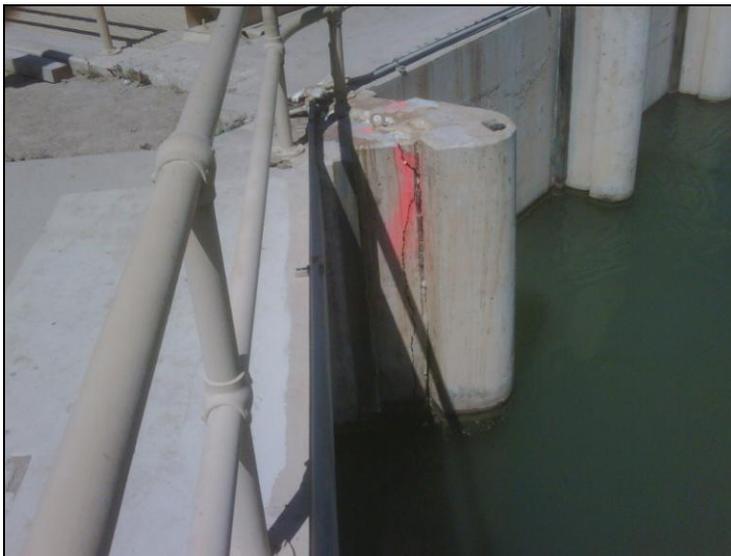
**Figure 5.9:** Damaged pier at the headworks of the All American Canal siphons crossing of the New River northwest of Calexico (source: Michael Kemp, Imperial Irrigation District).

Due to the potential loss of water for the communities of Westmoreland, Brawley, Seeley, and farmlands west of the siphons as well as the potential for flooding properties near the siphons, the IID had representatives from the Los Angeles office of the United States Army Corps of Engineers (USACE) inspect the headworks and spillway area on April 14th, 2010. The USACE indicated that at the time of their inspection, the damage did not pose an immediate threat of flooding. The canal was leaking water at the location of the damaged pier at the time of the USACE inspection. At the time of this writing the extent of the damage as well as the scope of the repairs, the cost and time to make repairs on the All American Canal at the northern end of the headworks was not known.

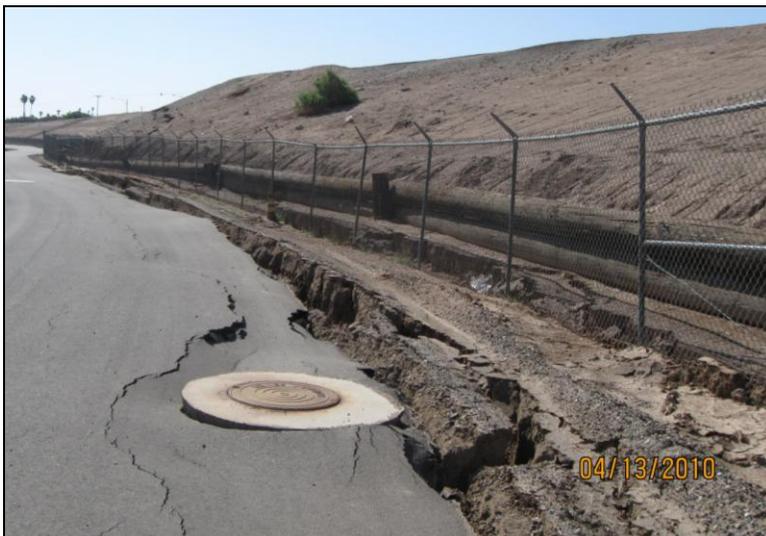
The main access road to the treatment plant was also damaged by lateral spreading perhaps causing damage to the second main influent pipeline to the treatment plant (Figure 5.12).

**Figure 5.12:** Damage to road by lateral spread (32.6677°N, 115.5097°W).

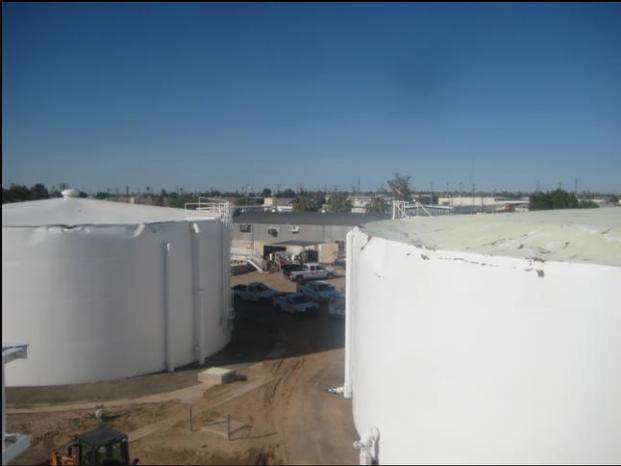
The City of Calexico had significant roof damage to their three storage tanks at the water treatment plant. Two tanks with capacities of 1 MG and 3 MG were constructed in the 1950s. A third 4 MG tank was constructed in the 1990s. All had damage to the roof girder systems with tearing of the roof steel and partial collapse of the roof (Figures 5.19 and 5.20).

Figure 5.19: Damage to roof girder systems.

A video survey was conducted on all three tanks and repair plans are underway for the replacement of the roofing systems.

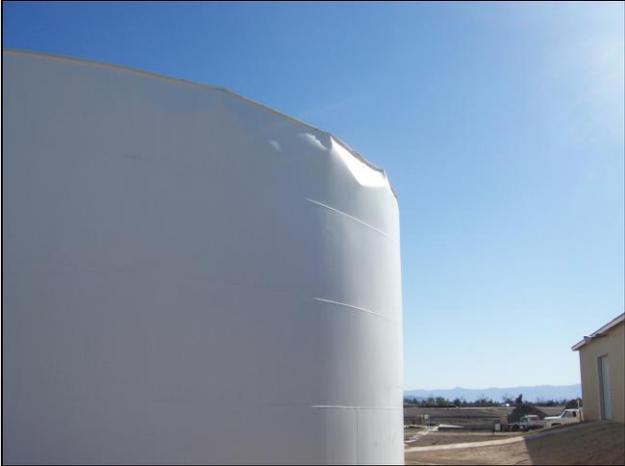
Figure 5.20: Partial collapse of roof.

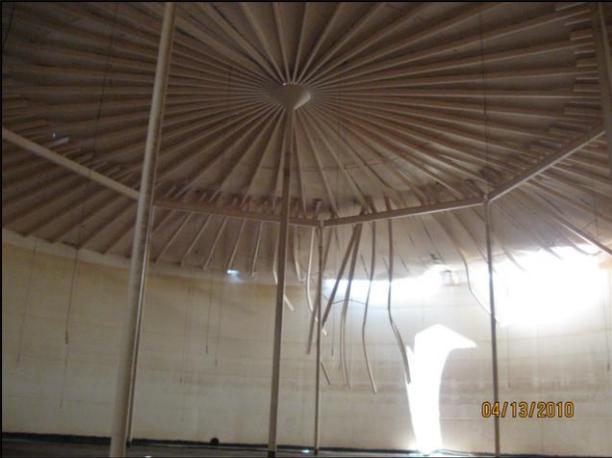
One of El Centro’s main steel water storage tanks was also damaged in a similar manner by sloshing. Water force tore girder welds causing the roof to tear and partially collapse (Figures 5.21 and 5.22).

Figure 5.21: Partial collapse of roof.

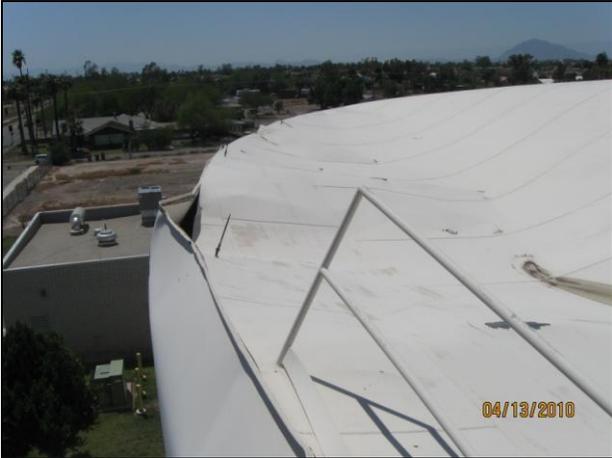
Figure 5.22: External view of partial collapse of roof.

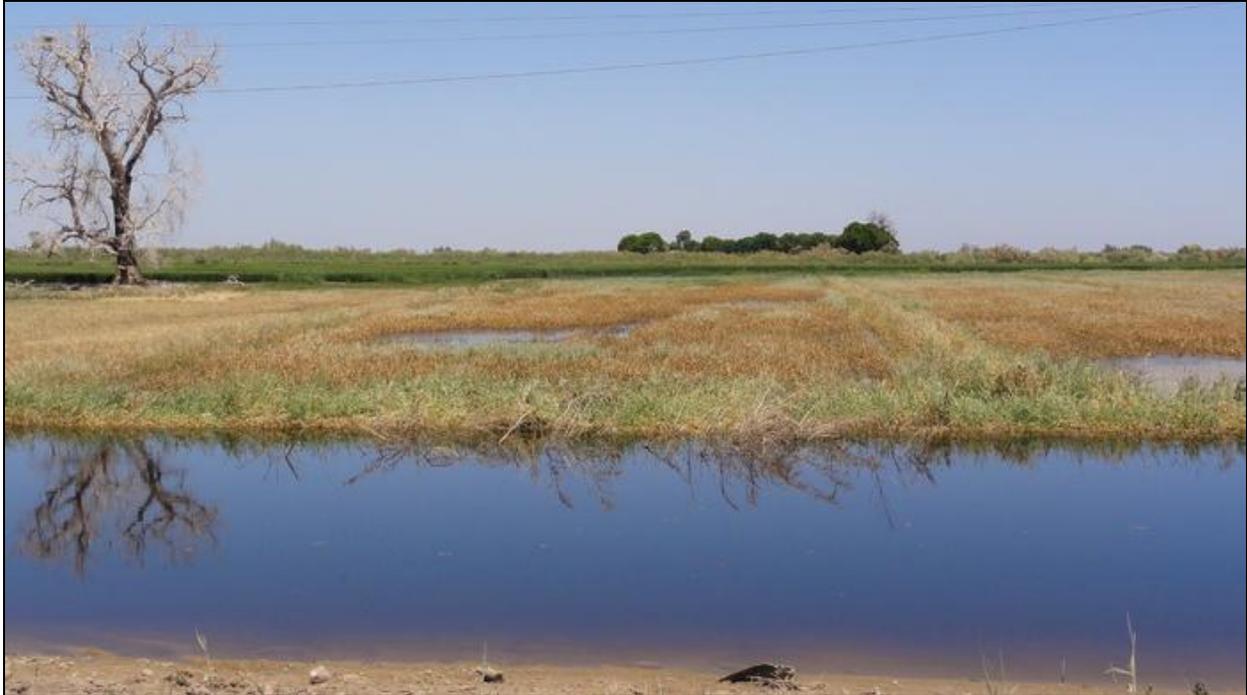
Portions of the area were inundated with water from liquefaction-induced sand boils, some of it reportedly saline, sulfurous, and/or contaminated. Some of the sand-boil deposits dried with a white mineral crust that appeared to have high gypsum content. Localized sections of roads, fields, and towns were also inundated with water from overflowing canals (Baja California government officials reported that canals overflowed the day after the earthquake as a result of increased flow in the Colorado River due to post-earthquake releases from one of the dams near the U.S./Mexico border). Standing water remained in some roadside ditches and fields (Figure 6.3) as of April 16, 2010.

**Figure 6.3:** Flooded roadside ditch and partially flooded wheat field west of Durango, Baja California, Mexico.

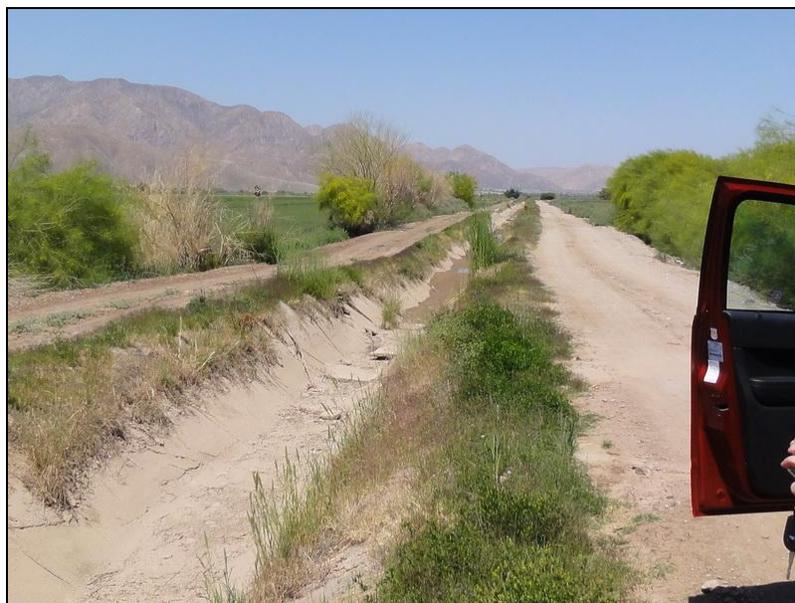
Liquefaction and lateral spreading caused cracking, settlement, and slumping of unreinforced-concrete-lined irrigation canals (Figures 6.4, 6.5, and 6.6), including the Nuevo Delta, Reforma and Revolución Canals (Figure 6.7). Some of the canals failed when portions of their sidewalls shifted laterally into adjacent unlined stream channels or drainage ditches (Figures 6.8 and 6.9). The Baja California government estimated that 57 km (35 mi) of major canals, 350 km (217 mi) of minor canals and 380 km (236 mi) of drainage channels were damaged.

**Figure 6.4:** Irrigation canal west of Cucapah, Baja California, Mexico.

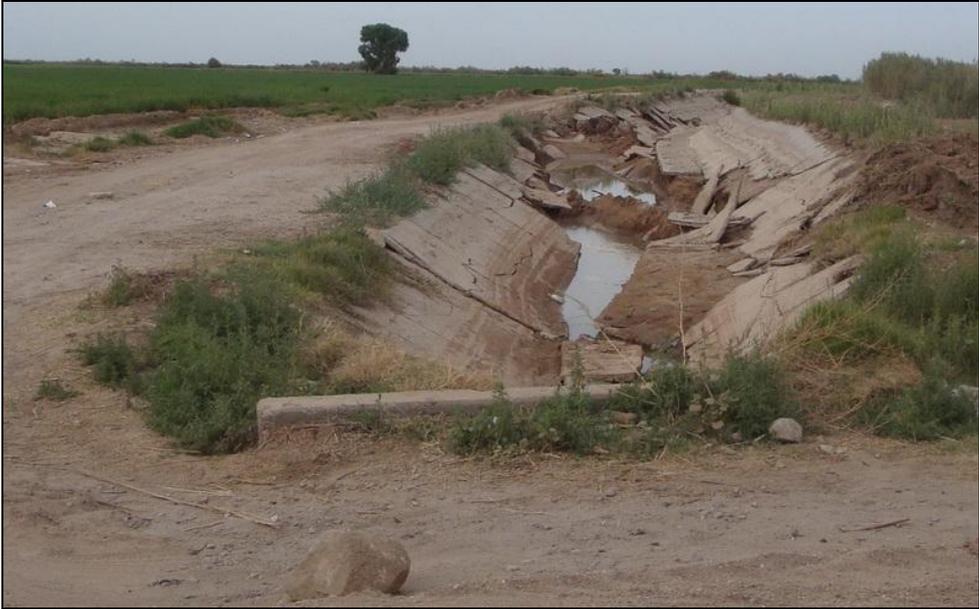
**Figure 6.5:** Irrigation canal west of Nayarit, Baja California, Mexico.

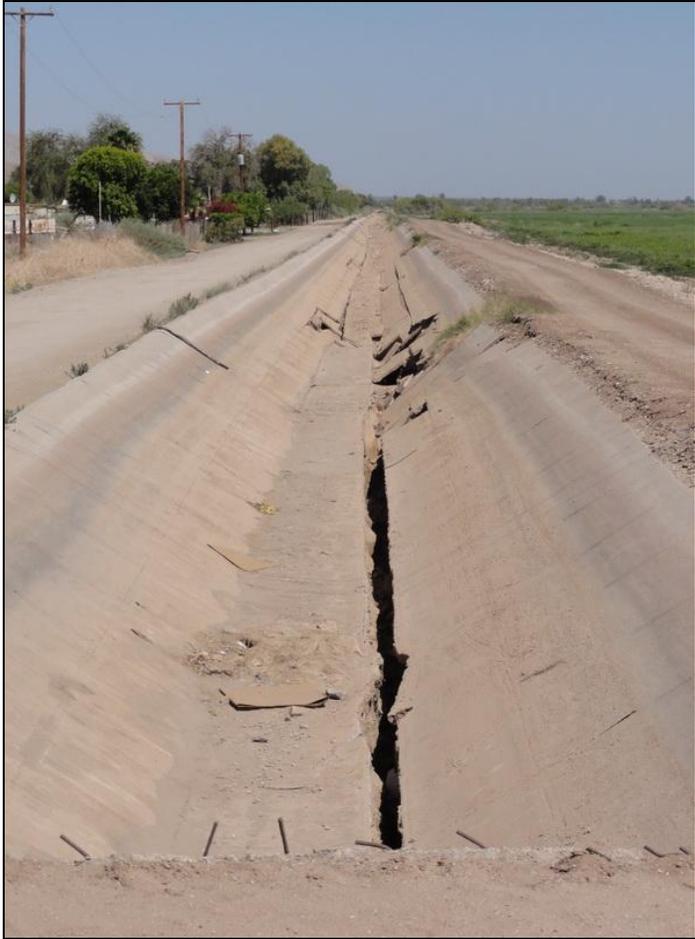
**Figure 6.6:** Irrigation canal west of Cucapah, Baja California, Mexico.

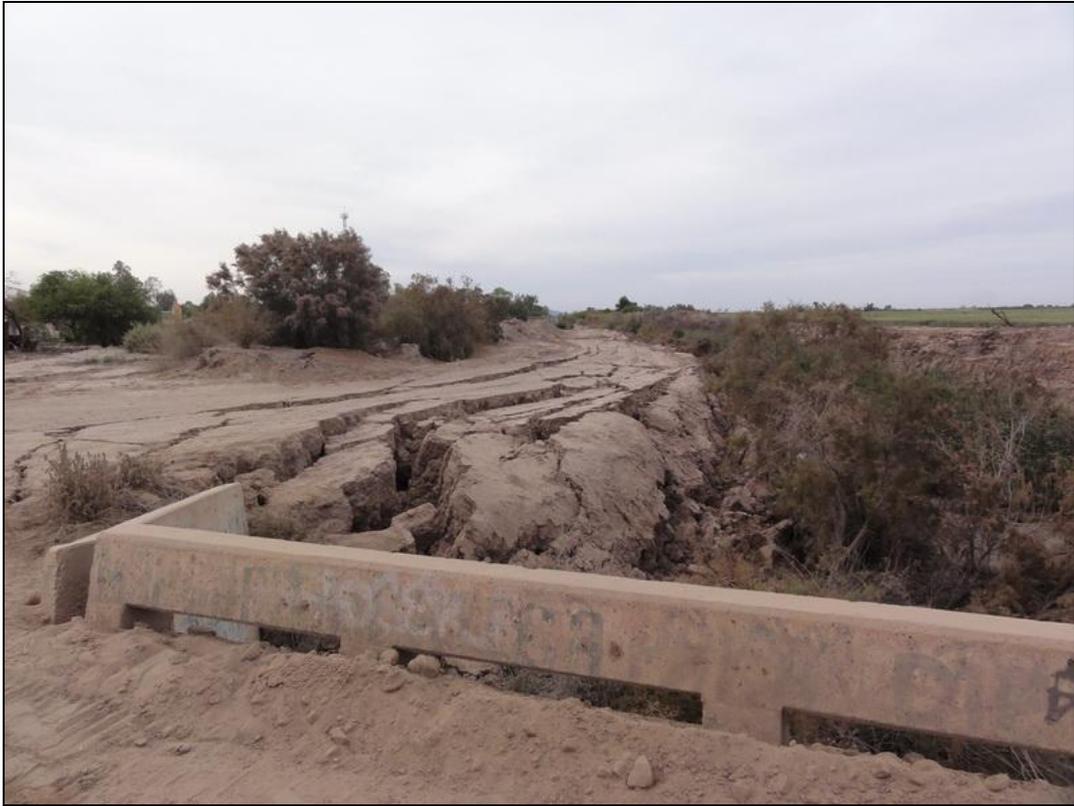
**Figure 6.7:** Stream bank on eastern edge of Nayarit, Baja California, Mexico.

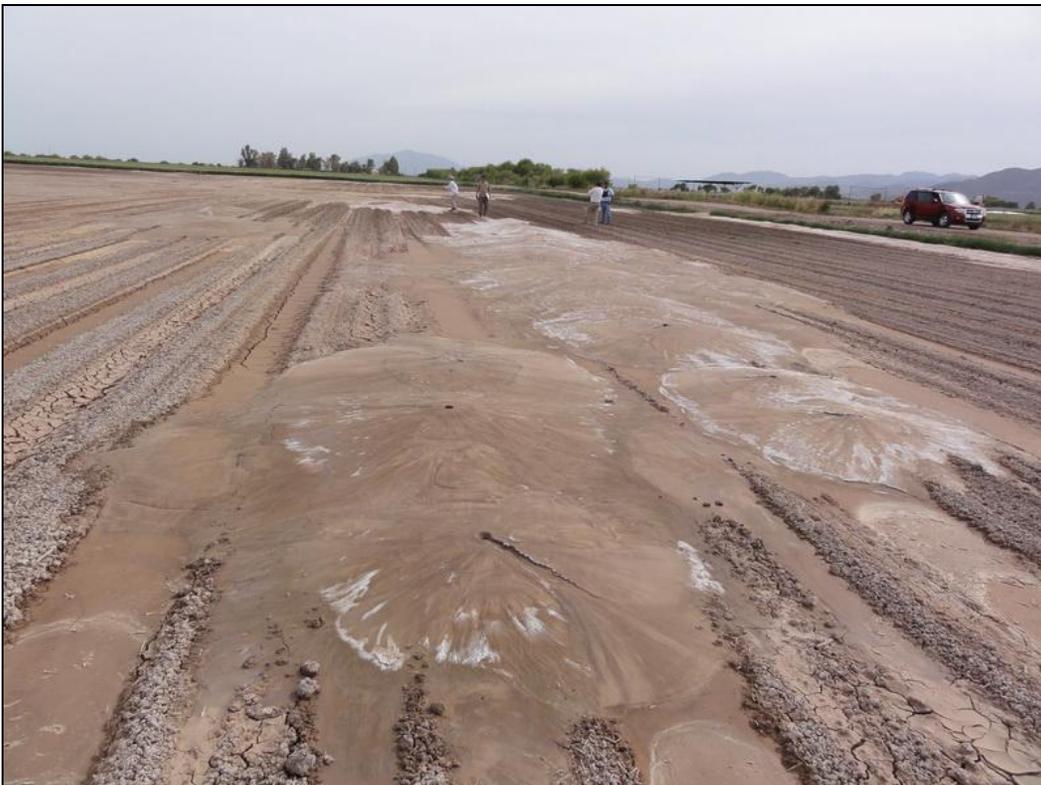
Most crops in the fields at the time of the earthquake, predominantly wheat and alfalfa but also cabbage and newly planted cotton, were beginning to wilt due to lack of irrigation and are likely to be lost this season. In addition, massive sand boils (see Figures 6.10, 6.11 and 6.12) and sand sheets blanketed portions of fields, and large-scale lateral spreading created scarps and fissures that crossed fields (Figures 6.13 and 6.14). The Baja California government reported that the earthquake also caused regional topographic tilting. The resulting disrupted topography will require earthwork and leveling before gravity-controlled irrigation can resume.

**Figure 6.11:** Sand boils in newly seeded cotton field west-northwest of Zacamoto, Baja California, Mexico.

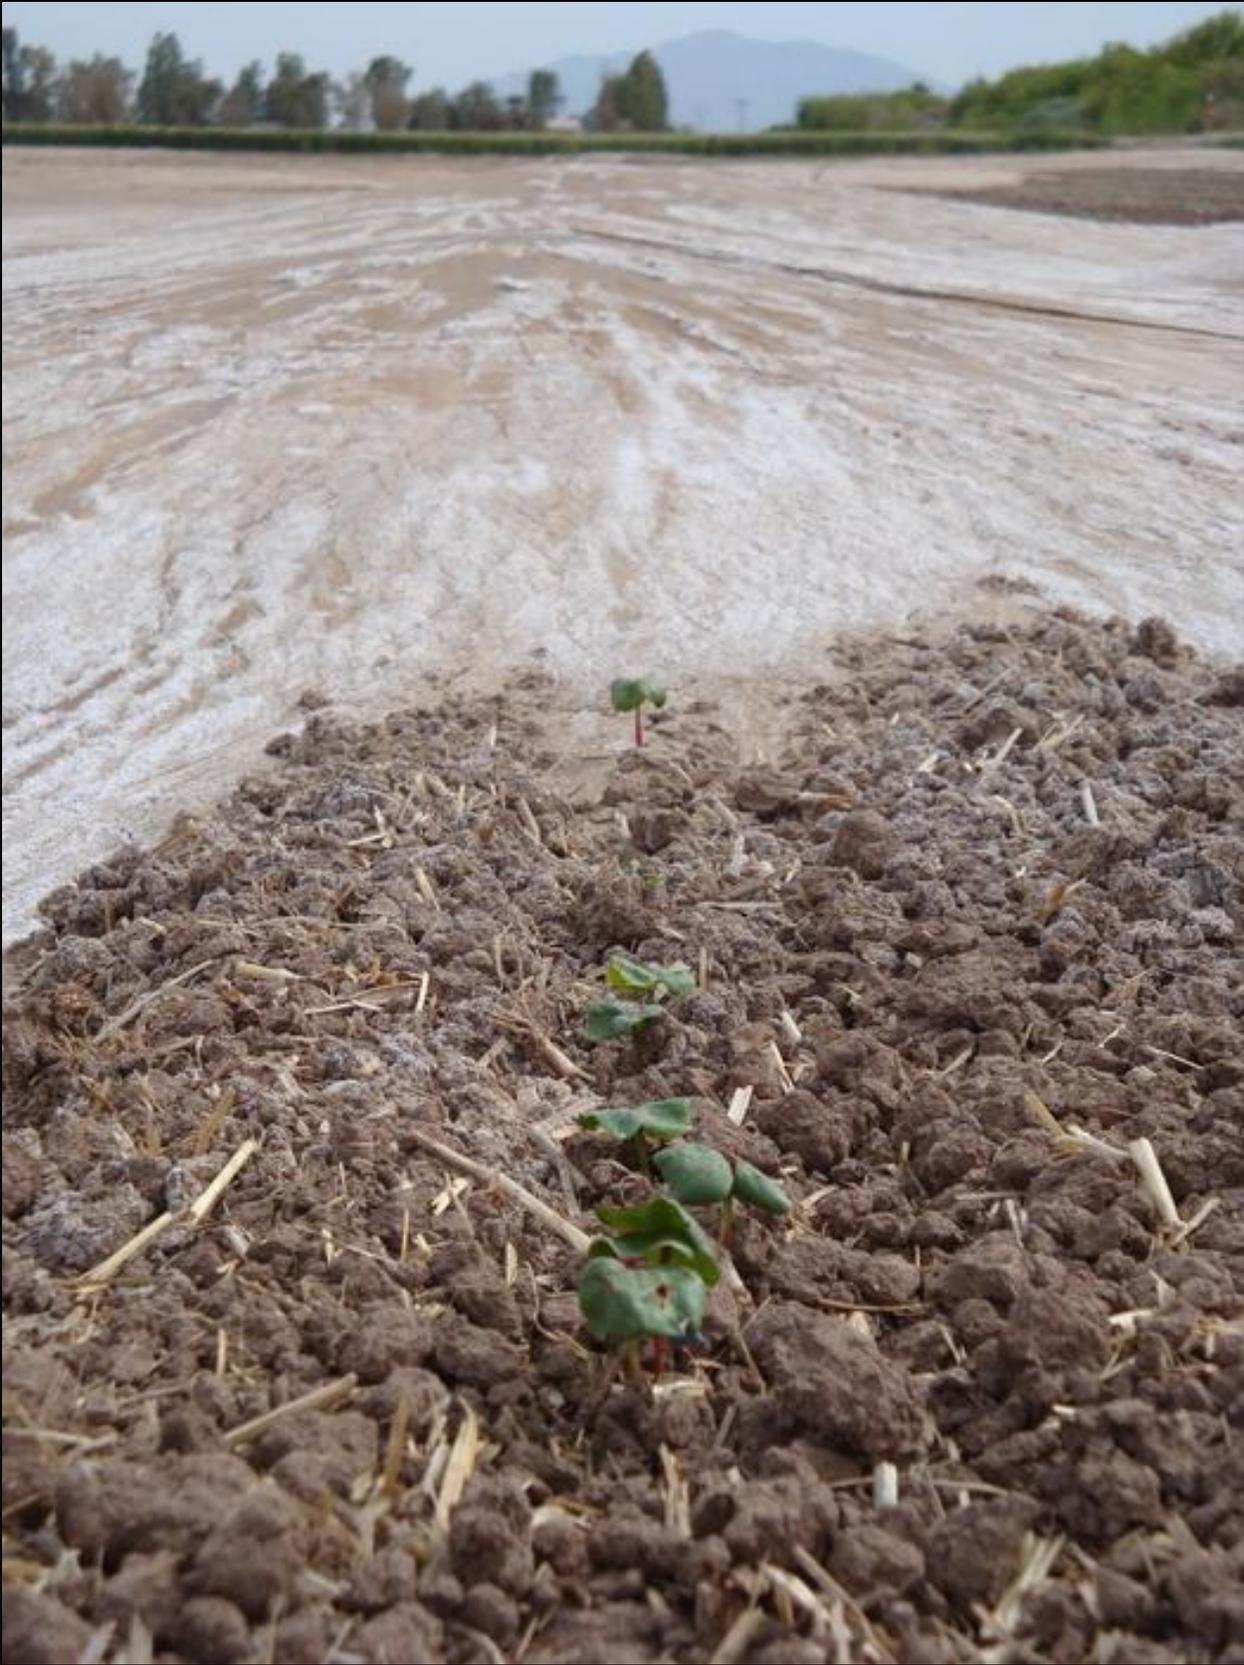
Figure 6.12: Sand boils and cotton seedlings west-northwest of Zacamoto, Baja California, Mexico.

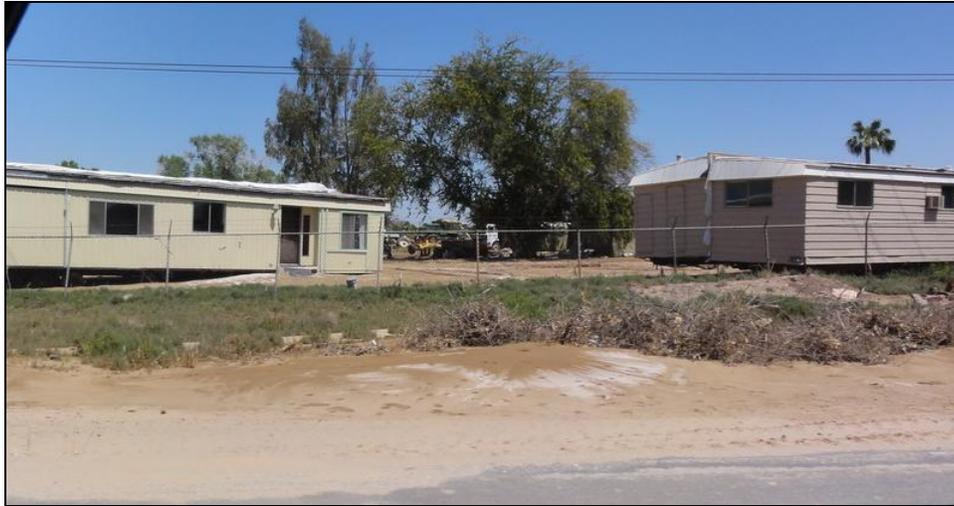
As in the fields, sand boils and sand sheets also blanketed portions of roads, yards, and parks in towns (Figure 6.15) including Nayarit, Oaxaca, and Zacamoto, and scarps and fissures damaged roads, utilities, and buildings (Figure 6.16).

**Figure 6.15:** Sand boils and mobile homes west-northwest of Durango, Baja California, Mexico.
